”Simulated solar radiation test”

Simulated solar radiation test according to ISO 4892-2 of a VHF-radio.

One orange VHF-radio, type TRON TR20 GMDSS from JOTRON.

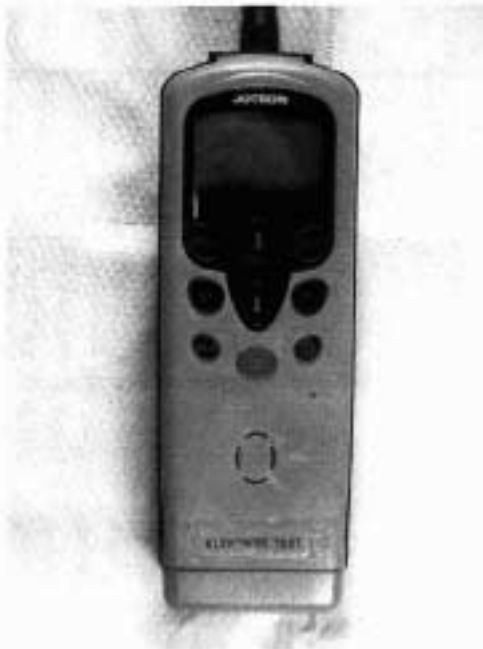
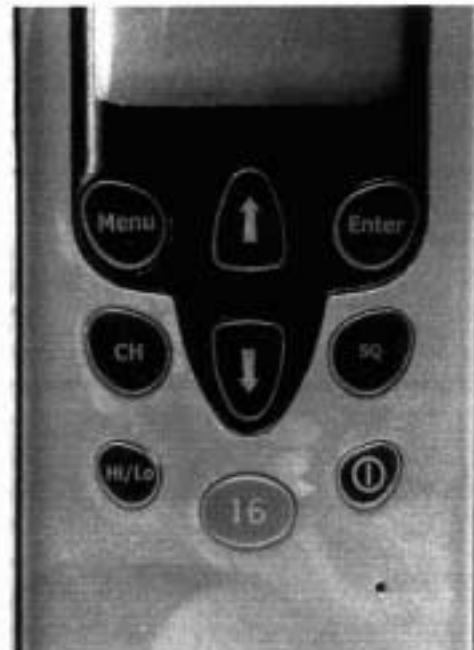
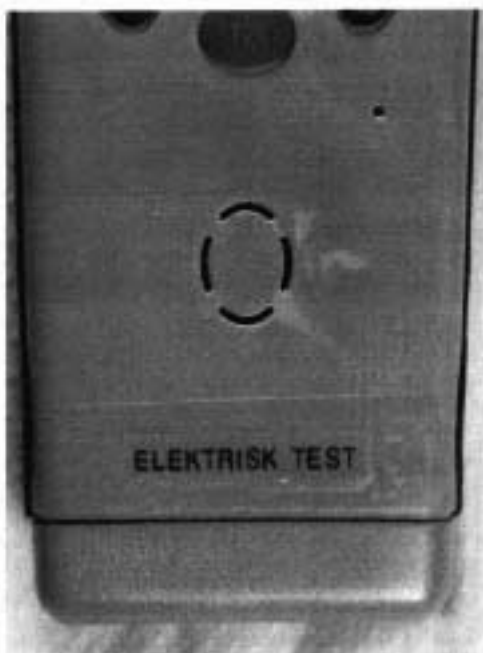
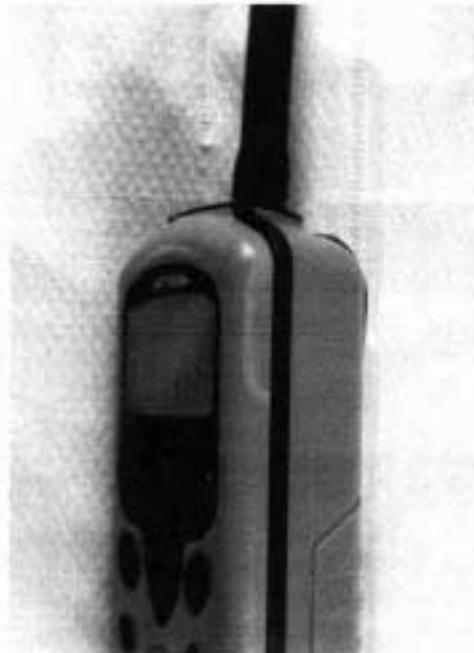
Photographs taken after exposure

Some local variations of the colour have appeared in the area of the microphone/speaker at the front of the VHF-radio and on both sides of the LCD-display.

See photographs in appendix 1, taken before and after the exposure.
