APPENDIX 3: Photographs of test setup

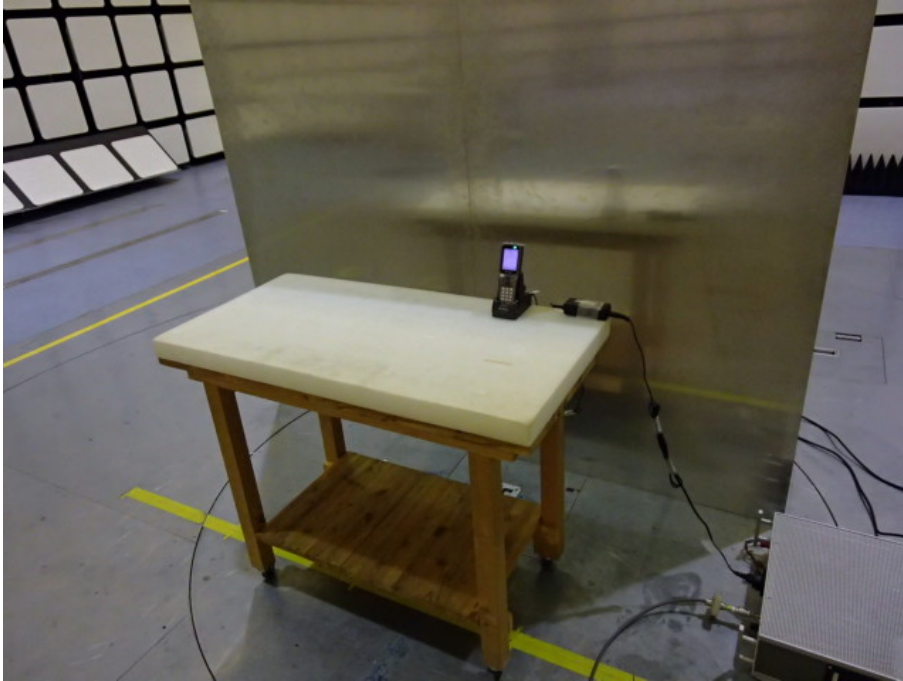
Photo 1

Conducted Emission

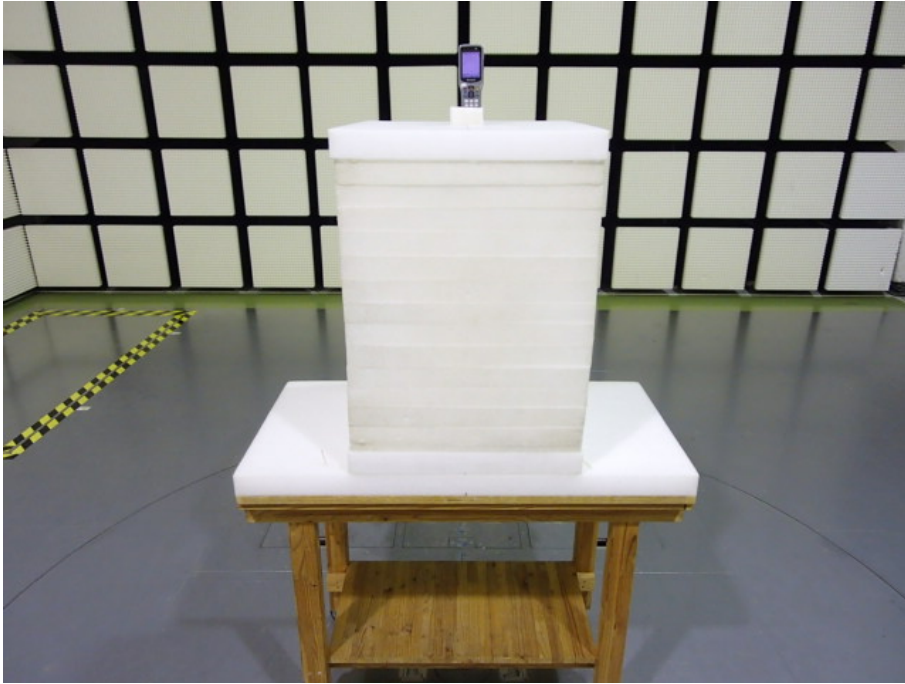
Photo 1

Radiated Spurious Emission

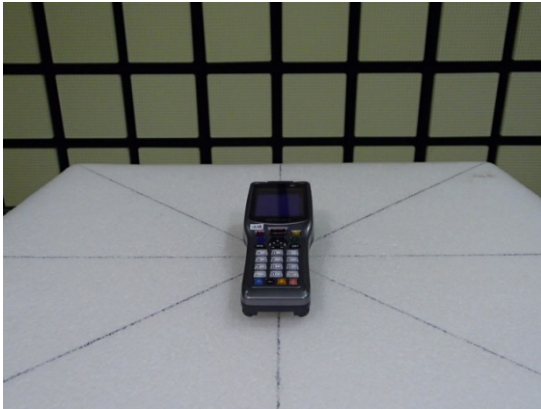
X-axis

Worst Case Position

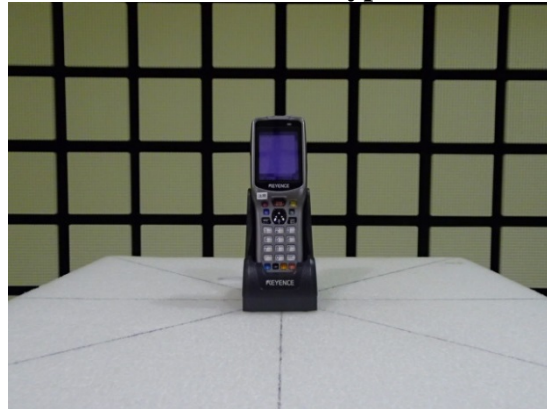
With Cradle Type1

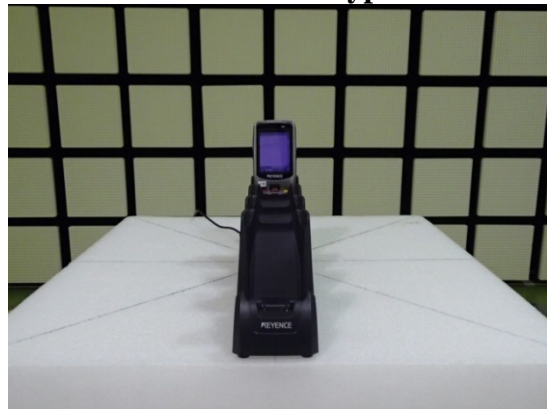
With Cradle Type2

| | Horizontal | Vertical |
|---|---|---|
| Below 1GHz | With Cradle Type2 | With Cradle Type2 |
