APPENDIX 3: Photographs of test setup

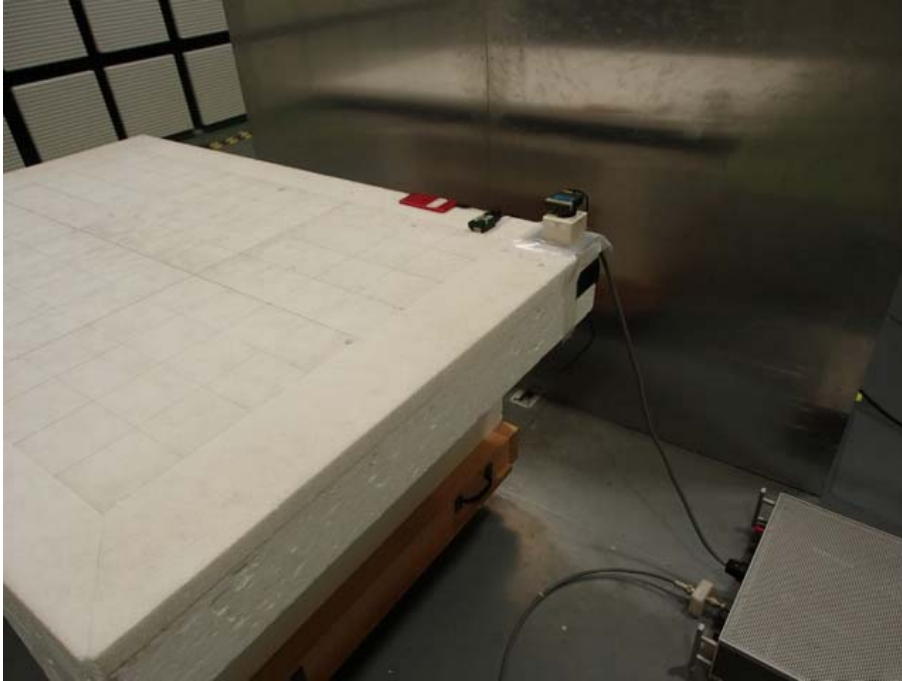
Photo 1

Conducted Emission

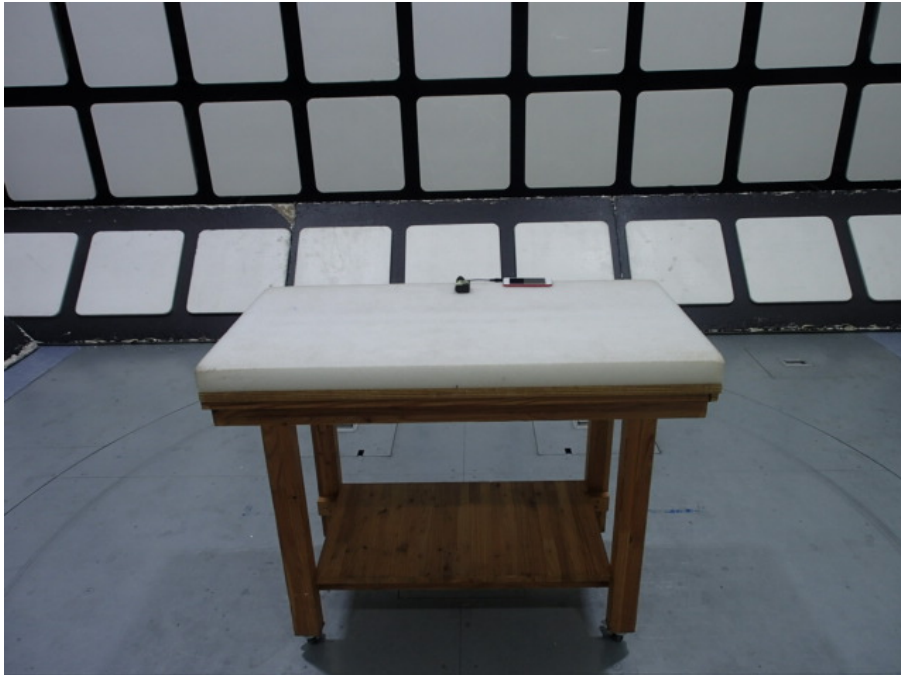
Photo 1

Radiated Spurious Emission
Below 1 GHz

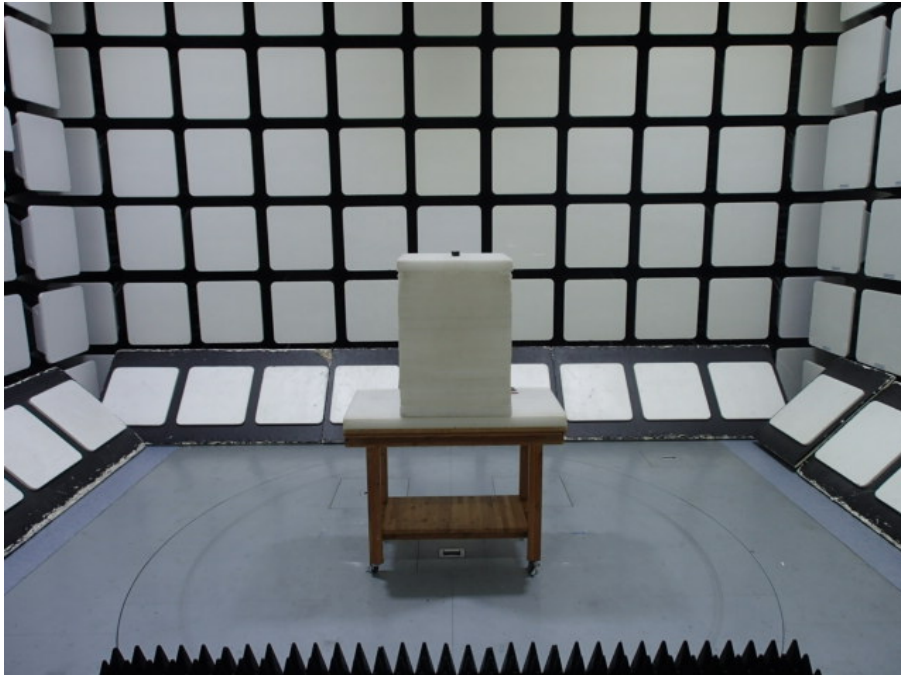
Photo 1

Radiated Spurious Emission
Above 1 GHz

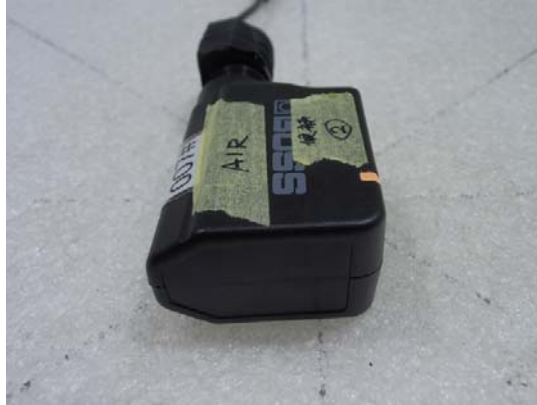
X-axis

Worst Case Position

Below 1 GHz (Horizontal: X-axis/ Vertical: X-axis)
Above 1 GHz (Horizontal: X-axis/ Vertical: Y-axis)
