APPENDIX 3: Photographs of test setup

Conducted Emission

Radiated Spurious Emission

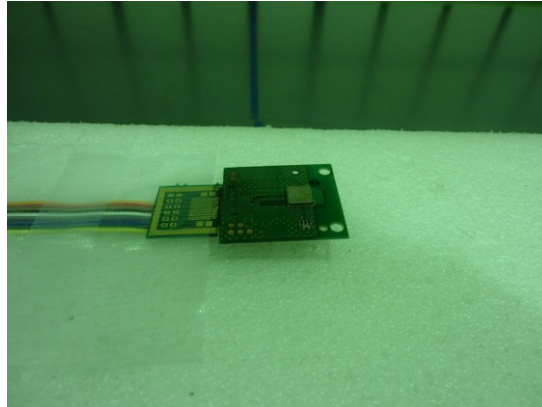
X-axis

Worst Case Position (Horizontal: Z-axis/ Vertical:Y-axis)
