APPENDIX 3: Photographs of test setup

Conducted Emission

Radiated Spurious Emission

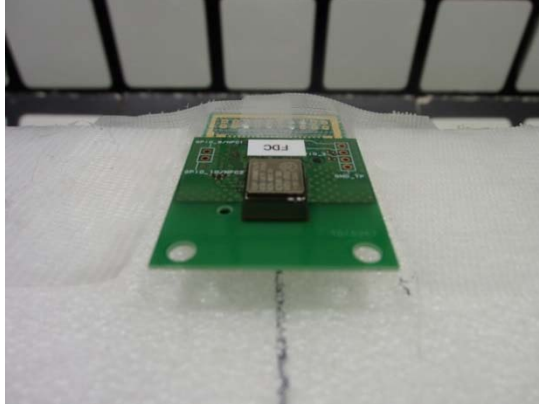
X-axis

Worst Case Position
(Below 1 GHz Horizontal: X-axis/ Vertical: X-axis)
(Above 1 GHz Horizontal: Z-axis/ Vertical: Y-axis)
