Occupied Bandwidth Plots

FCC Test Report

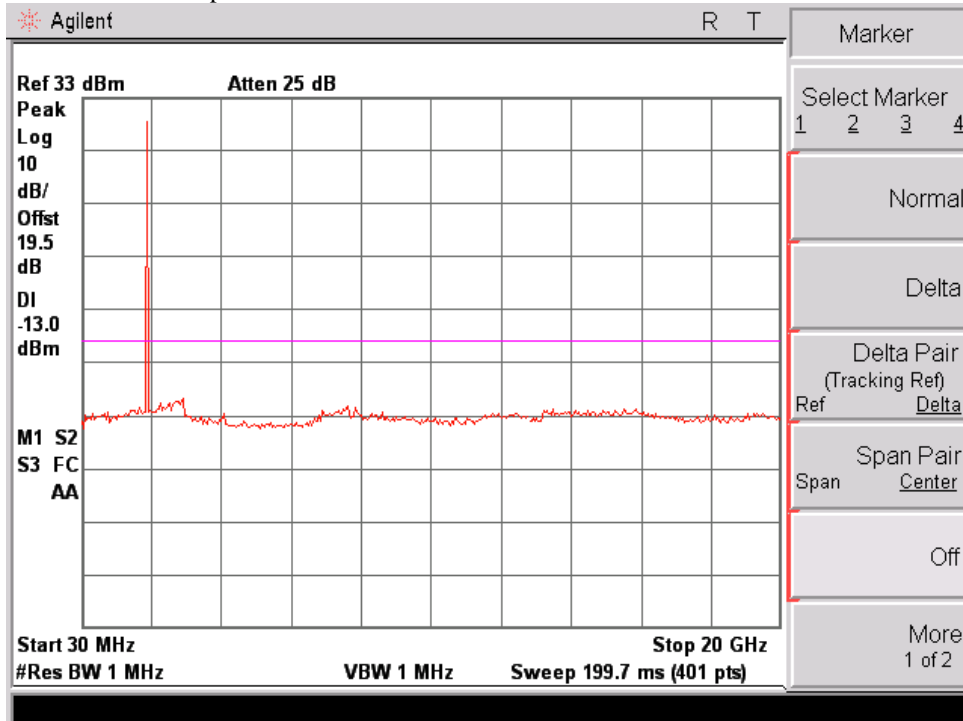
A1. Measurement result – Plot no.3

Spurious Emissions at Antenna Terminal – Channel 512

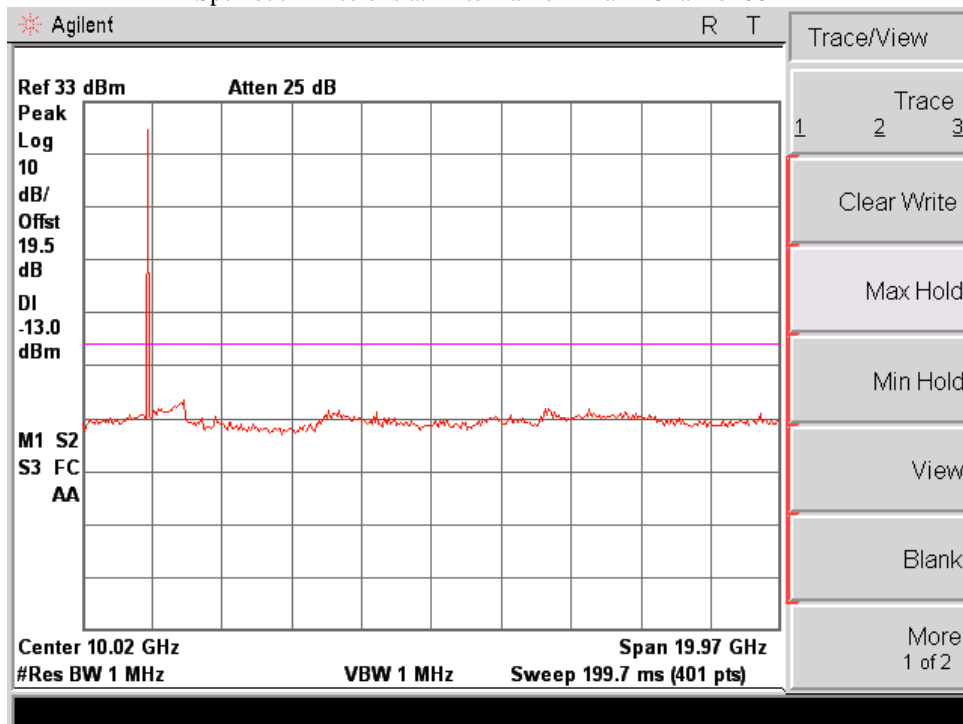
Spurious Emissions at Antenna Terminal – Channel 661

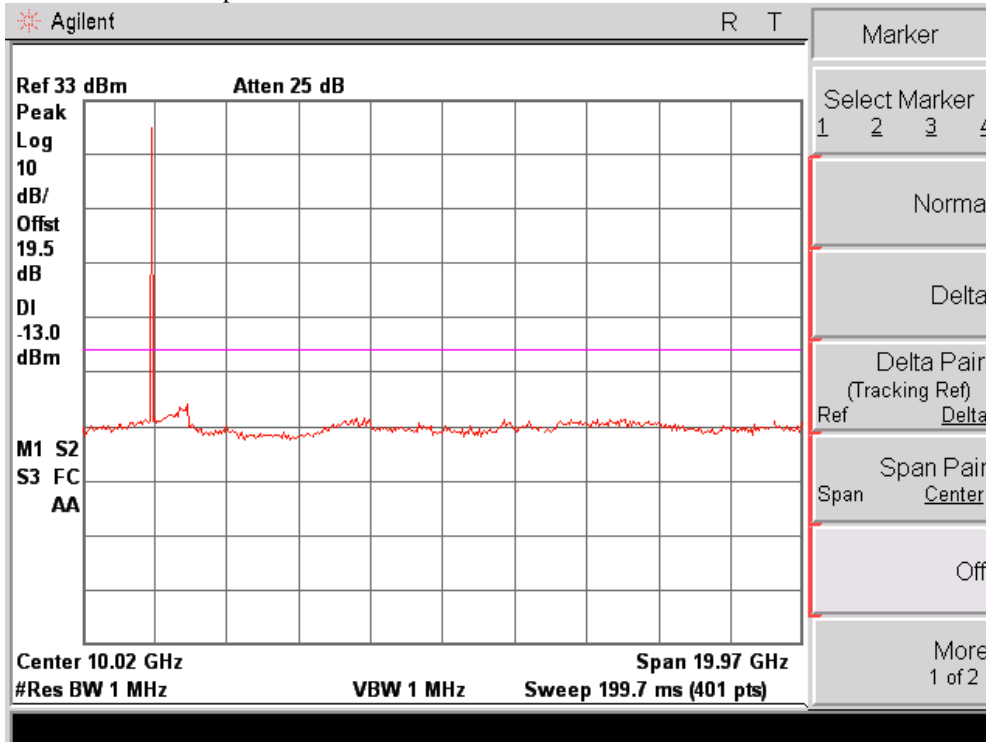
A1. Measurement result – Plot no.4

Spurious Emissions at Antenna Terminal – Channel 810

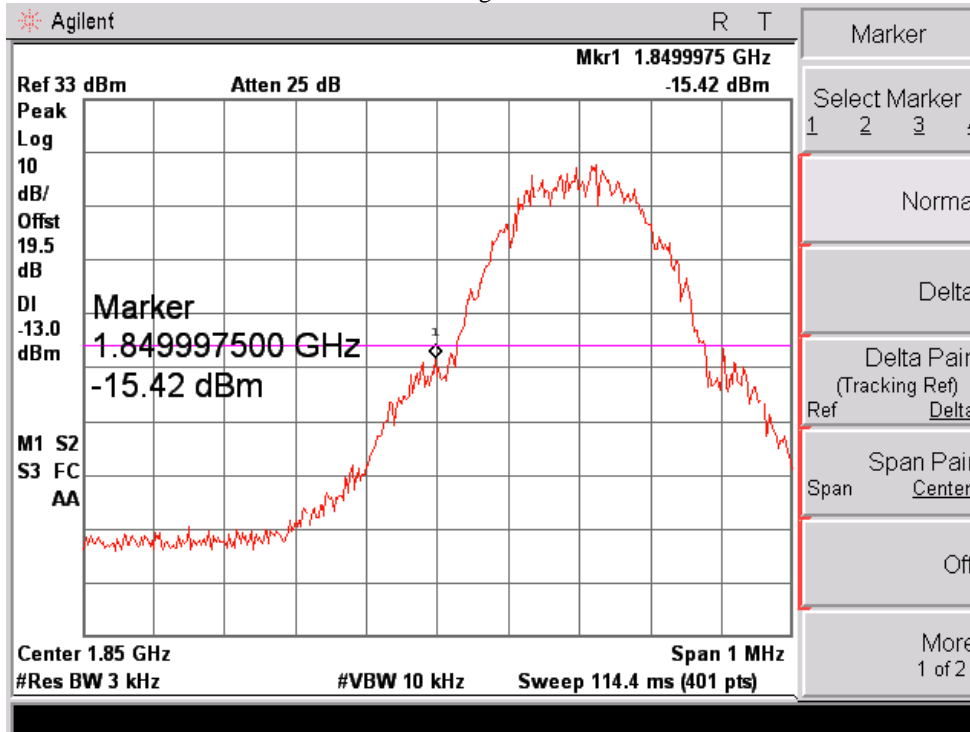
A1. Measurement result – Plot no.5

Band edge – Lower

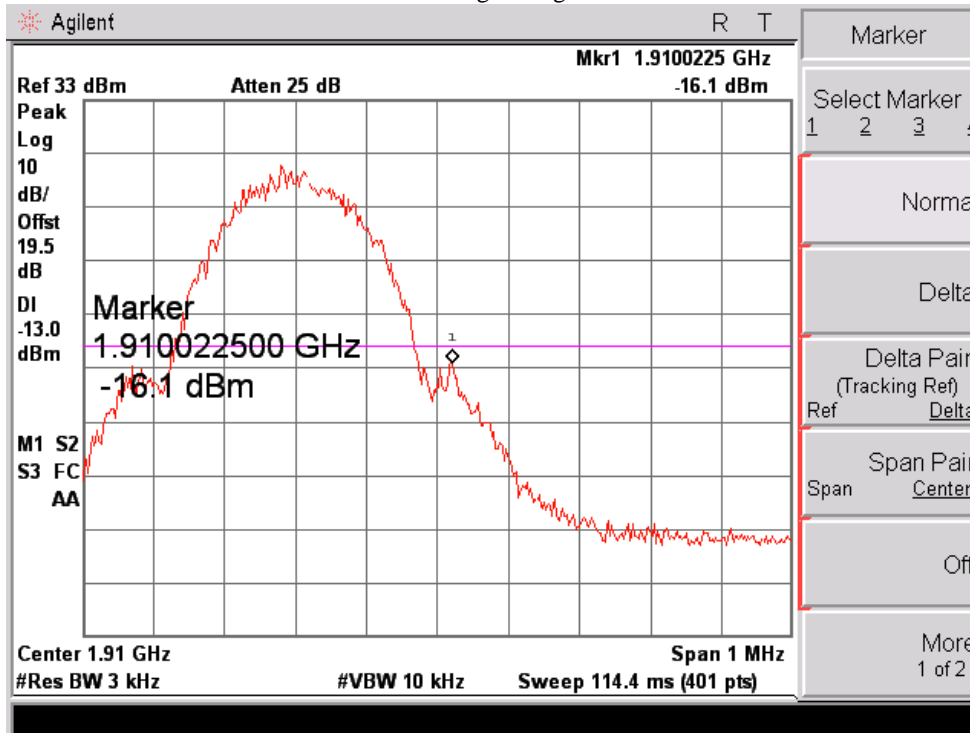
Band edge – Higher
