PHOTOGRAPHS OF TEST SETUP

Test model No.:BP3MV1-3B

Page 49 of 61 Report No.: EED32M00176801

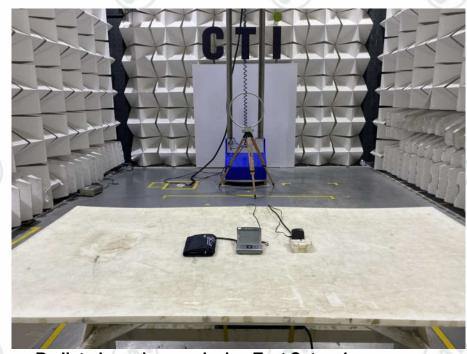
Radiated spurious emission Test Setup-1(Below 30MHz)

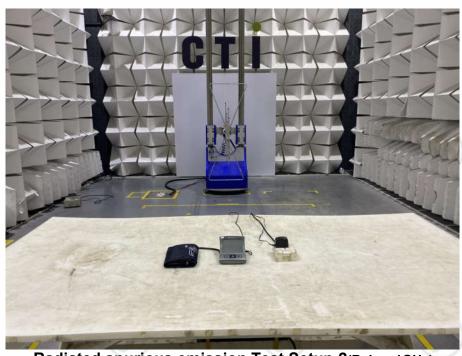
Radiated spurious emission Test Setup-2(Below 1GHz)

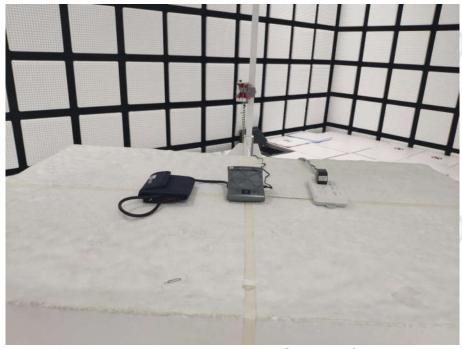
Radiated spurious emission Test Setup-3 (Above 1GHz)

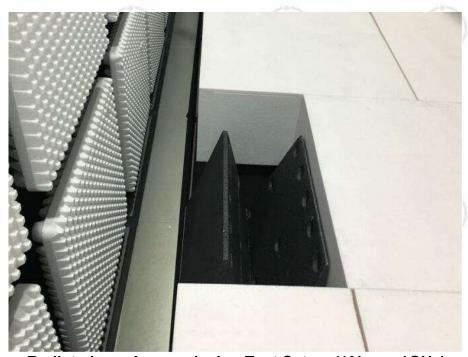
Radiated spurious emission Test Setup-4(Above 1GHz) There are absorbing materials under the ground.

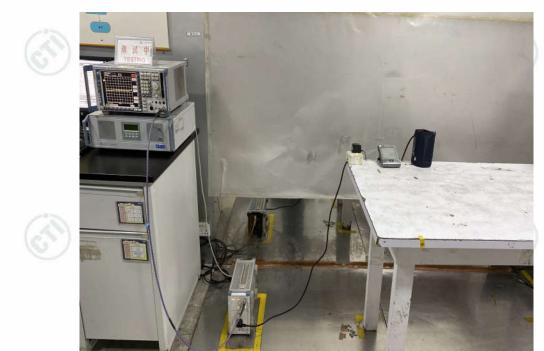
Conducted Emissions Test Setup
