9 PHOTOGRAPHS OF TEST SETUP

Report No.: EED32P81107301 Page 33 of 43

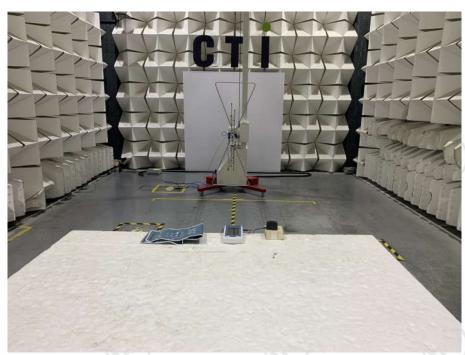
Radiated spurious emission Test Setup-1(Below 1GHz)

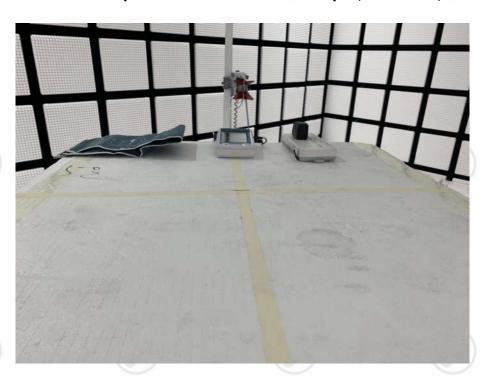
Radiated spurious emission Test Setup-2(Above 1GHz)

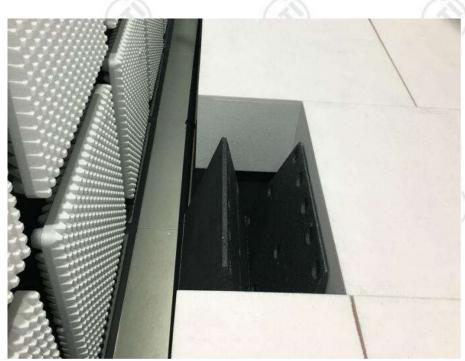
Radiated spurious emission Test Setup-3(Above 1GHz)
There are absorbing materials under the ground.

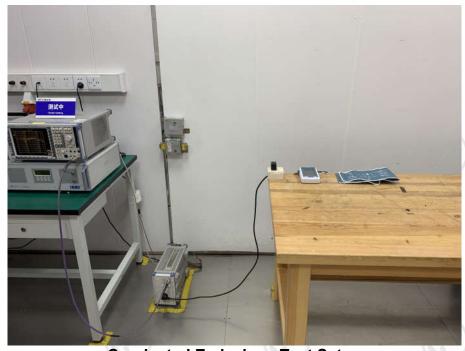
Conducted Emissions Test Setup
