Report No.: EED32M00009001

## PHOTOGRAPHS OF TEST SETUP

Test model No.: BP3NQ1-4B

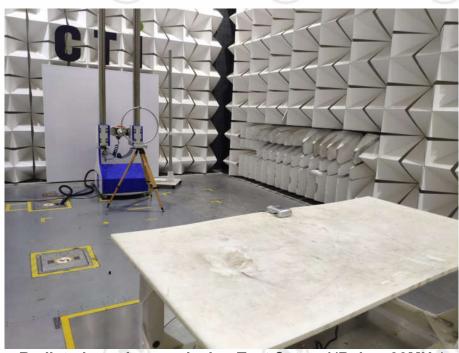
Radiated spurious emission Test Setup-1(Below 30MHz)

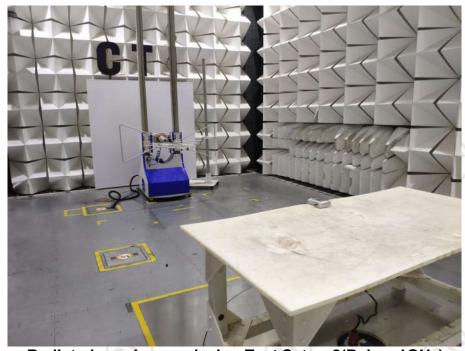
Radiated spurious emission Test Setup-2(Below 1GHz)

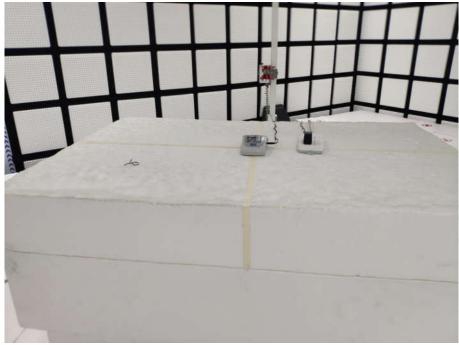
Radiated spurious emission Test Setup-3(Above 1GHz)

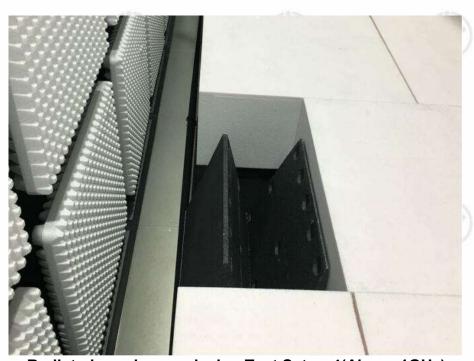
Radiated spurious emission Test Setup-4(Above 1GHz)
There are absorbing materials under the ground.
