APPENDIX 3: Photographs of test setup

Radiated Spurious Emission

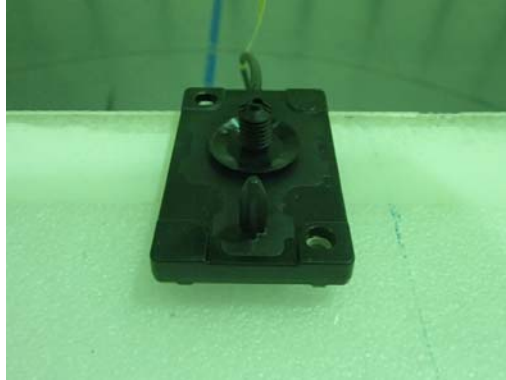
X-axis

Worst Case Position

W52, W53, W56(Horizontal: X-axis/ Vertical:X-axis)
W58 (Horizontal: Y-axis/ Vertical:Y-axis)
