**APPENDIX 3: Photographs of test setup**

**Radiated Spurious Emission**

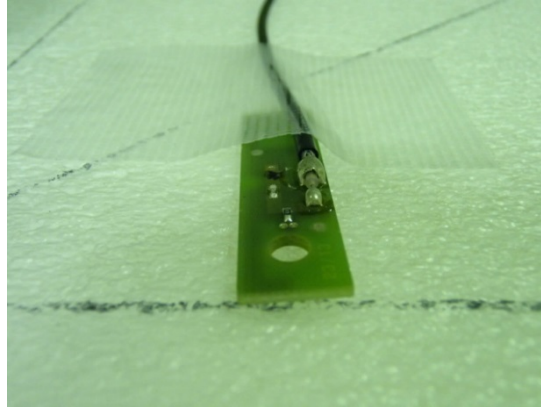
**X-axis**

**Worst Case Position**

(Above 1GHz : Horizontal: X-axis/ Vertical:Y-axis)  
(Below 1GHz : Horizontal: Y-axis/ Vertical:Y-axis)
