**APPENDIX 3: Photographs of test setup**

**Radiated Spurious Emission**

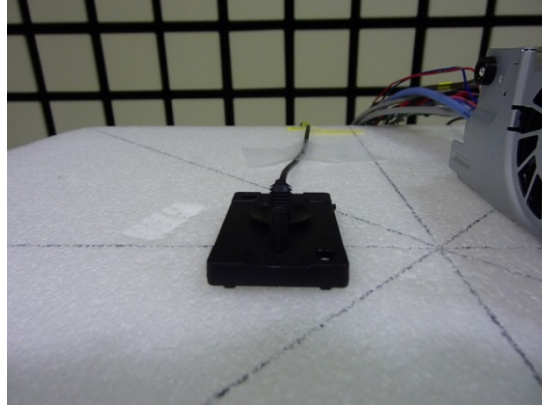
**X-axis**

**Worst Case Position**

(Above 1GHz : Horizontal: Z-axis/ Vertical:Y-axis)

(Below 1GHz : Horizontal: Y-axis/ Vertical:Y-axis)
