8.1.8 Test data for LTE B25 at middle channel, WIFI at 5170 MHz and BT at low channel

8.1.9 Test data for LTE B7 at middle channel, WIFI at 5170 MHz and BT at high channel

Section 9. Block diagrams of test set-ups

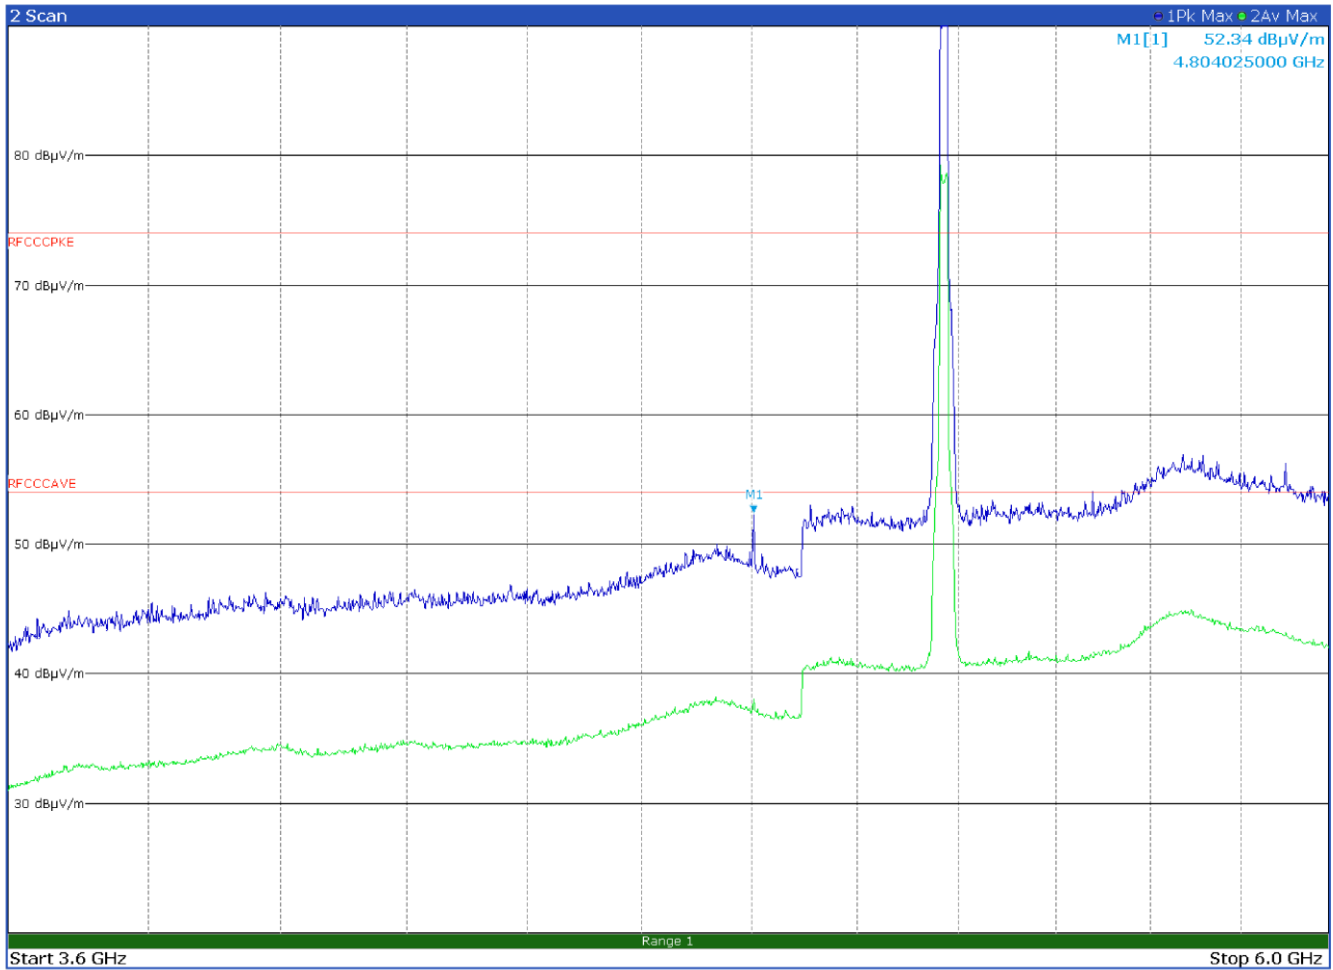
Antenna in horizontal polarization – No inter-modulation product founds

Limit exceeded by carrier

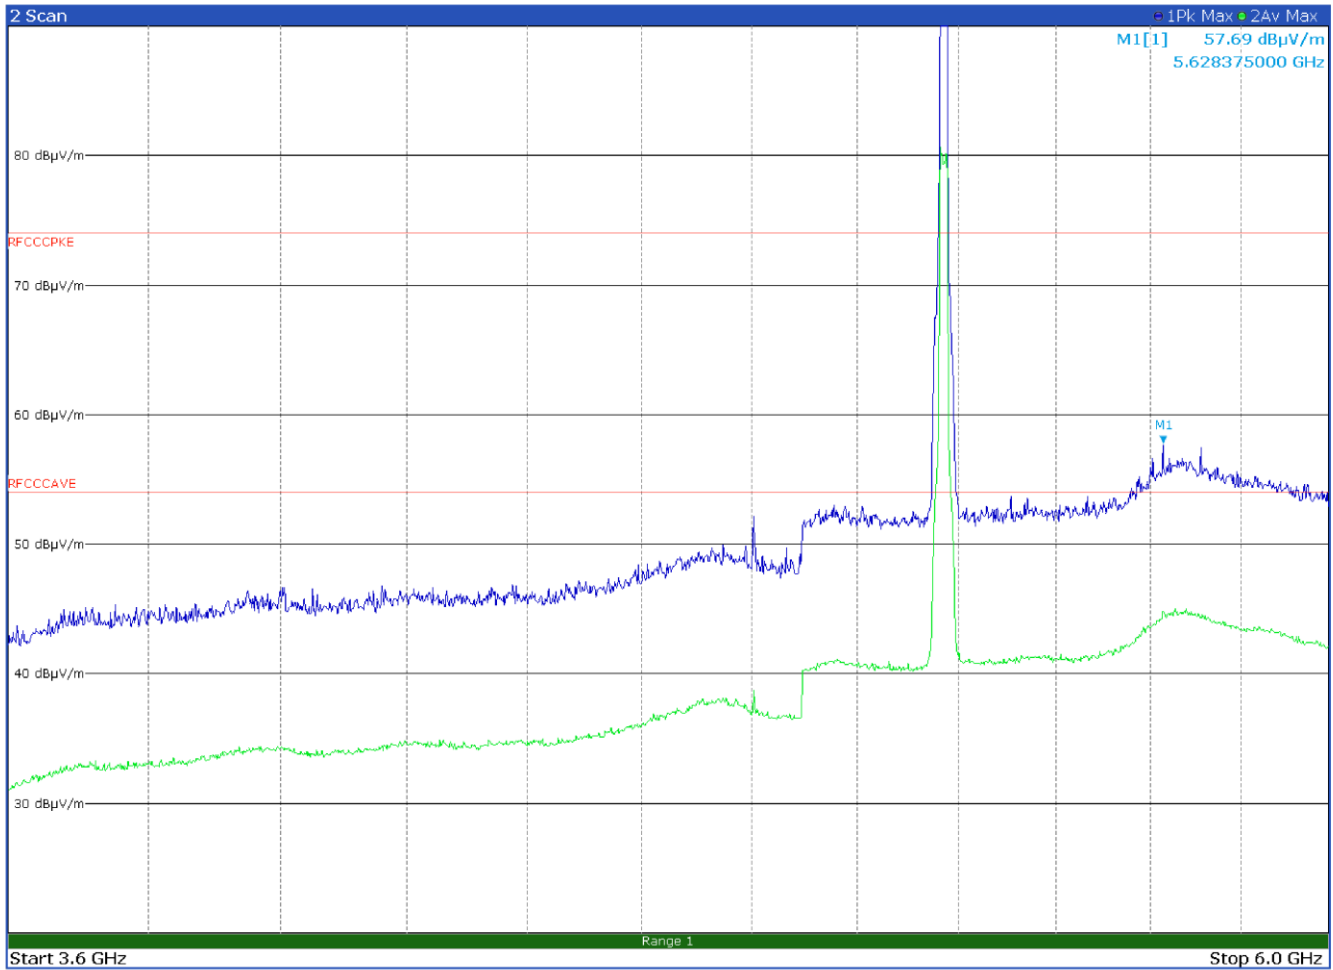
Antenna in vertical polarization – No inter-modulation product founds

Limit exceeded by carrier

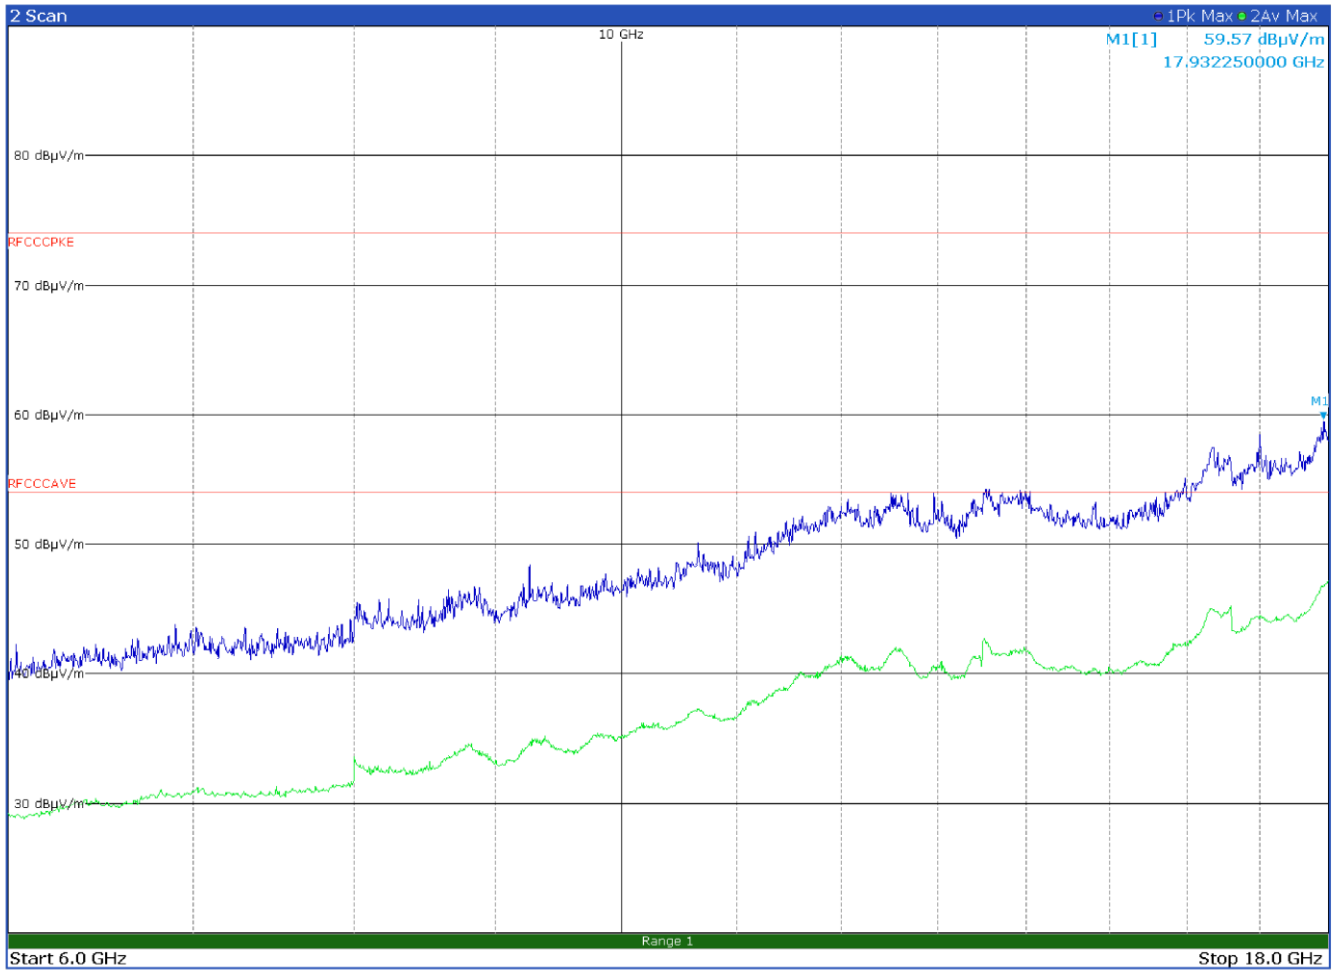
Antenna in horizontal polarization – No inter-modulation product founds

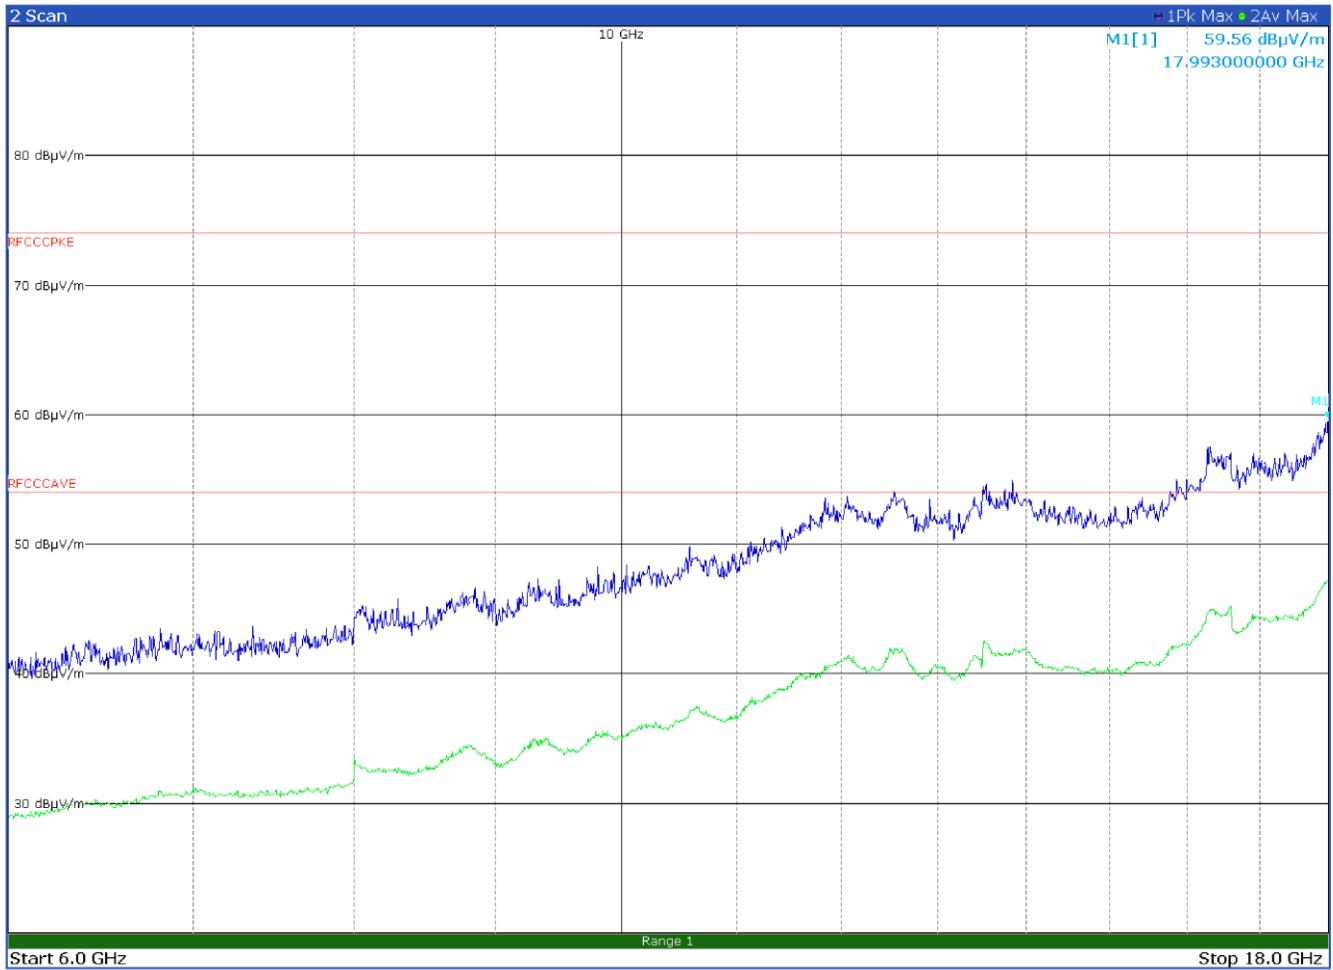
Antenna in vertical polarization – No inter-modulation product founds

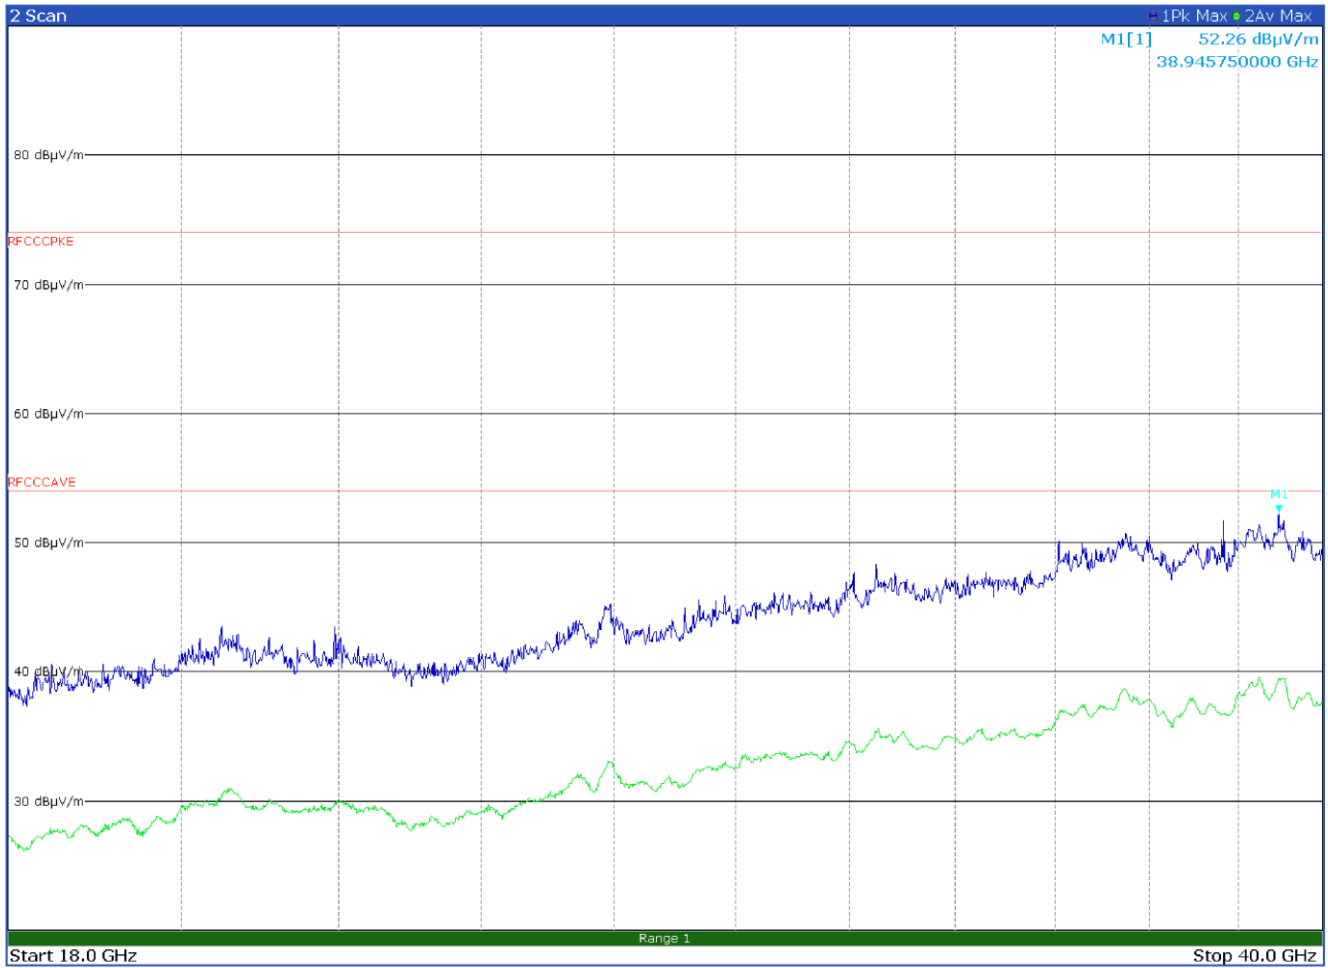
Antenna in horizontal polarization – No inter-modulation product founds

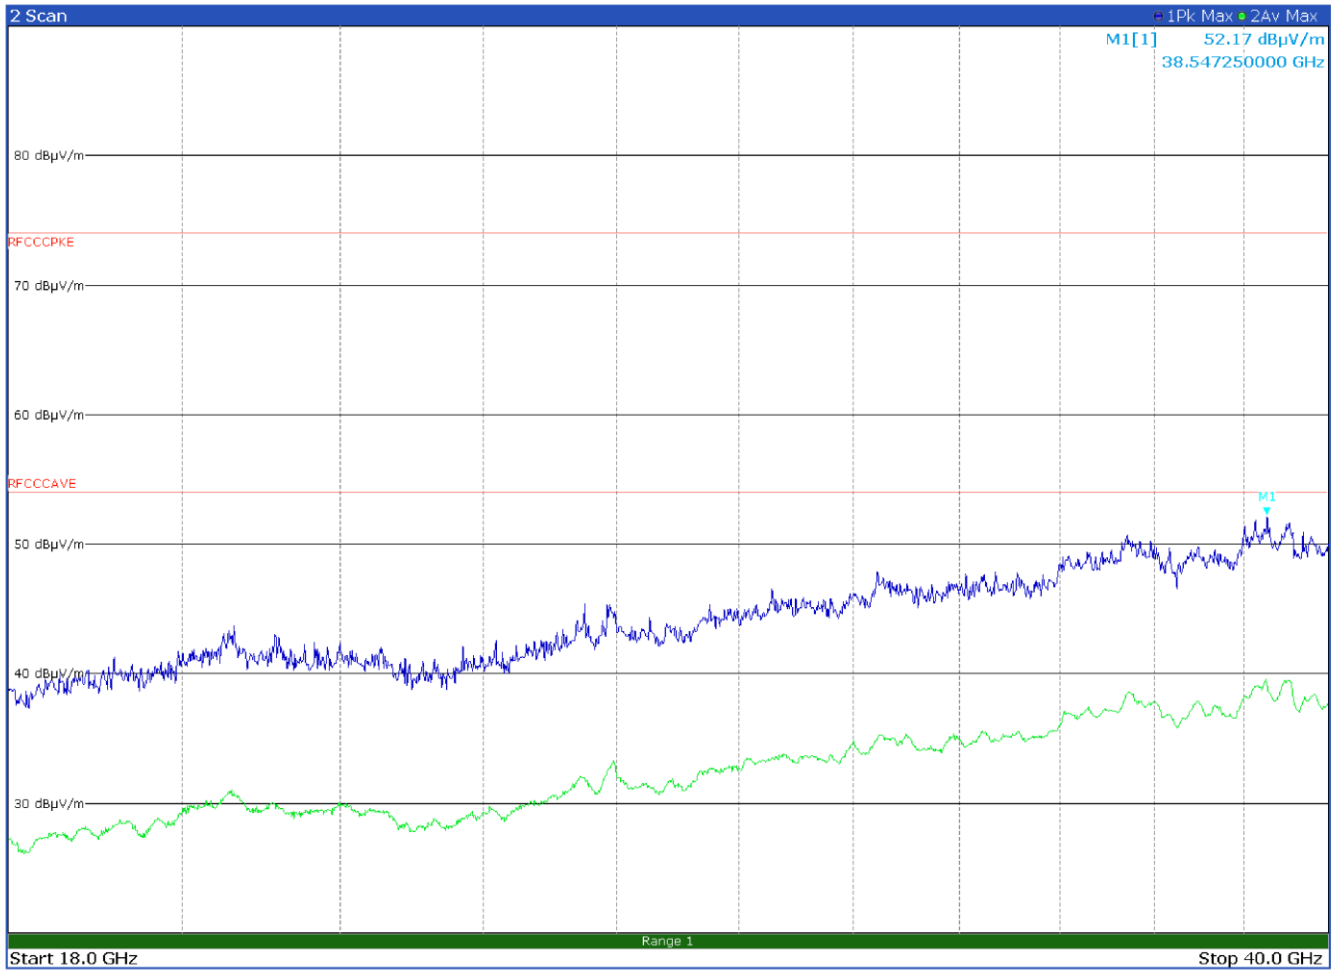
Antenna in vertical polarization – No inter-modulation product founds

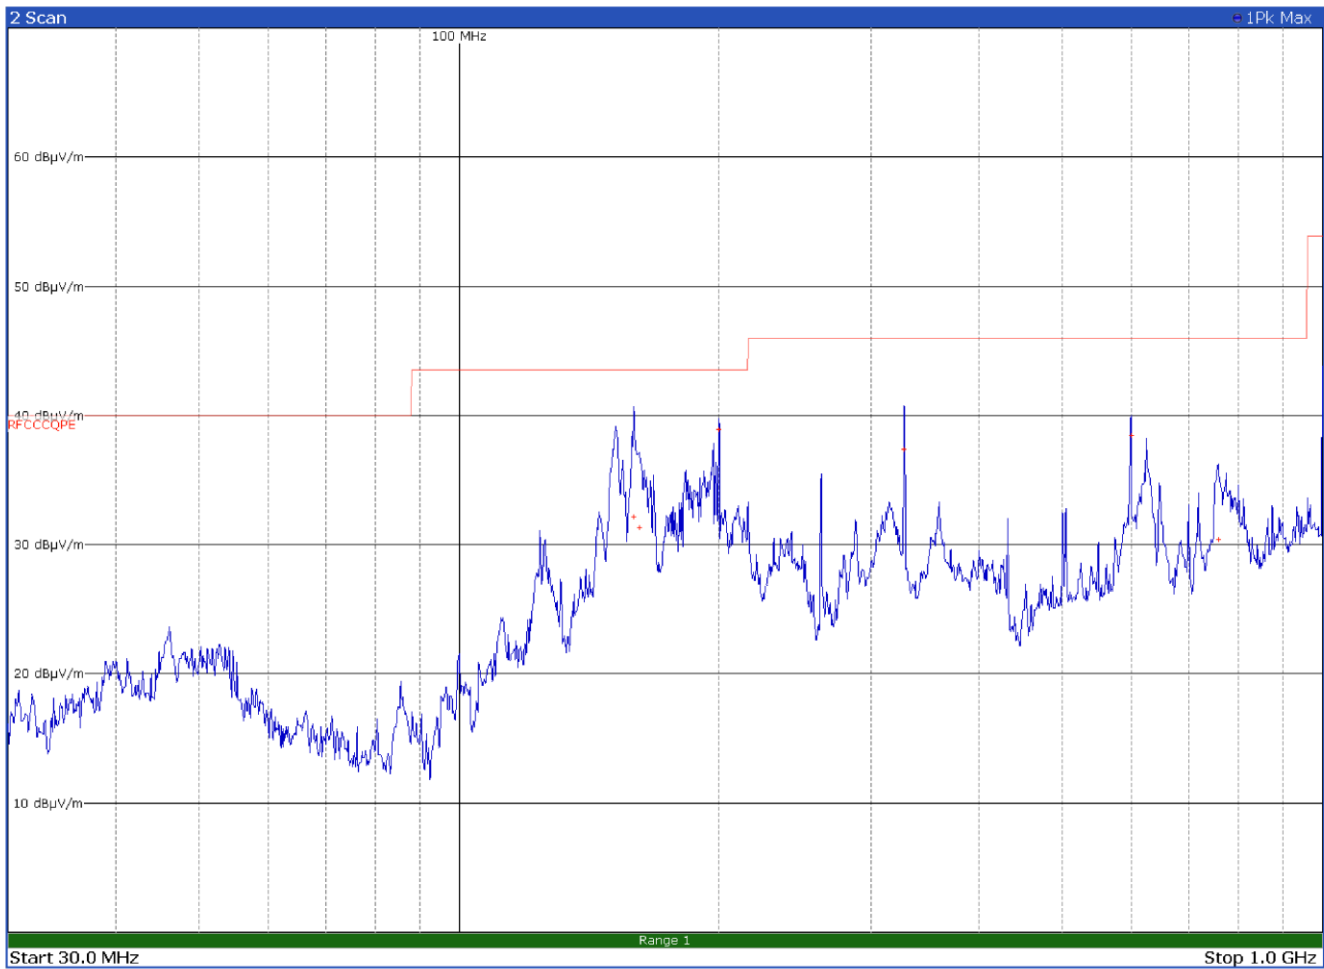
Antenna in horizontal polarization

Frequency (MHz)	Level (dBµV/m)	Limit (dBµV/m)	Margin (dB)	Detector
159.3300	32.2	43.5	-11.3	QP
161.6100	31.4	43.5	-12.1	QP
200.0100	39.0	43.5	-4.5	QP
327.6600	37.5	46.0	-8.5	QP
600.0000	38.5	46.0	-7.5	QP
756.9000	30.4	46.0	-15.6	QP

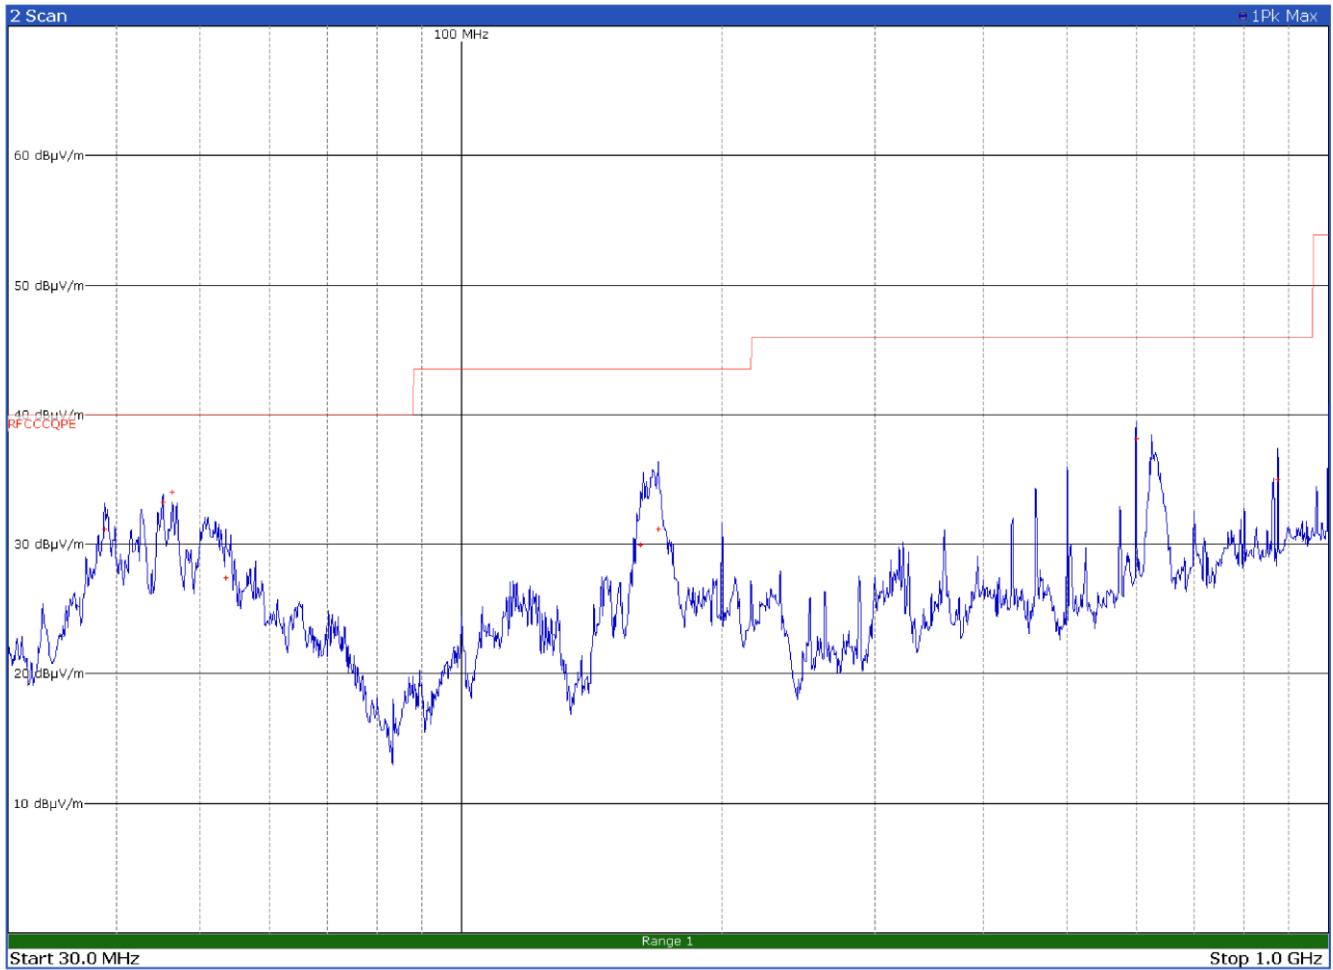
Antenna in vertical polarization

Frequency (MHz)	Level (dBµV/m)	Limit (dBµV/m)	Margin (dB)	Detector
38.7900	31.2	40.0	-8.8	QP
45.2400	33.3	40.0	-6.7	QP
46.3500	34.0	40.0	-6.0	QP
53.4600	27.4	40.0	-12.6	QP
160.9200	30.0	43.5	-13.5	QP
168.6300	31.2	43.5	-12.3	QP
600.0000	38.2	46.0	-7.8	QP
874.9800	35.1	46.0	-10.9	QP

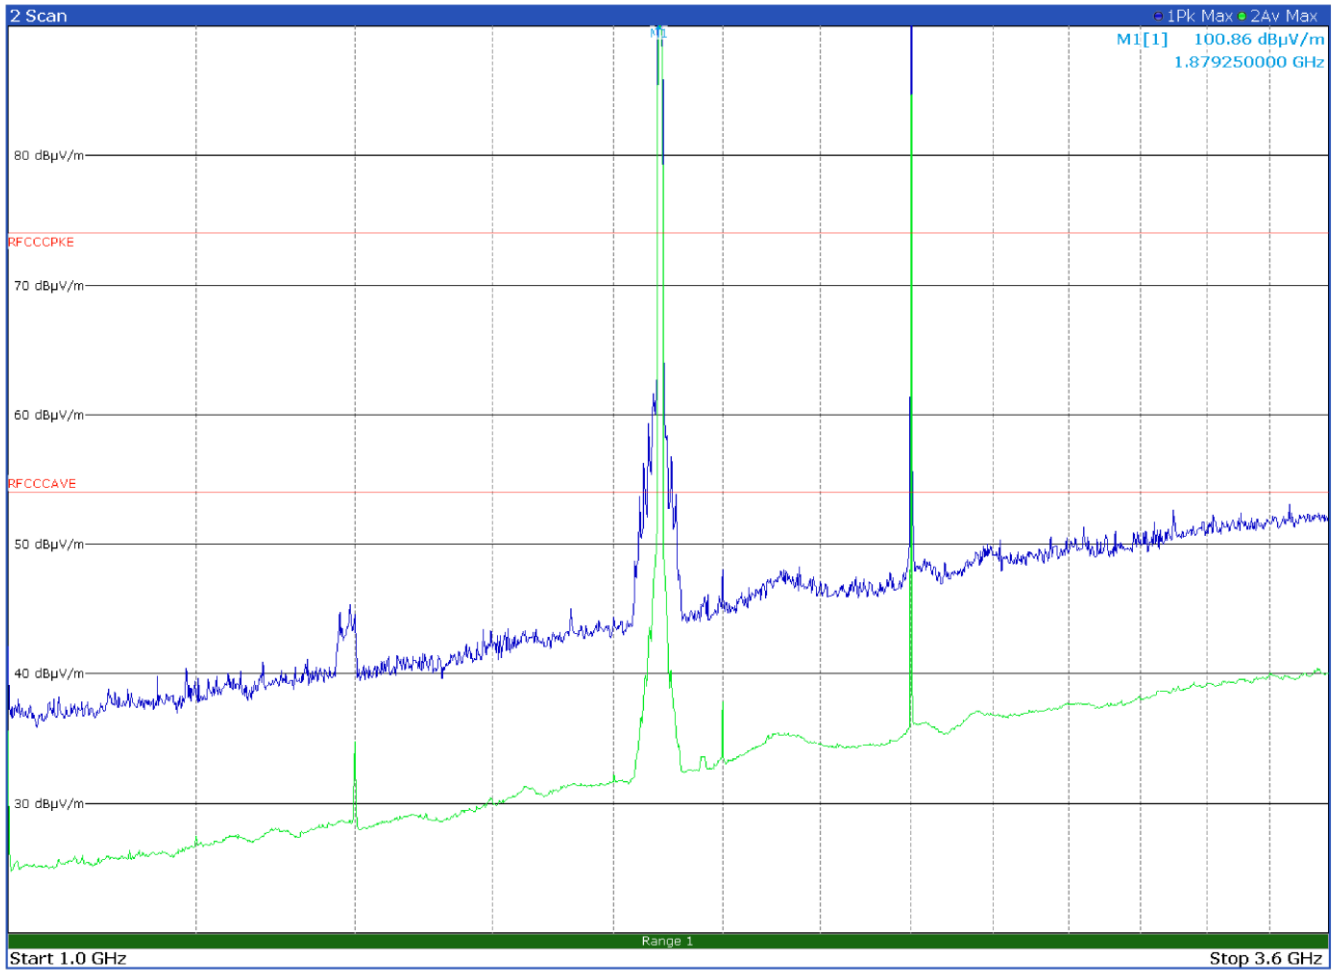
Antenna in horizontal polarization

Limit exceeded by carriers – No inter-modulation product founds

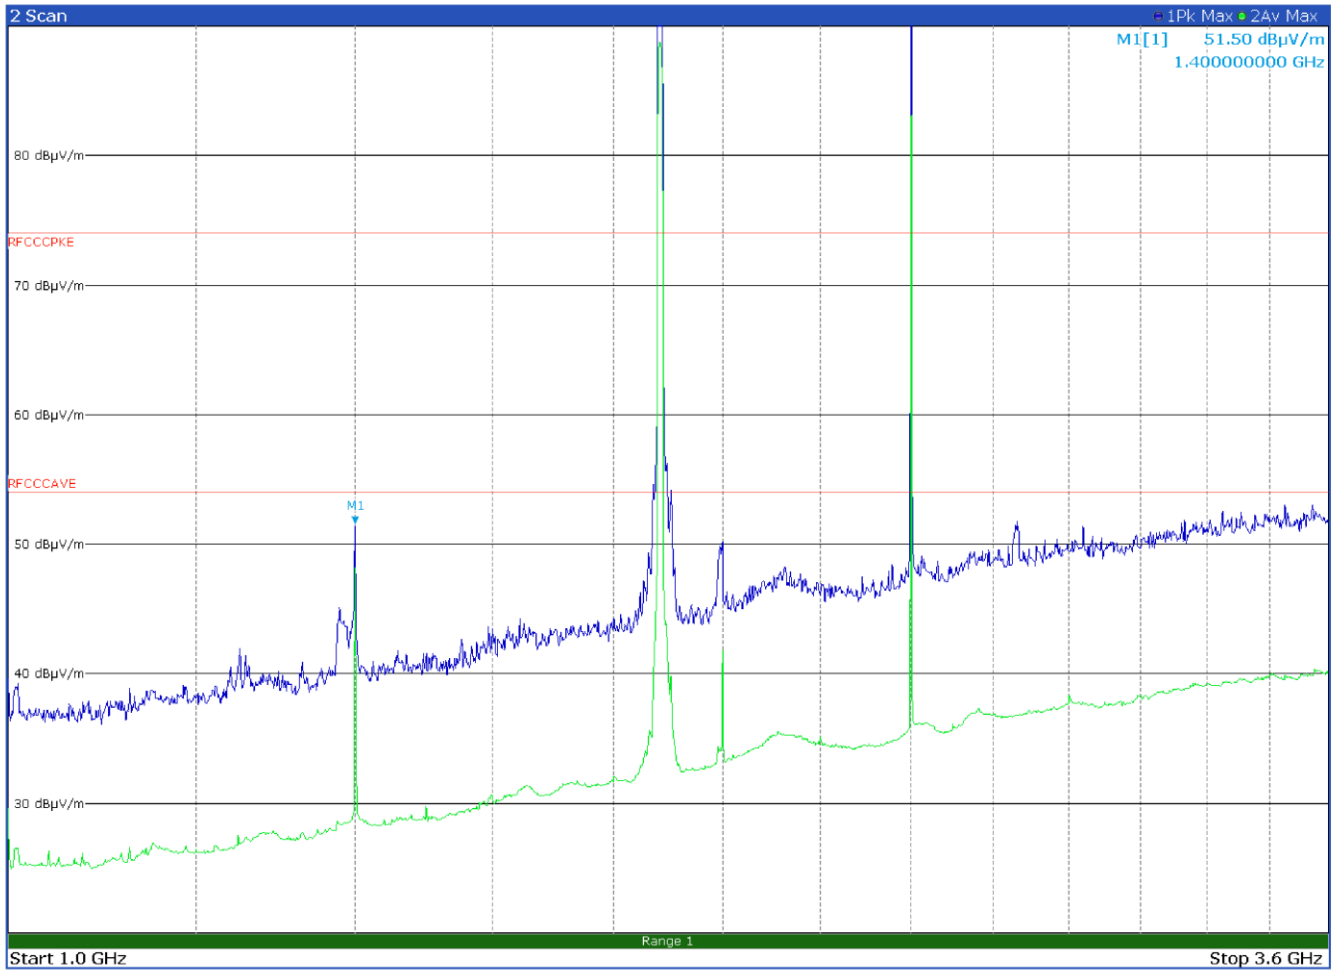
Antenna in vertical polarization

Limit exceeded by carriers – No inter-modulation product founds

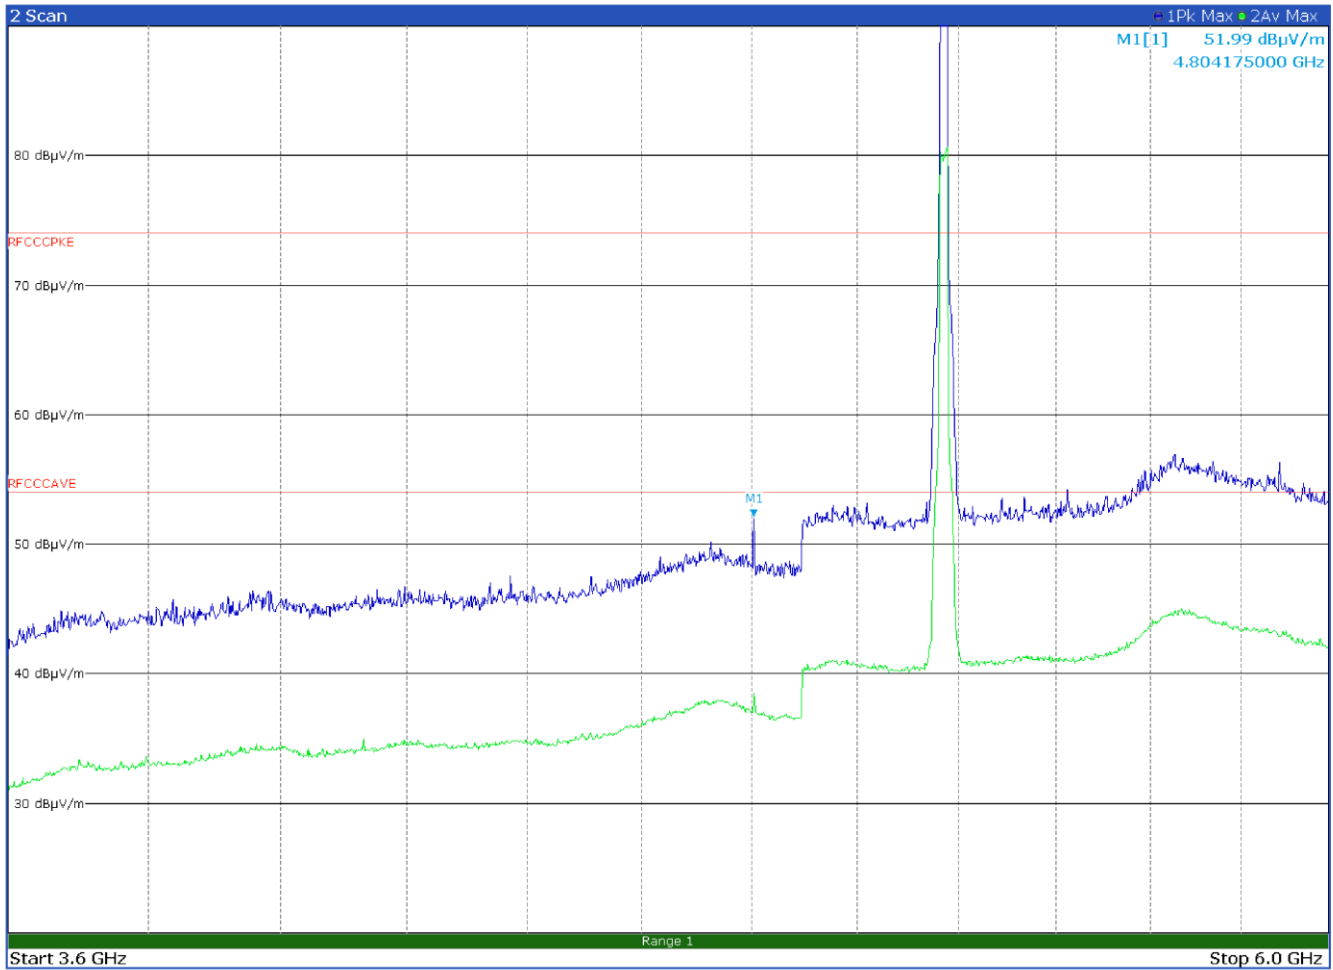
Antenna in horizontal polarization – No inter-modulation product founds

Limit exceeded by carrier

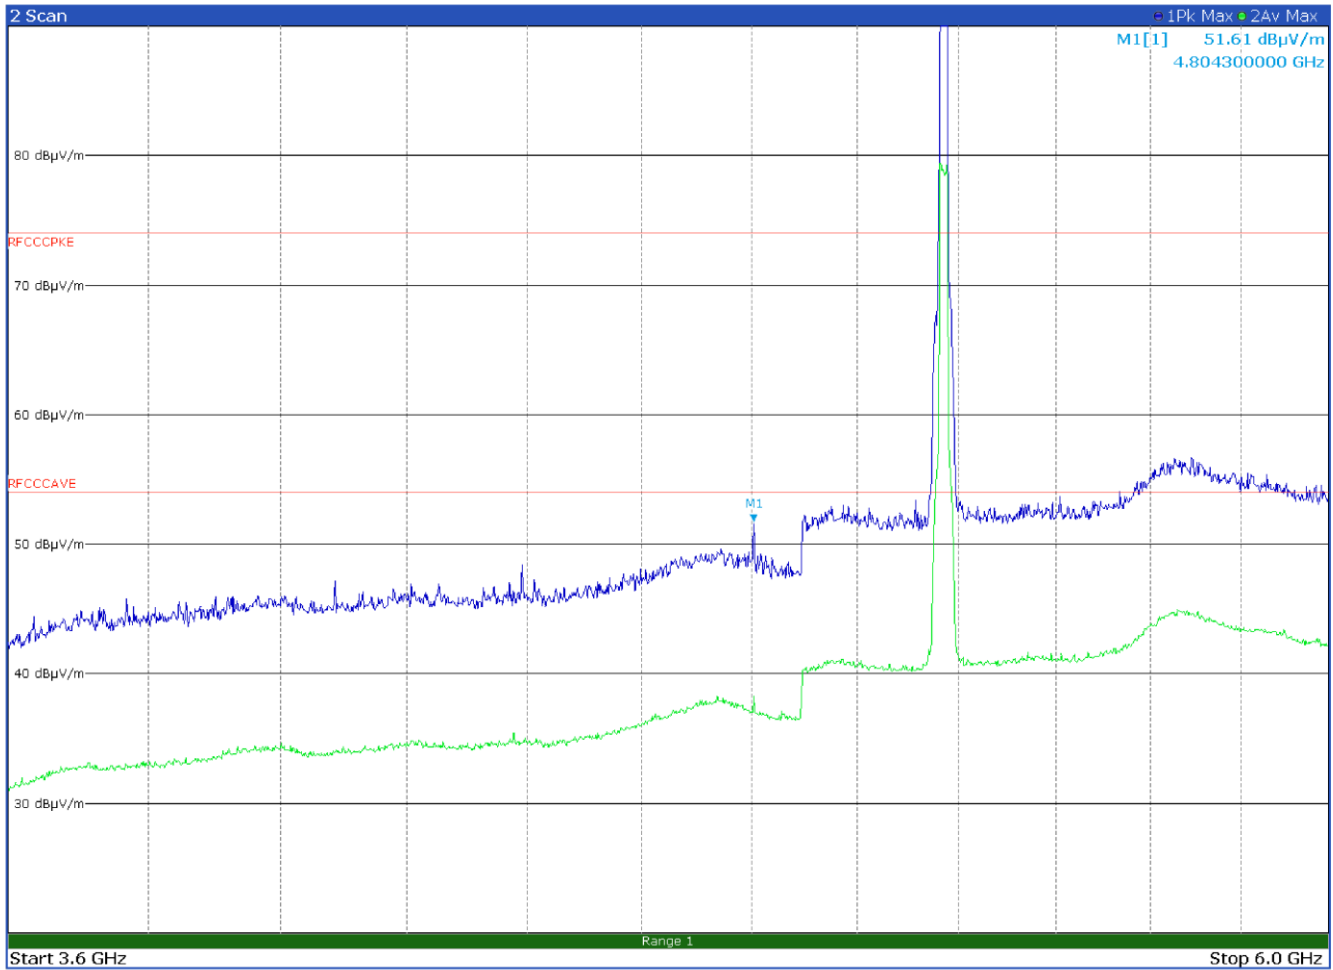
Antenna in vertical polarization – No inter-modulation product founds

Limit exceeded by carrier

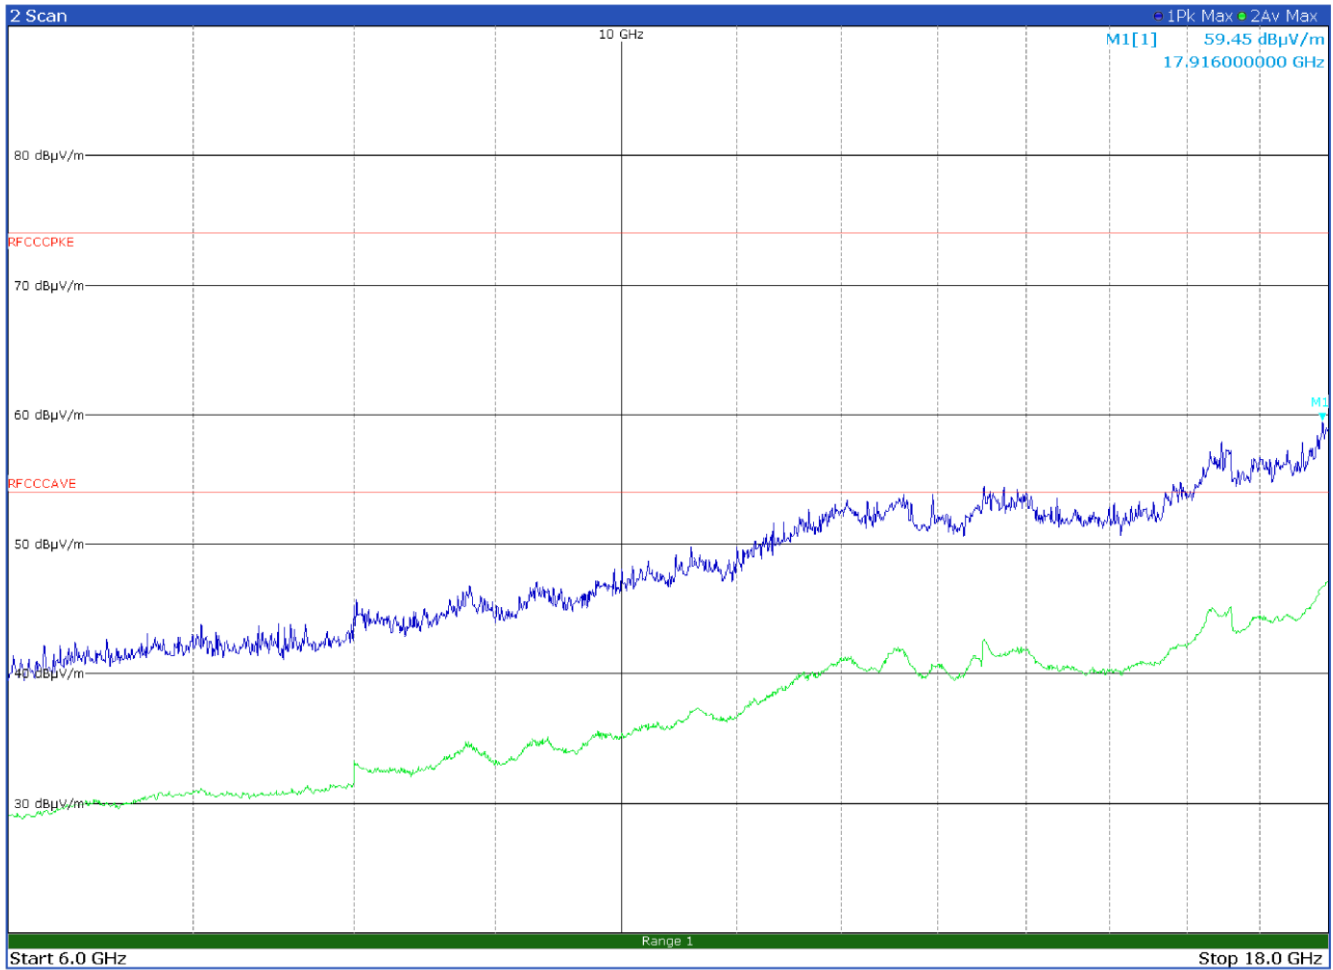
Antenna in horizontal polarization – No inter-modulation product founds

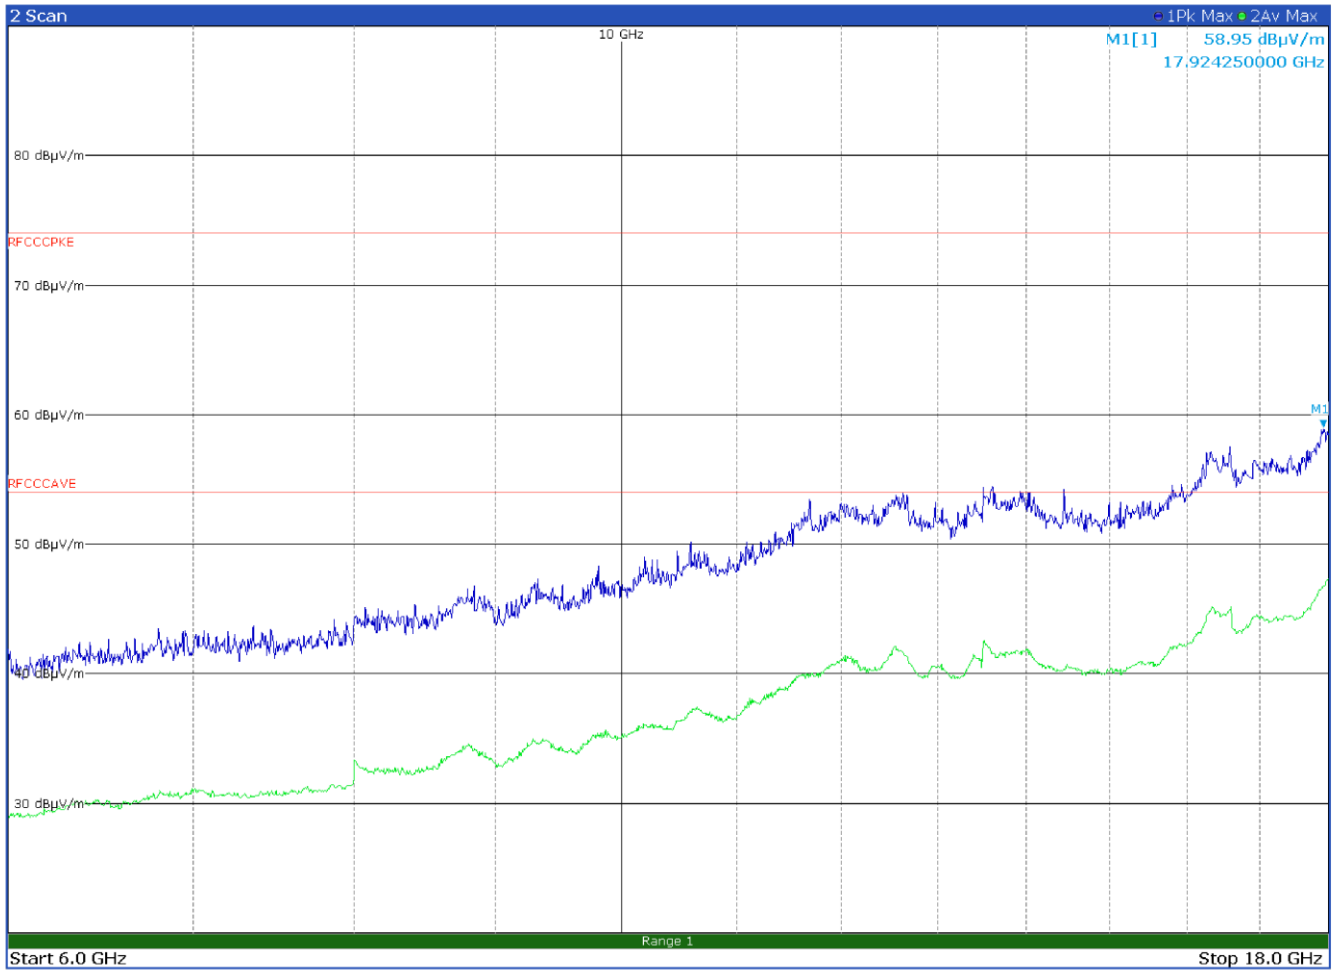
Antenna in vertical polarization – No inter-modulation product founds

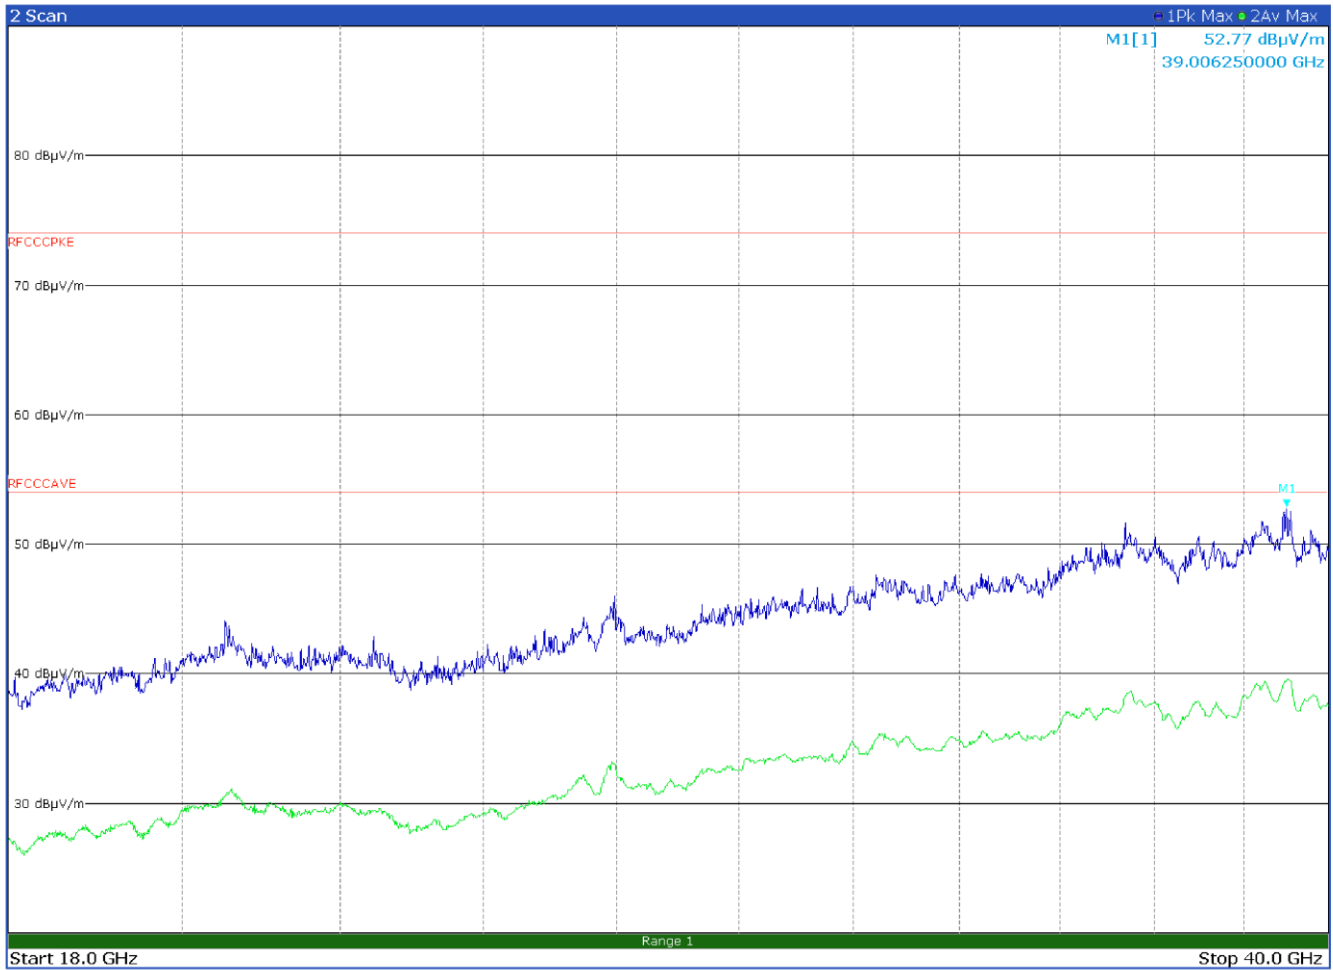
Antenna in horizontal polarization – No inter-modulation product founds

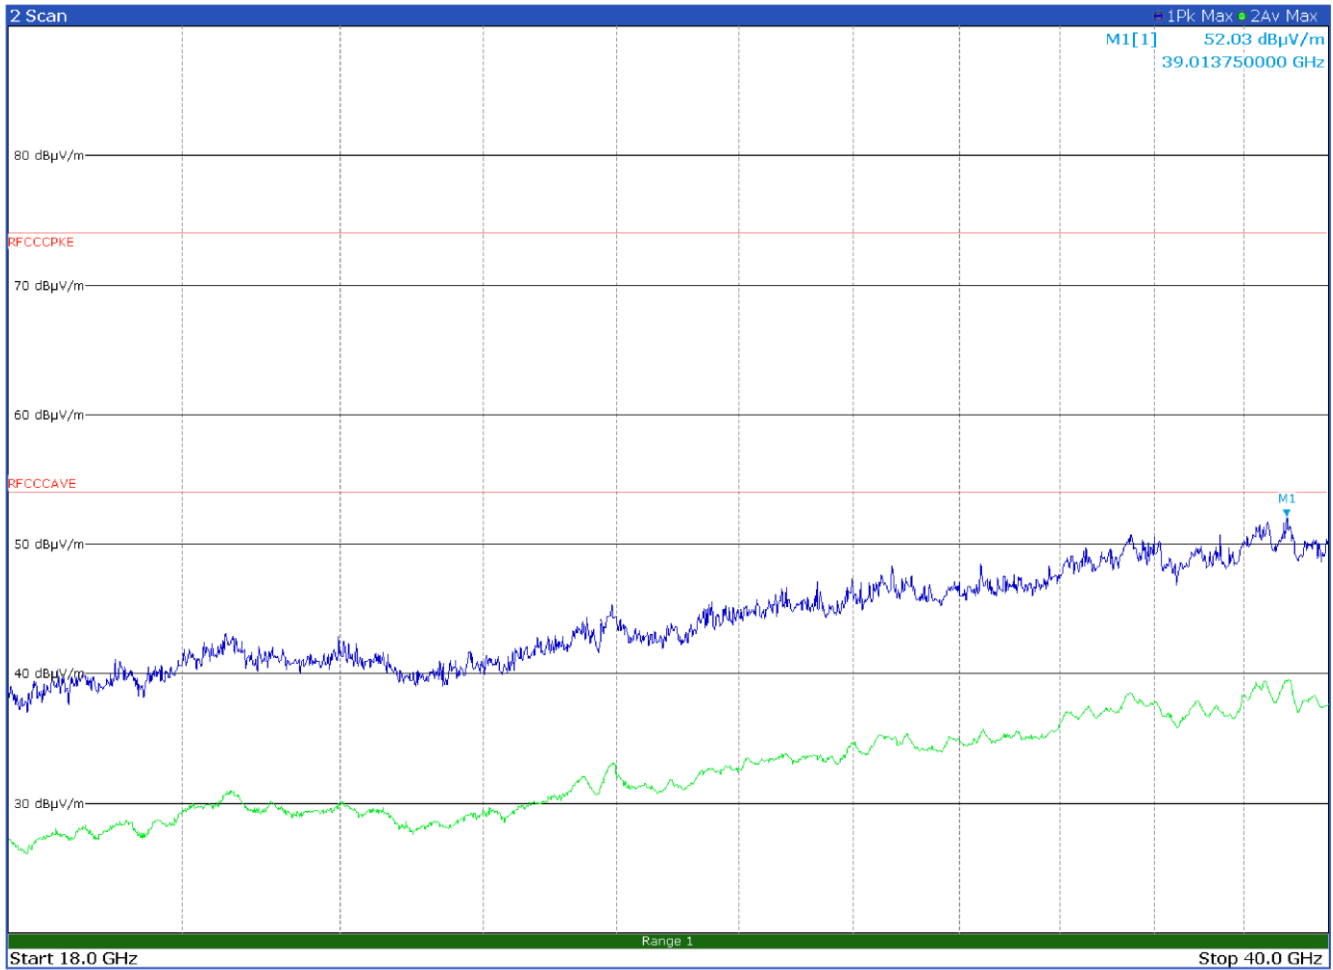
Antenna in vertical polarization – No inter-modulation product founds

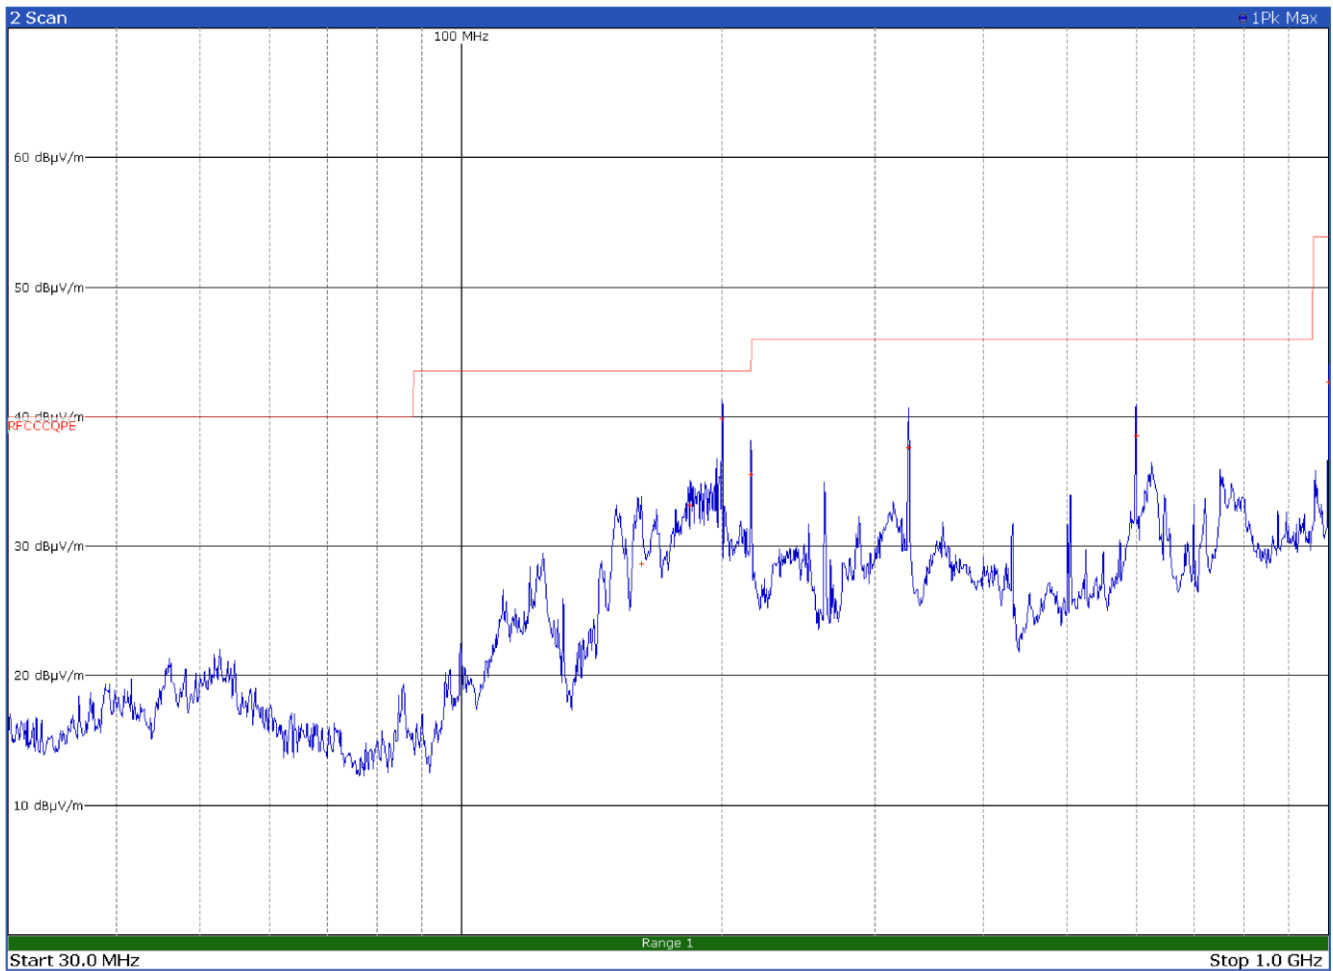
Antenna in horizontal polarization

Frequency (MHz)	Level (dBµV/m)	Limit (dBµV/m)	Margin (dB)	Detector
161.3100	28.7	43.5	-14.8	QP
183.7800	33.2	43.5	-10.3	QP
200.0100	39.8	43.5	-3.7	QP
215.5200	35.6	43.5	-7.9	QP
328.4700	37.7	46.0	-8.3	QP
600.0000	38.6	46.0	-7.4	QP
999.9900	42.7	53.9	-11.2	QP
