8.1.8 Test data for LTE B25 at middle channel, WIFI at 5170 MHz and BT at low channel

8.1.9 Test data for LTE B7 at middle channel, WIFI at 5170 MHz and BT at high channel

Section 9. Block diagrams of test set-ups

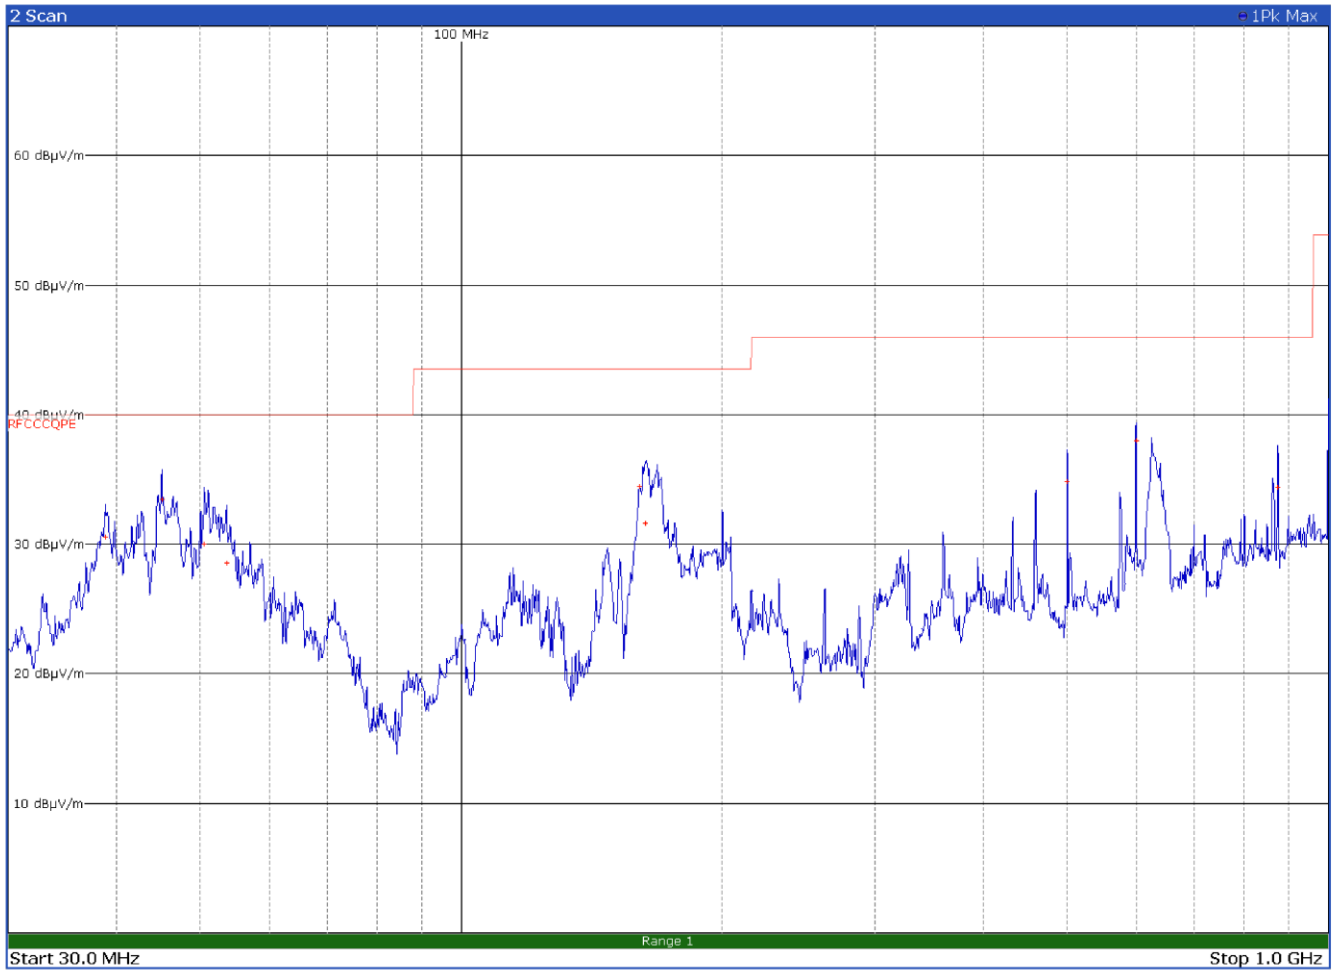
Antenna in vertical polarization

Frequency (MHz)	Level (dBµV/m)	Limit (dBµV/m)	Margin (dB)	Detector
38.8500	30.6	40.0	-9.4	QP
45.1200	33.5	40.0	-6.5	QP
50.4900	30.1	40.0	-9.9	QP
53.6100	28.6	40.0	-11.4	QP
160.5900	34.5	43.5	-9.0	QP
163.2000	31.6	43.5	-11.9	QP
500.0100	34.9	46.0	-11.1	QP
599.9700	38.0	46.0	-8.0	QP
875.0100	34.4	46.0	-11.6	QP

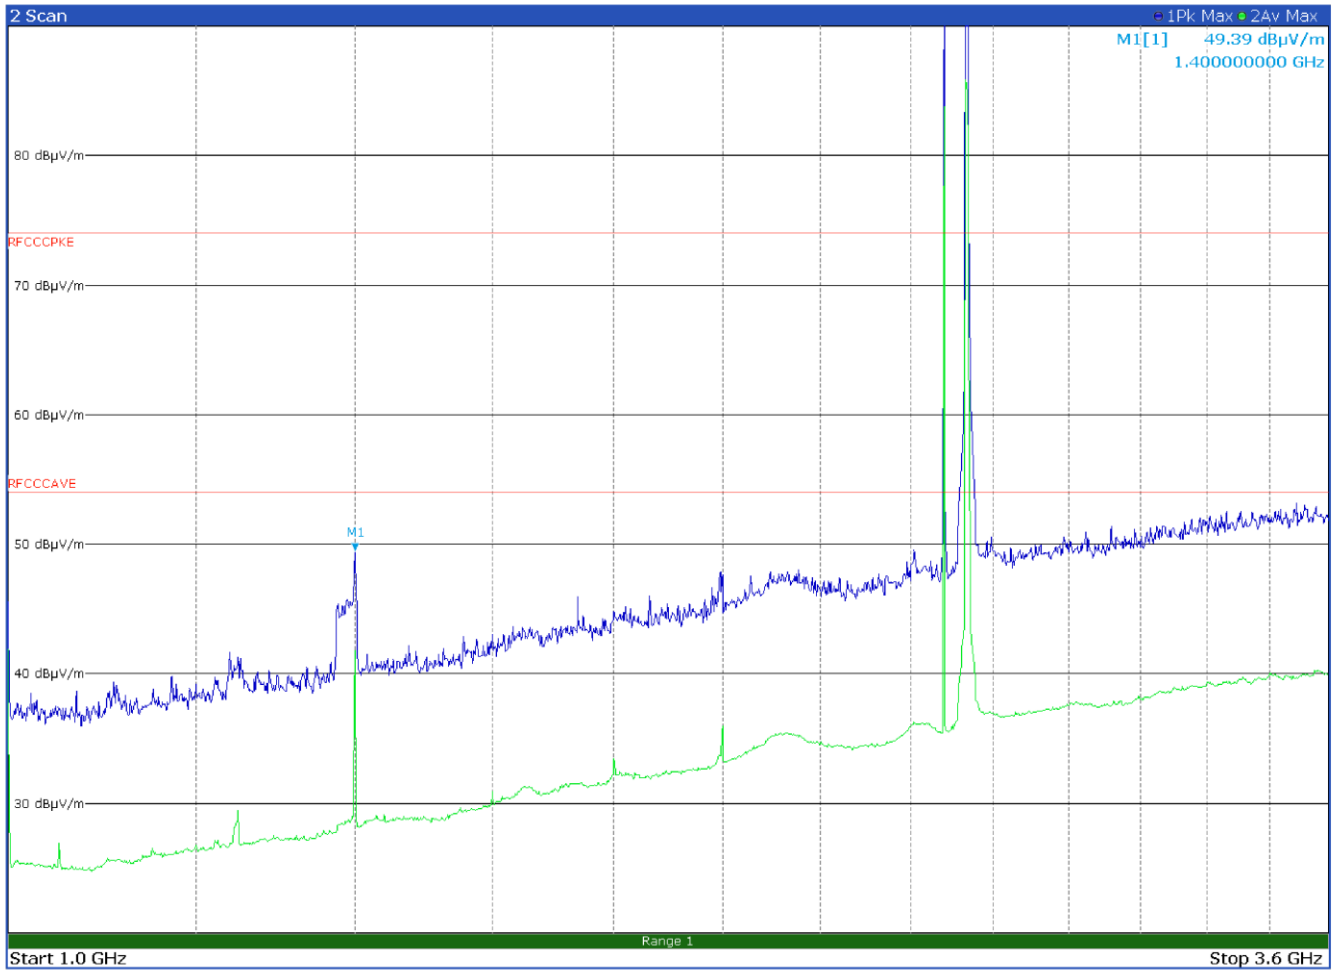
Antenna in horizontal polarization

Limit exceeded by carriers – No inter-modulation product founds

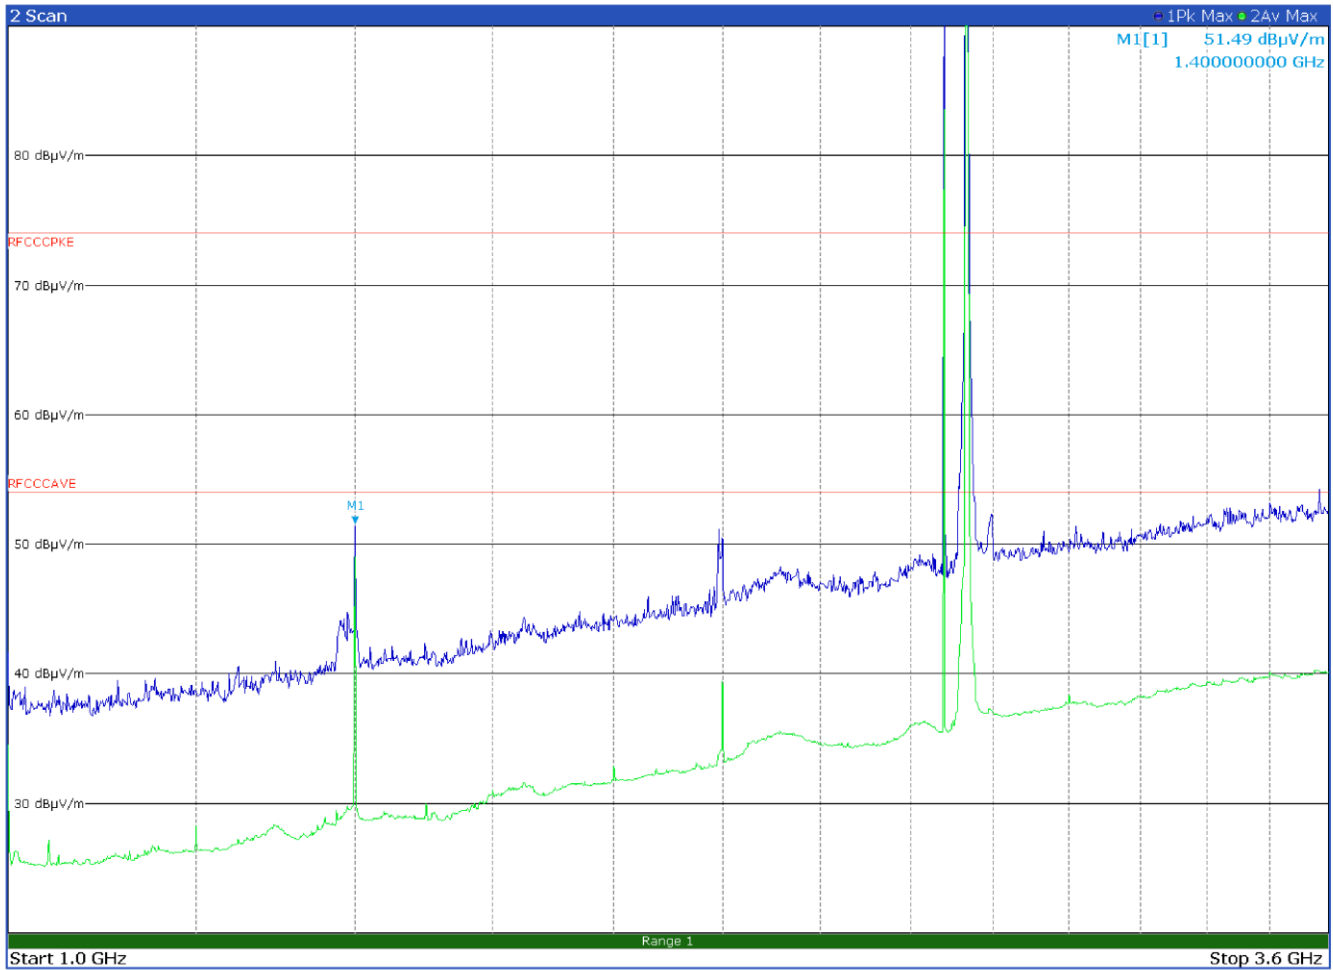
Antenna in horizontal polarization

Limit exceeded by carriers – No inter-modulation product founds

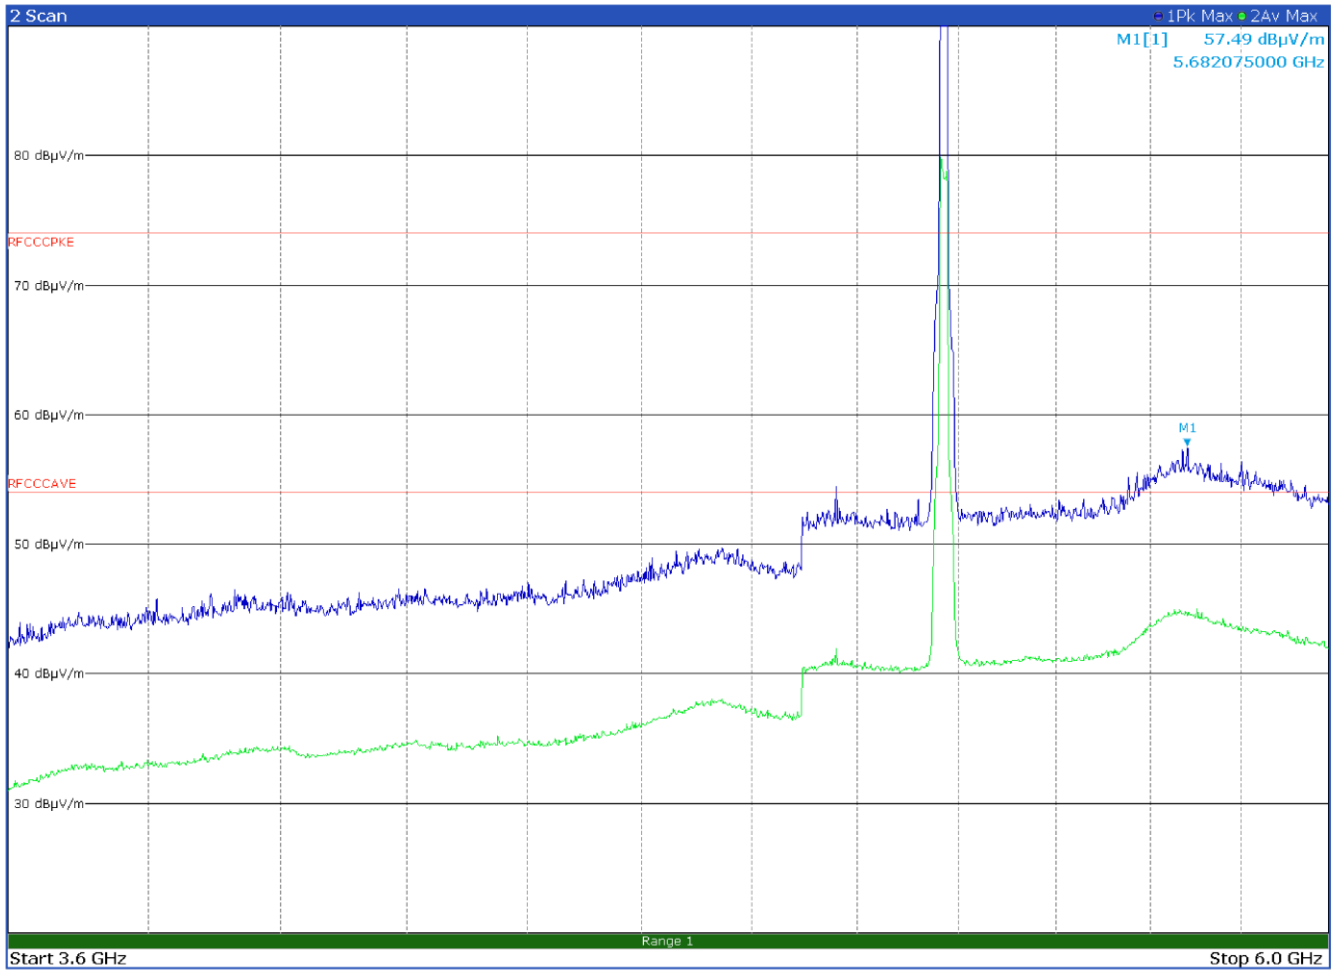
Antenna in horizontal polarization – No inter-modulation product founds

Limit exceeded by the carrier

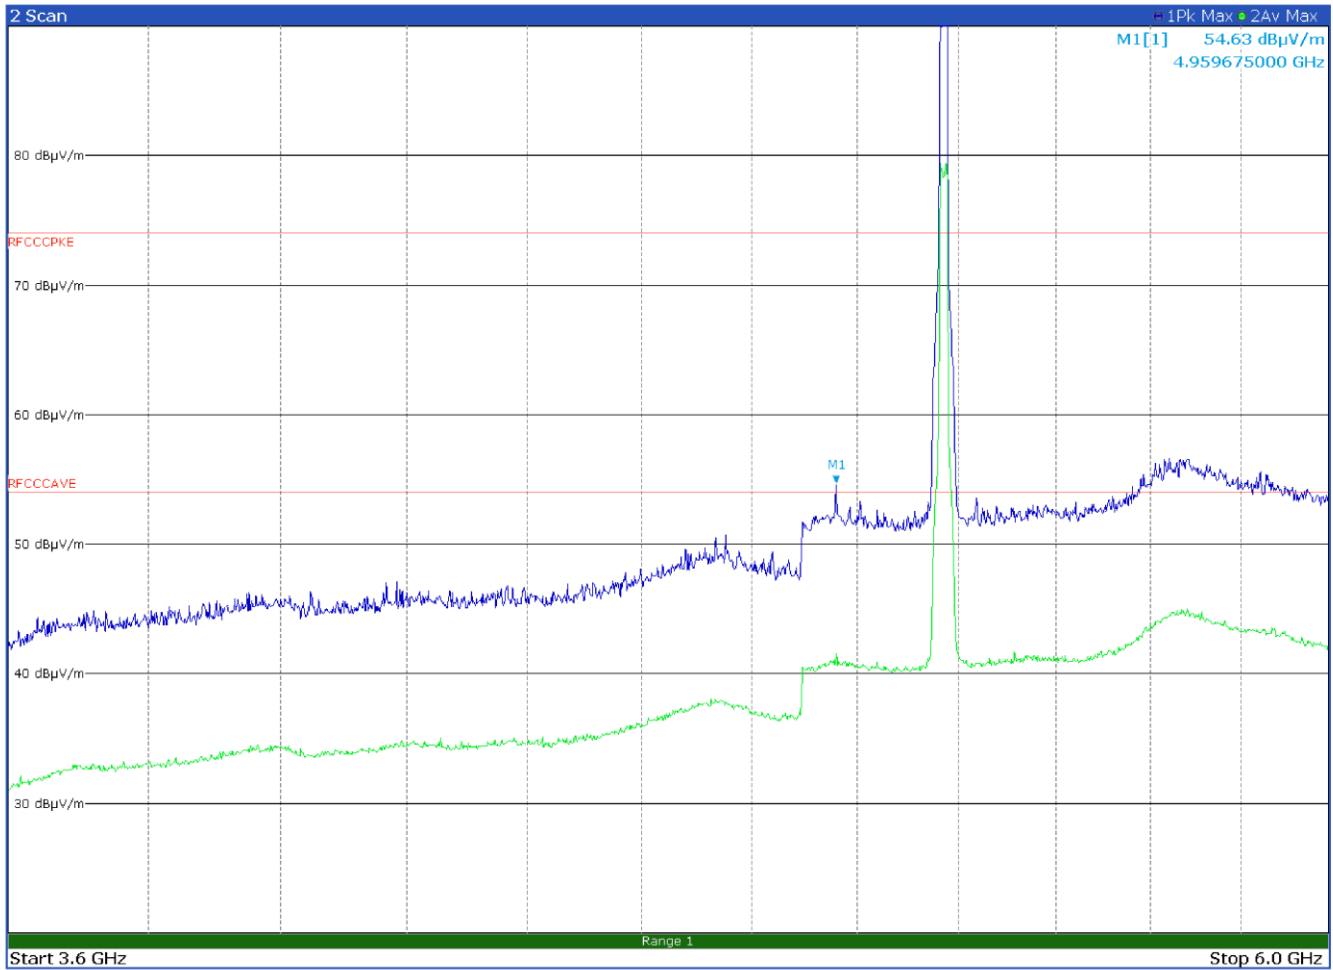
Antenna in vertical polarization – No inter-modulation product founds

Limit exceeded by the carrier

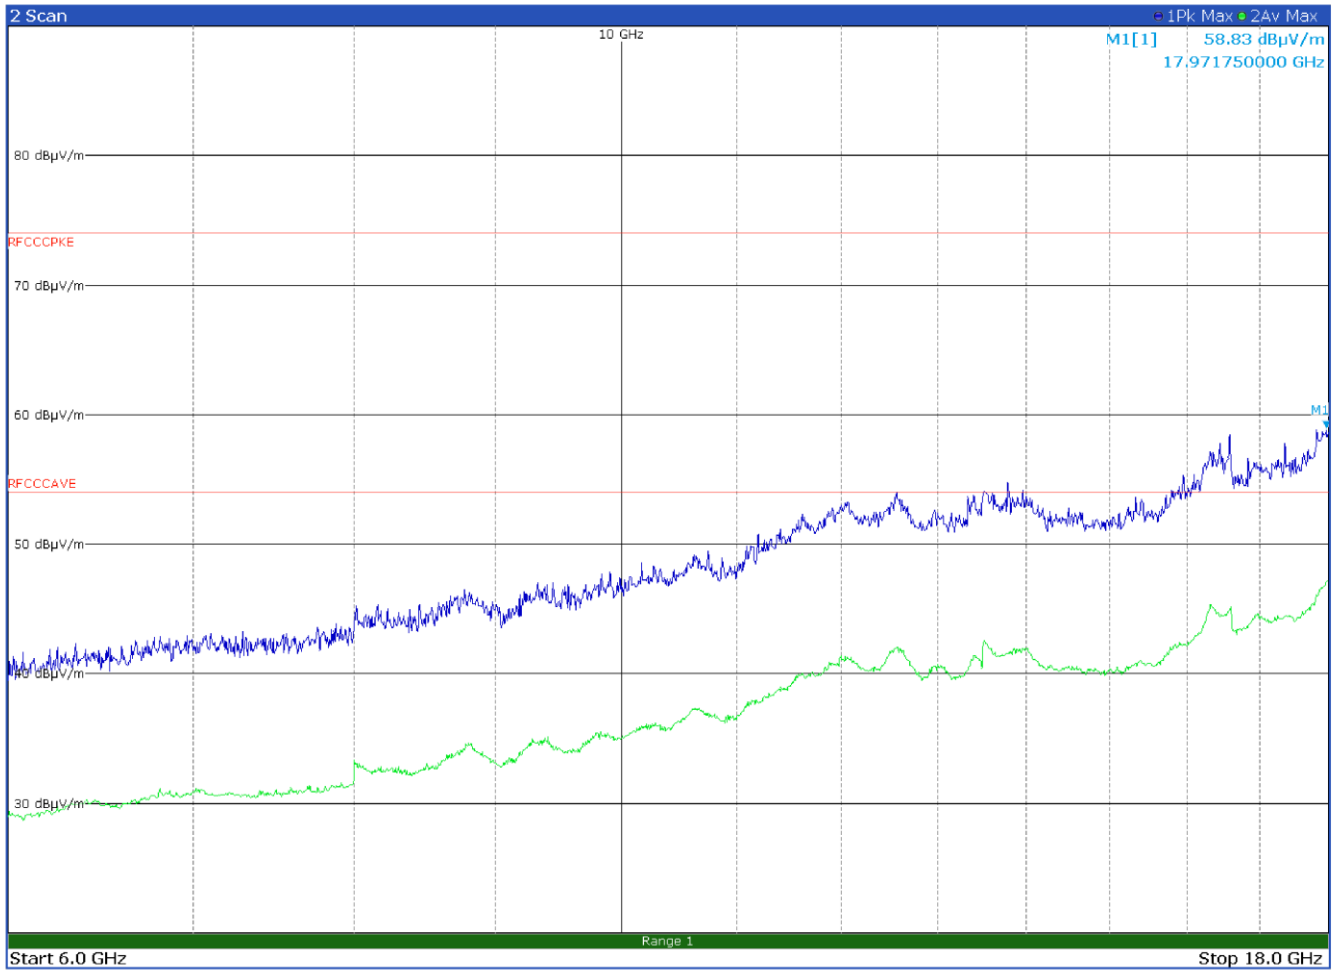
Antenna in horizontal polarization – No inter-modulation product founds

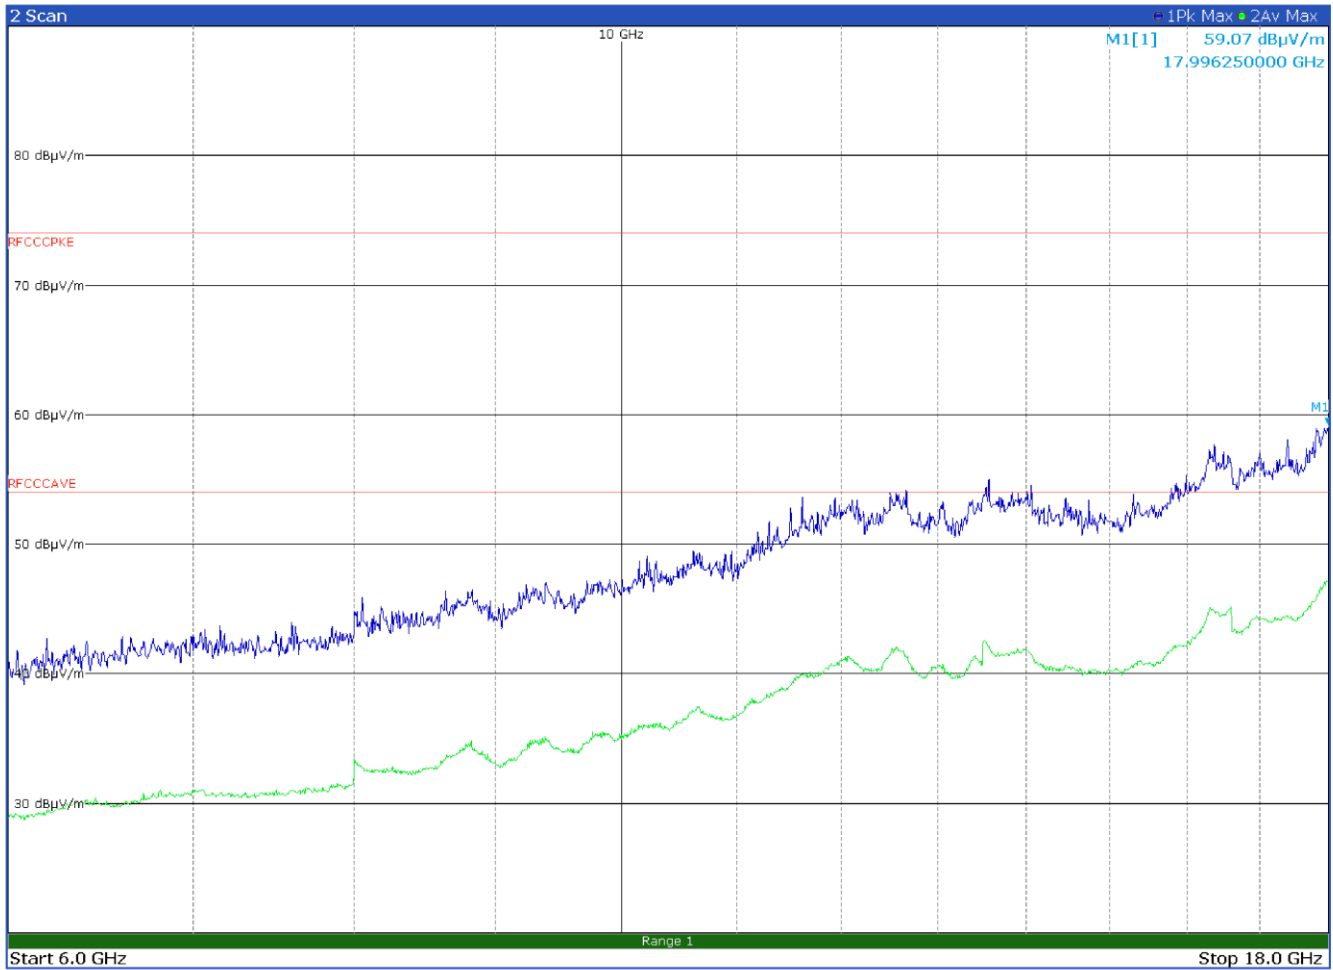
Antenna in vertical polarization – No inter-modulation product founds

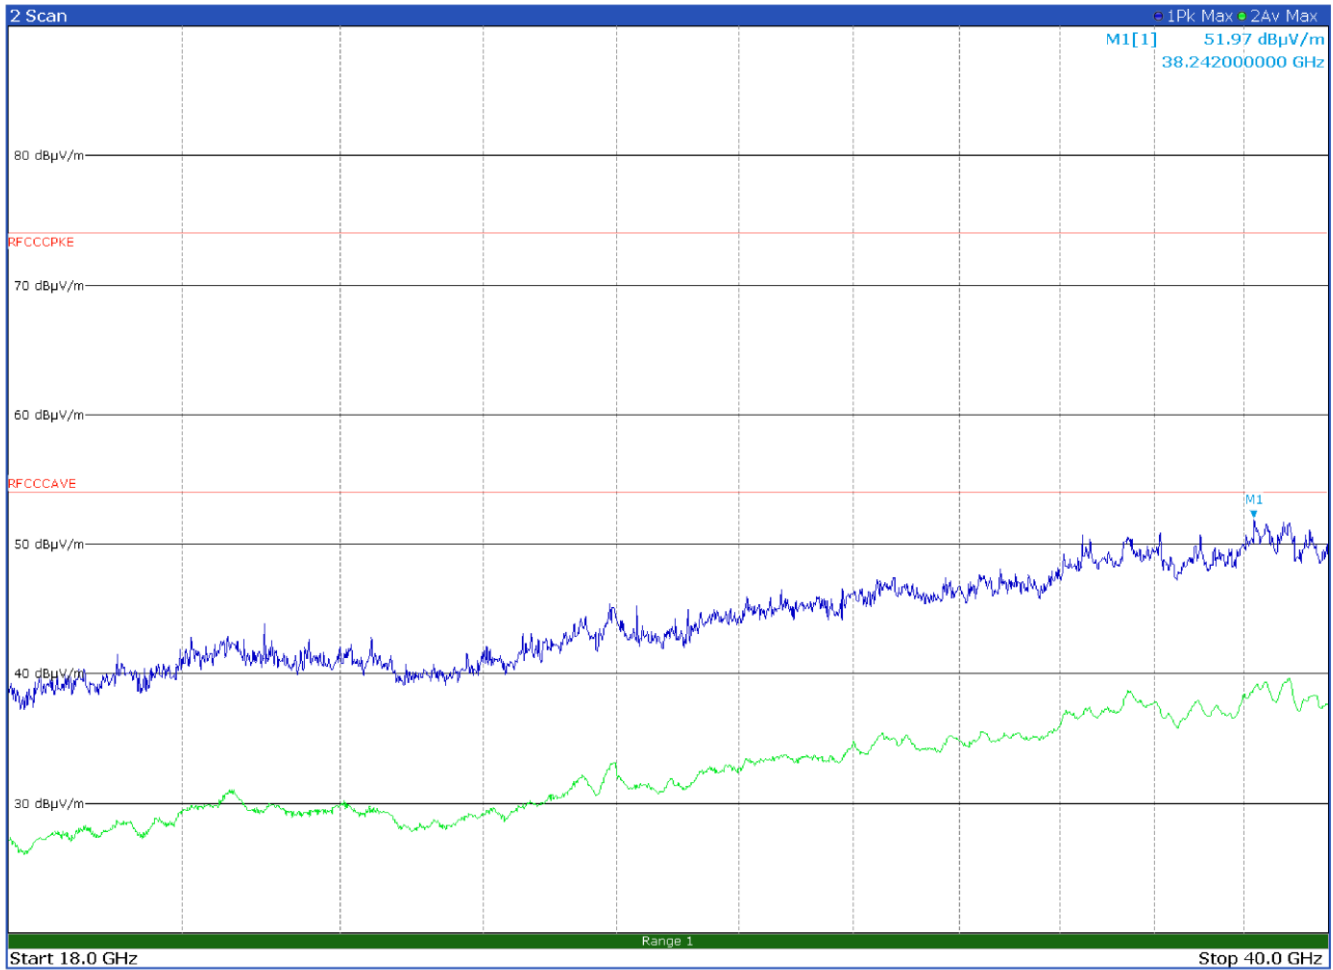
Antenna in horizontal polarization – No inter-modulation product founds

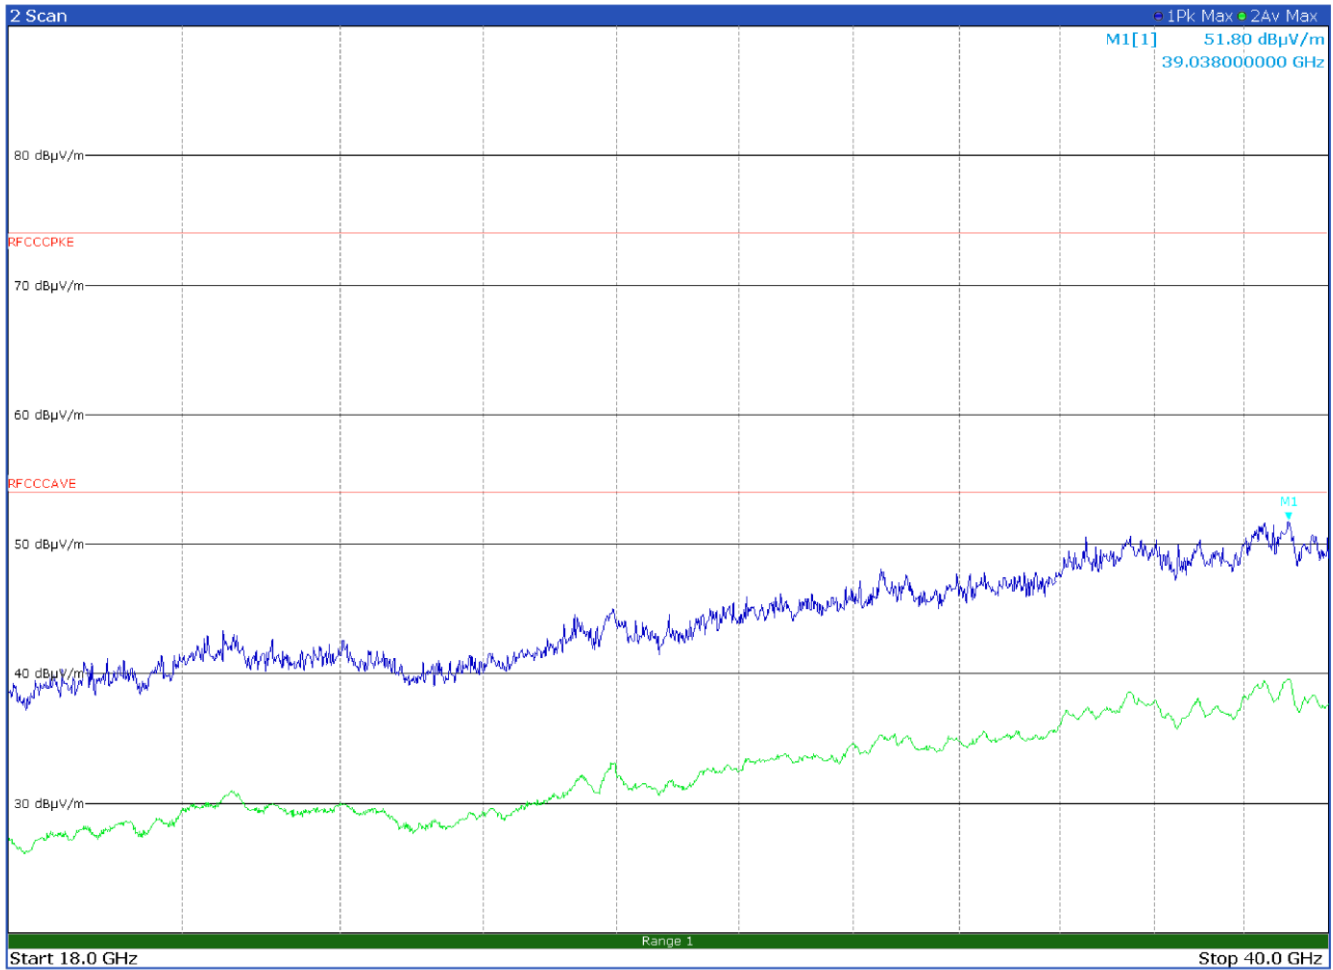
Antenna in vertical polarization – No inter-modulation product founds

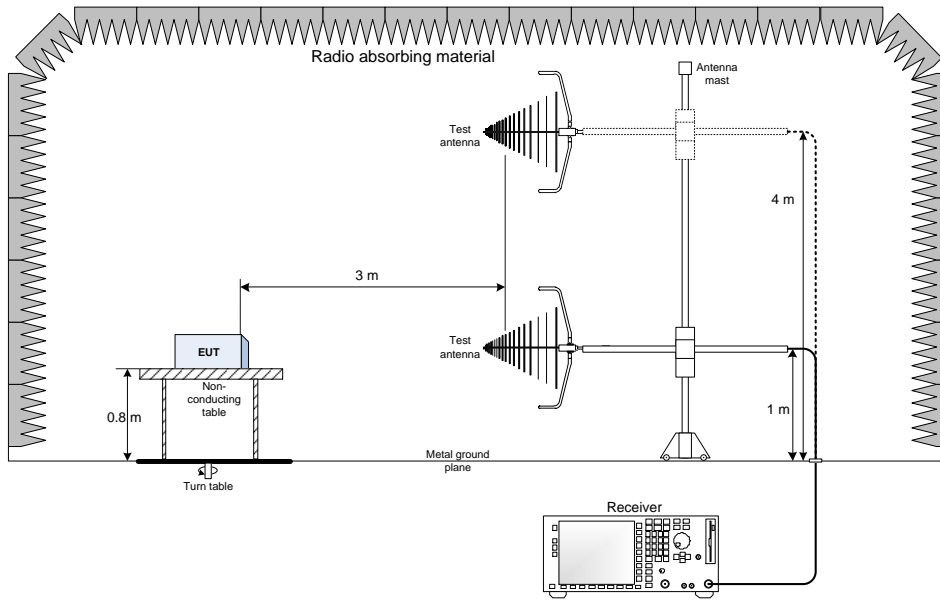
9.1 Radiated emissions set-up for frequencies below 1 GHz

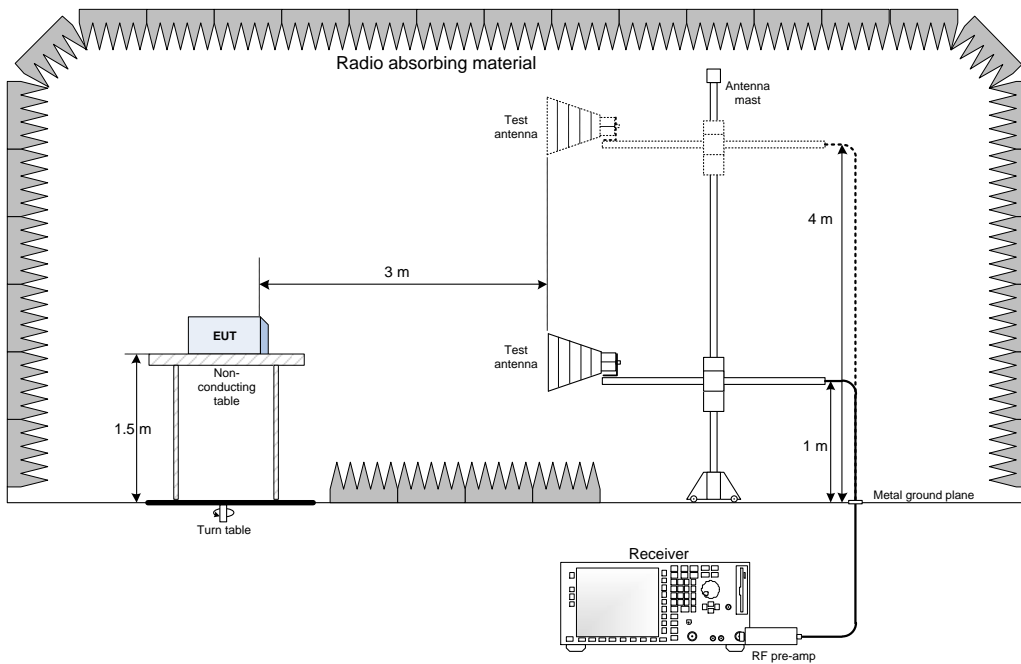
9.2 Radiated emissions set-up for frequencies above 1 GHz

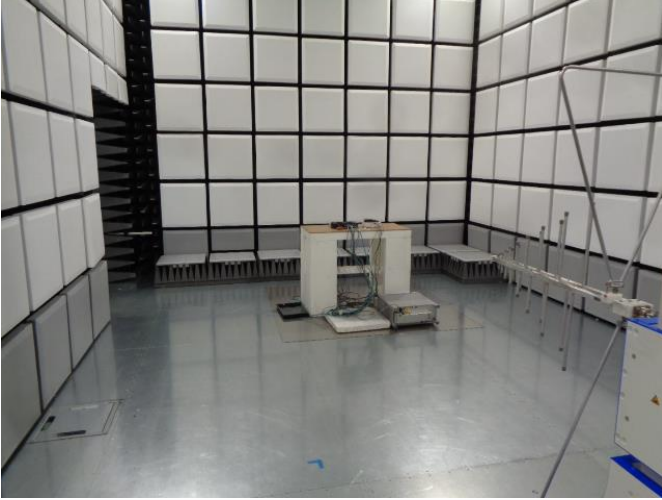
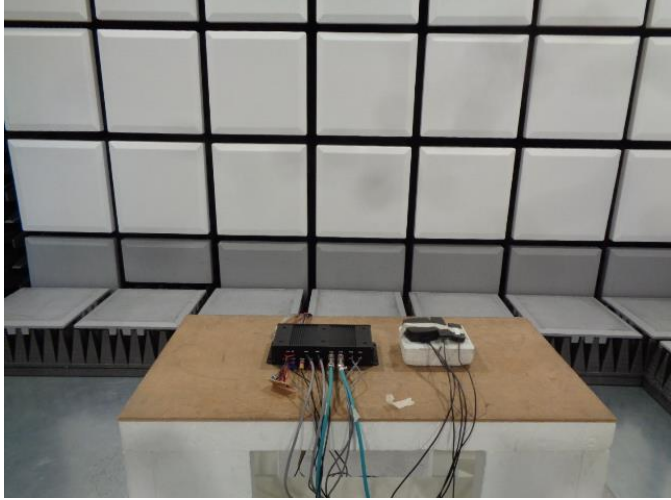
Radiated emission below 1 GHz

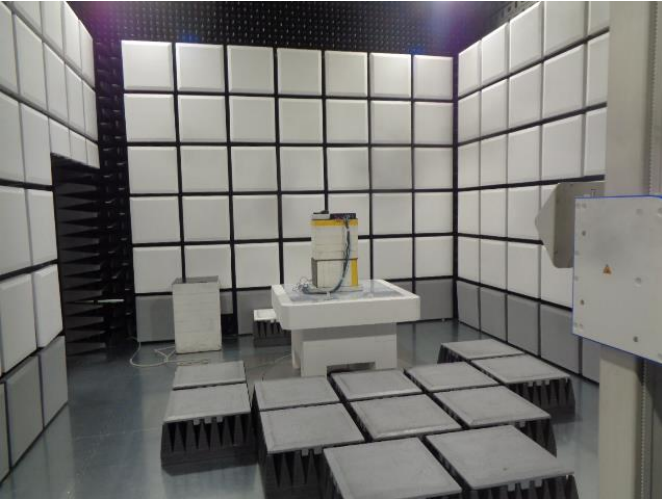
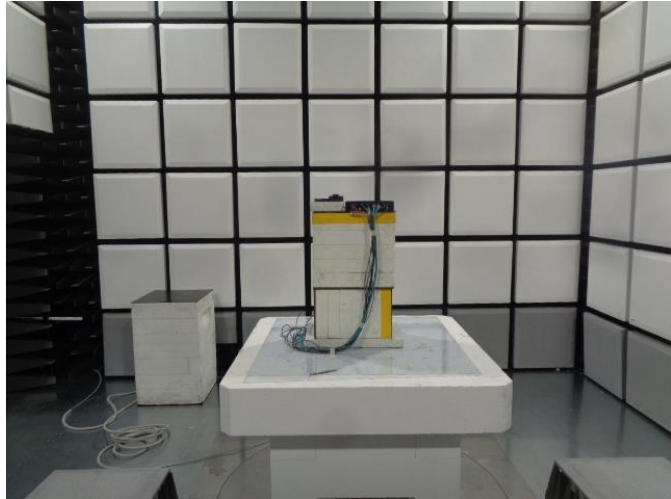
Radiated emission above 1 GHz
