Test Setup Photos

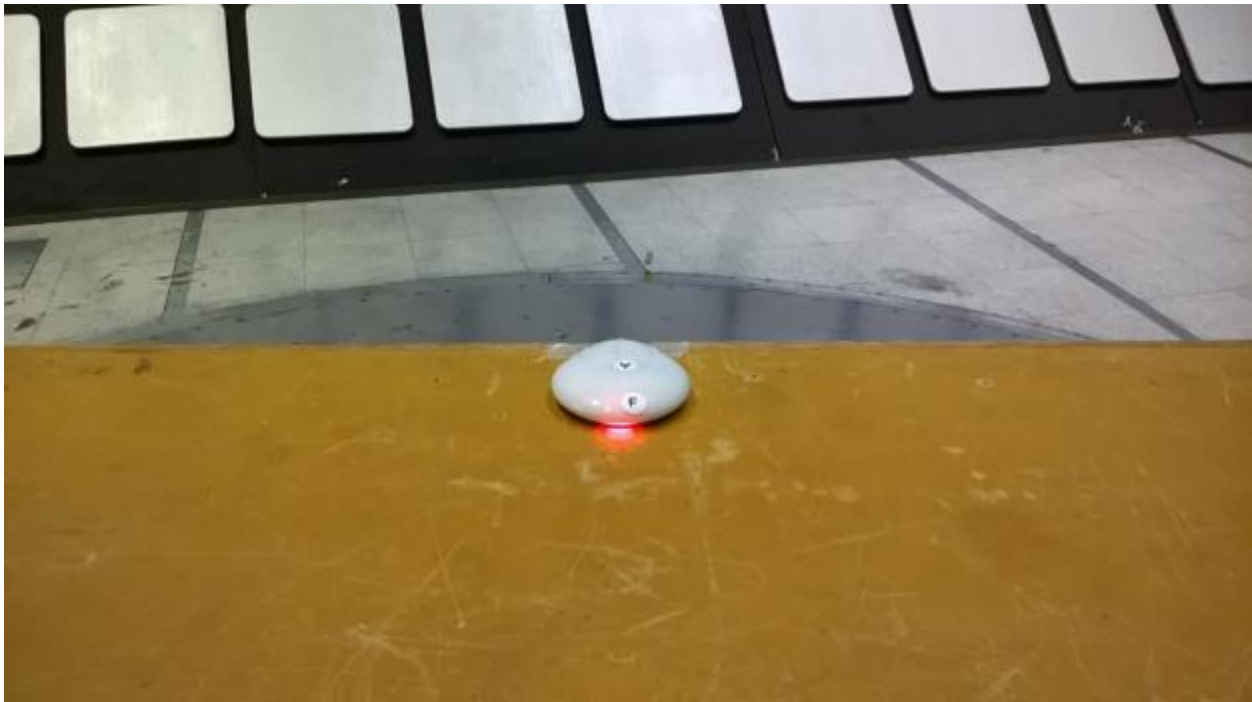
Figure 1 - EUT Test Setup, 30MHz – 1GHz

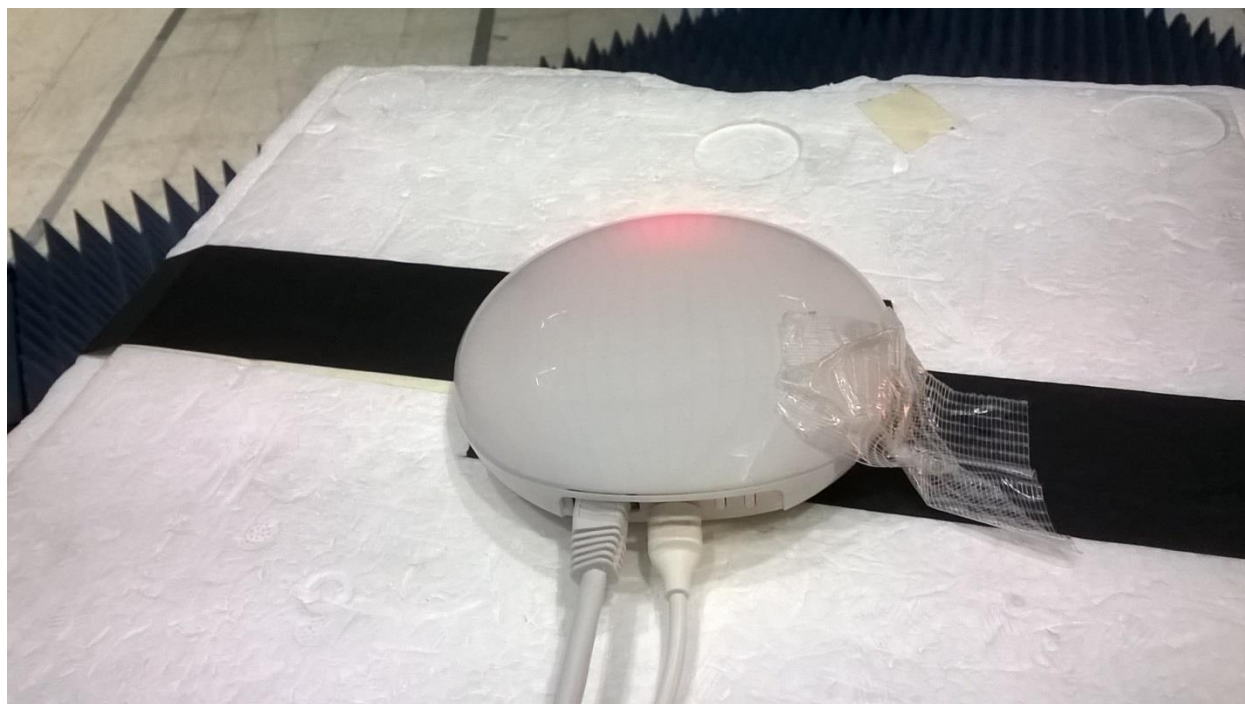
Figure 4 - x-axis

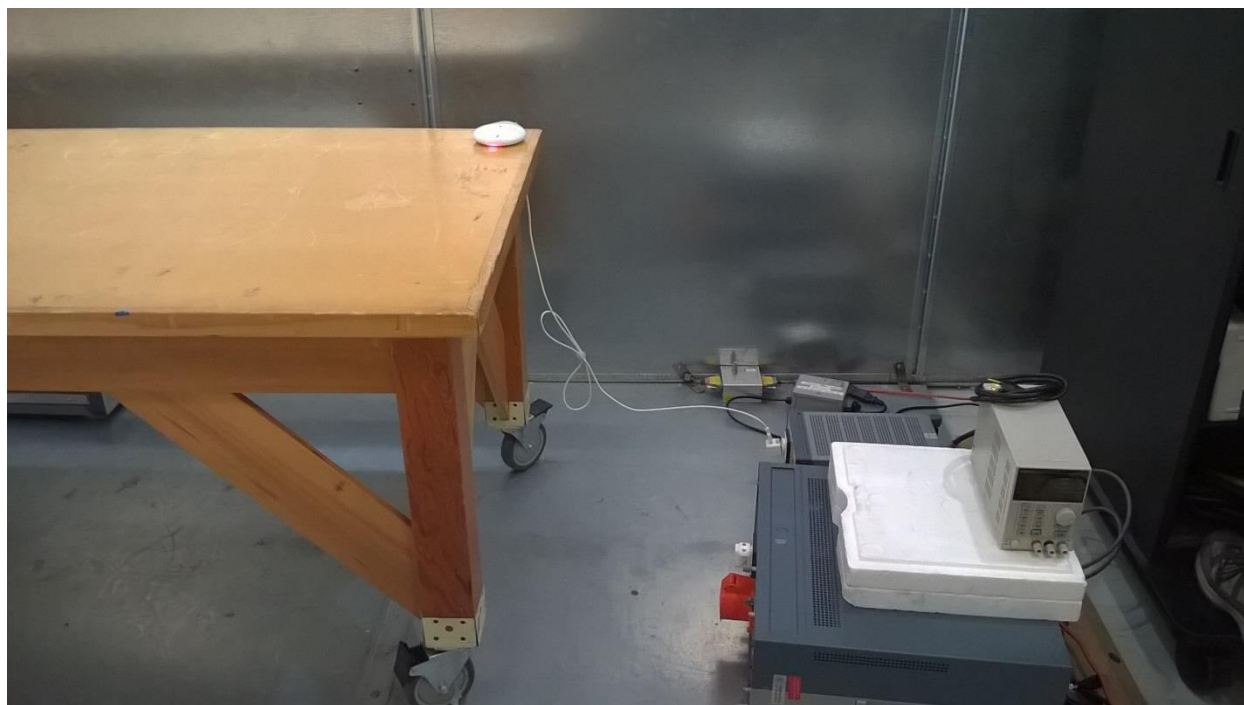
Figure 8 - Conducted AC emissions Test Setup, 150kHz - 30MHz

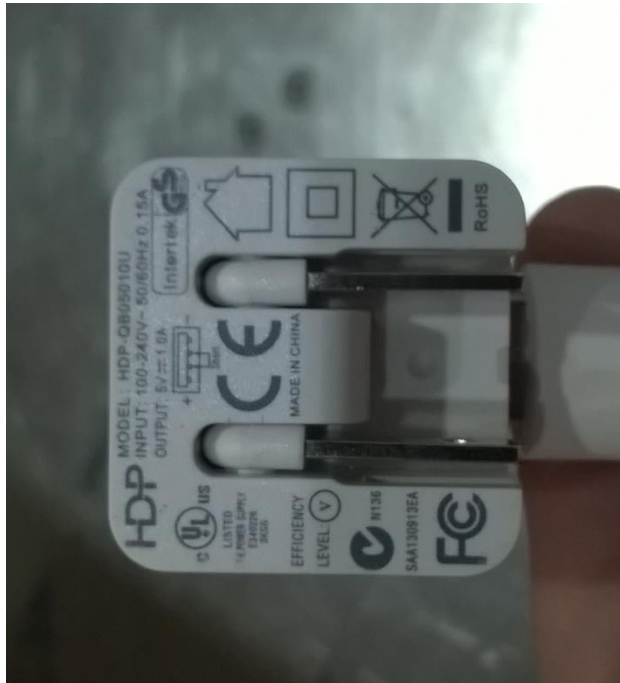
Figure 10 - Power supply used for testing

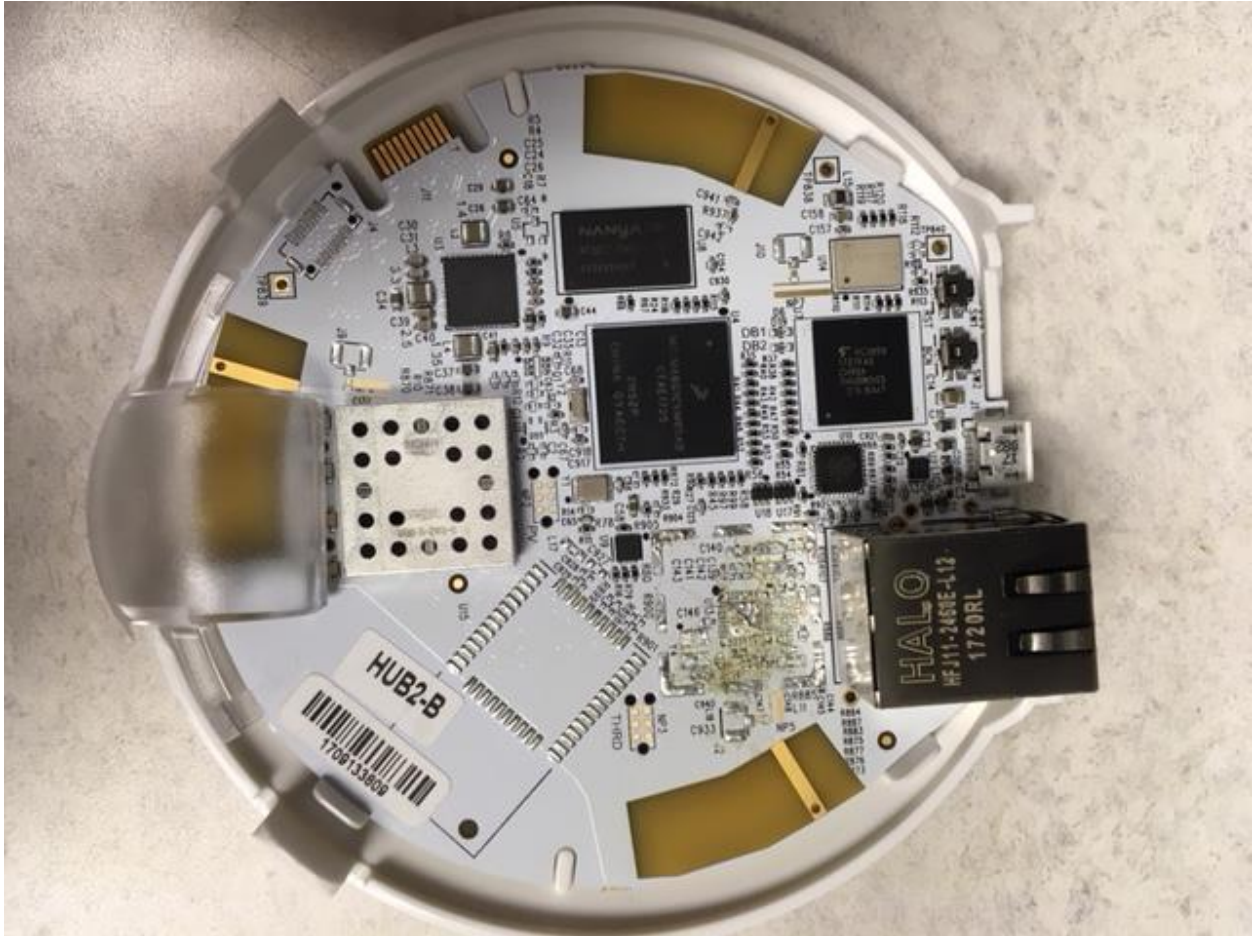
Figure 12 – EUT 2

The photo above is identical to the device under certification. EUT 1 shown in Figure 11 was tested. EUT 2 shown in Figure 12 above was briefly verified to ensure that the removal of the transmitter module did not affect the test results.
