Internal Photos

FCC ID: V7L300301

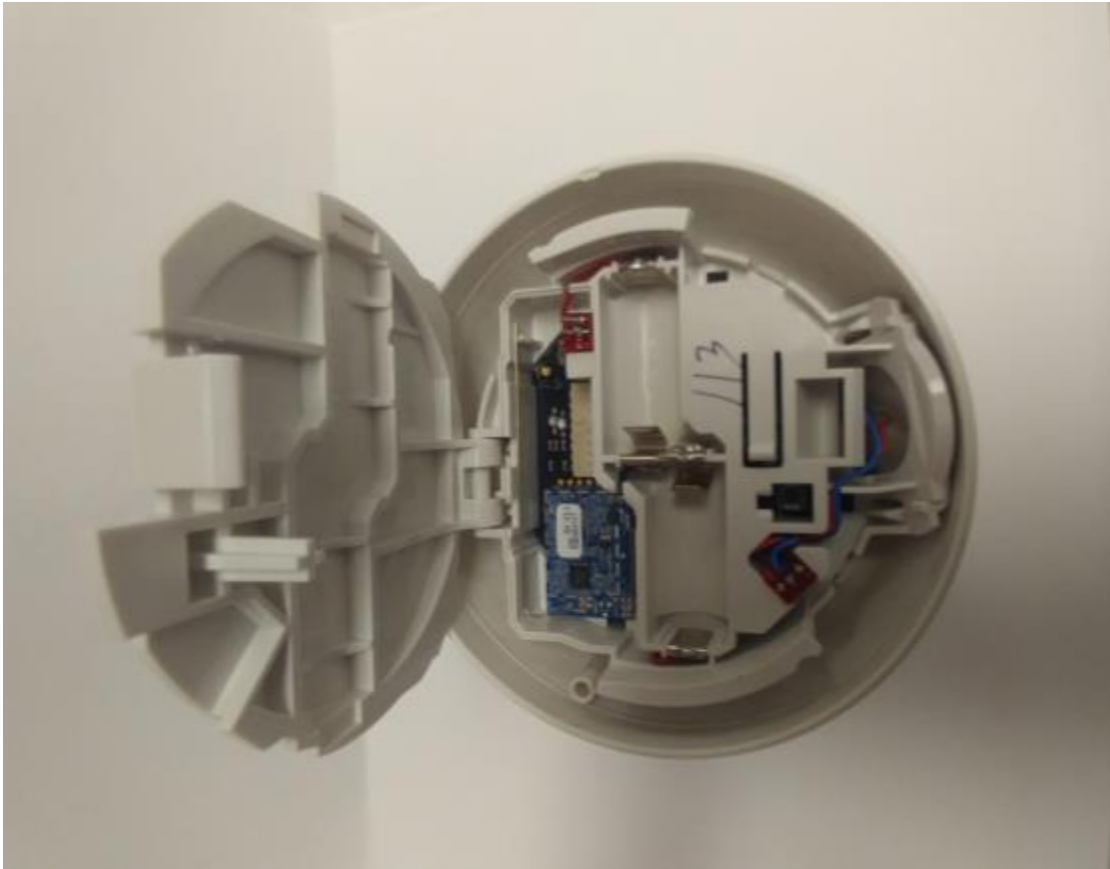
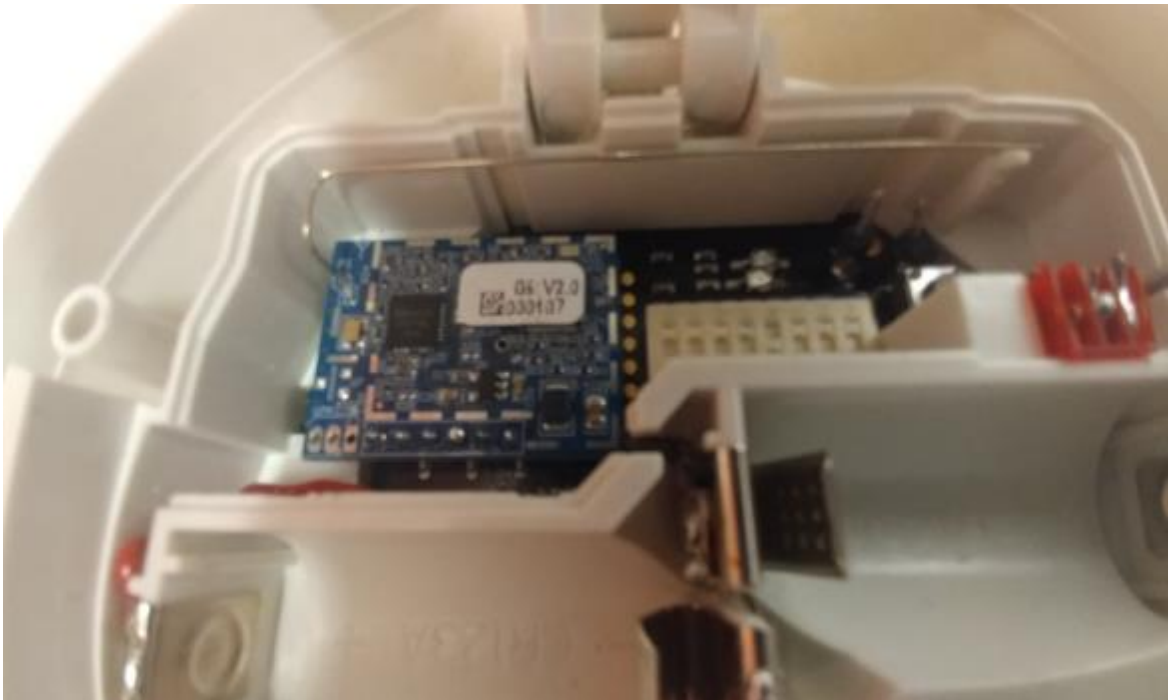
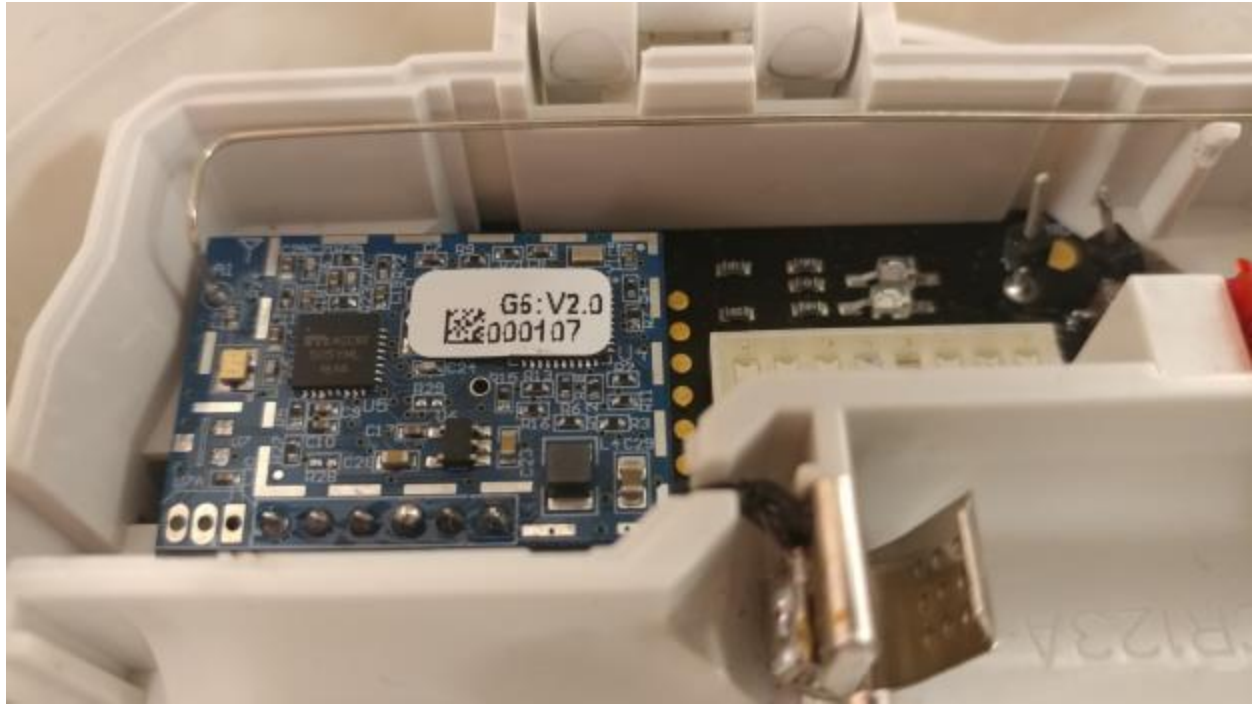
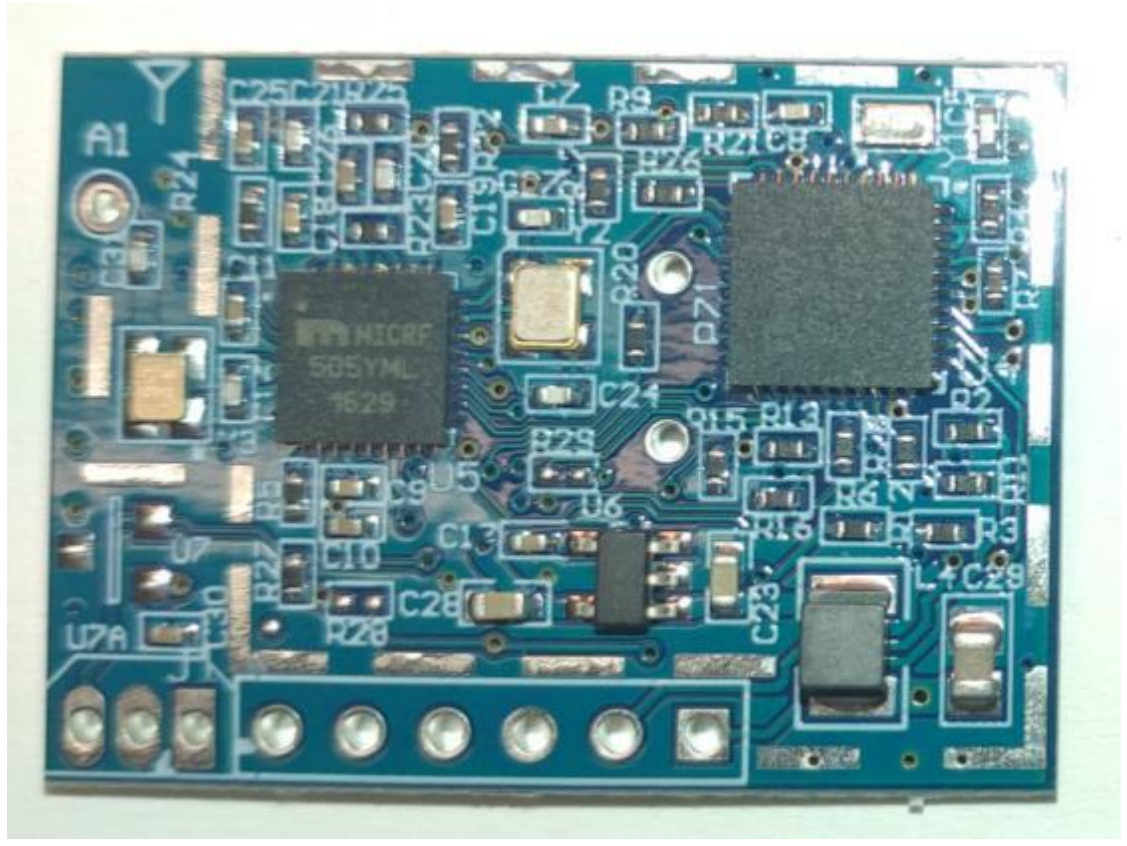
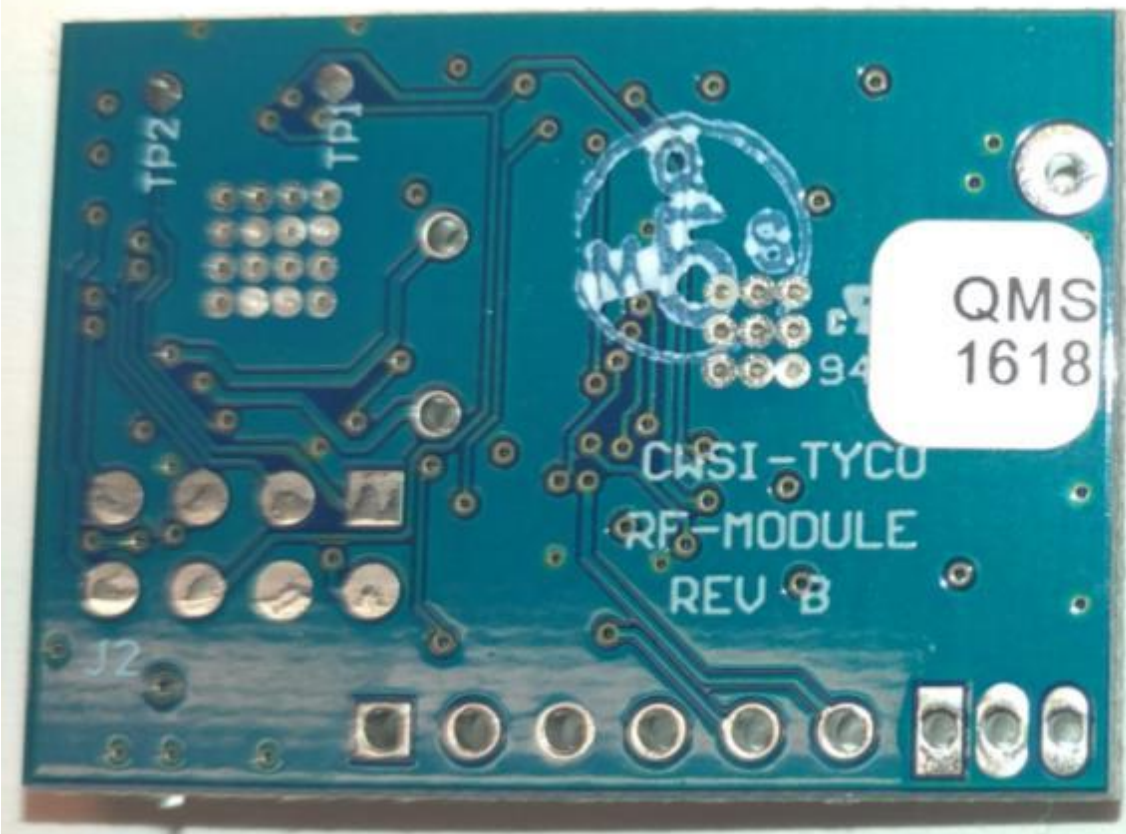
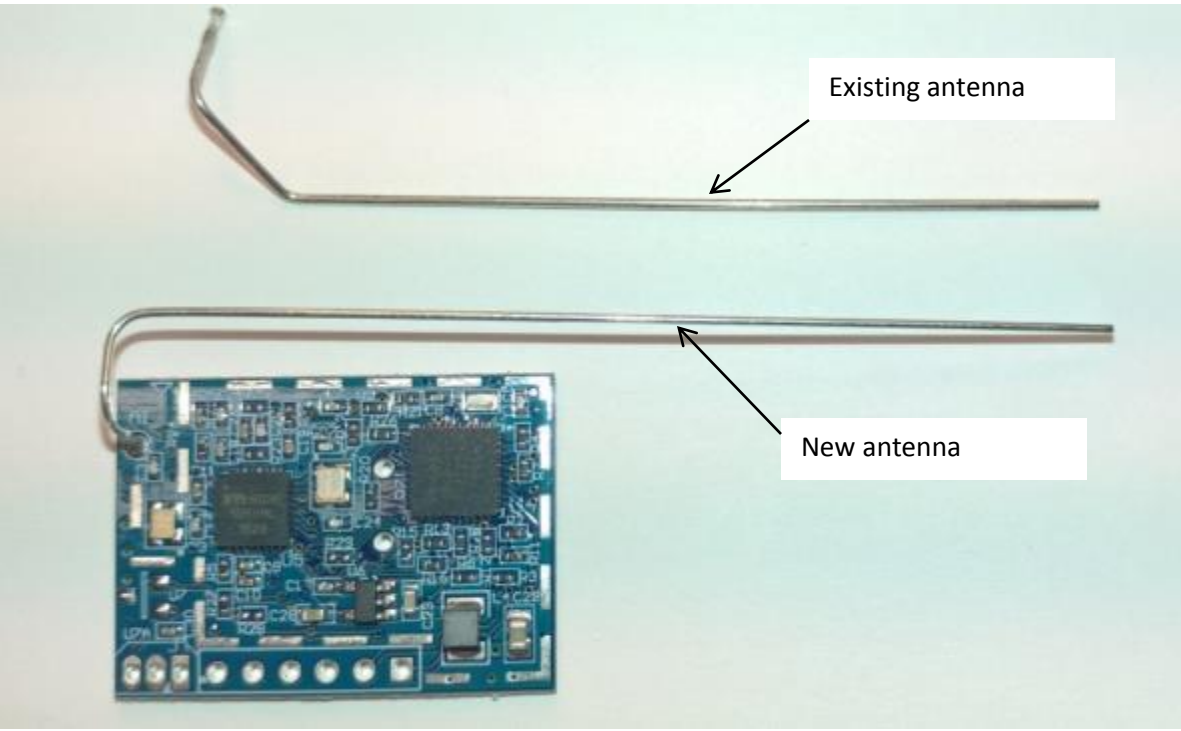
Old and new detectors with RF boards installed

The differences are:

1. The shape of the RF board was changed.
2. The antenna form was slightly changed.
3. Piezo sounder not populated.
4. A new detector head is being used.
