Prüfbericht - Nr.: 50049137 001

6 Photographs of the Test Set-Up

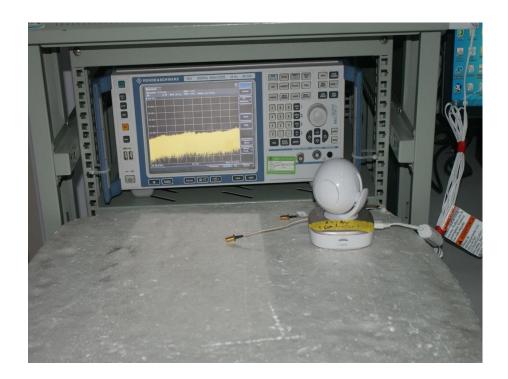
Photograph 1: Set-up for Radio Spectrum Test

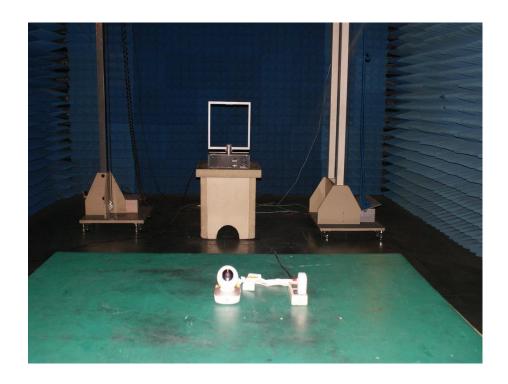
Photograph 2: Set-up for Radiated Spurious Emission (9kHz ~ 30MHz)

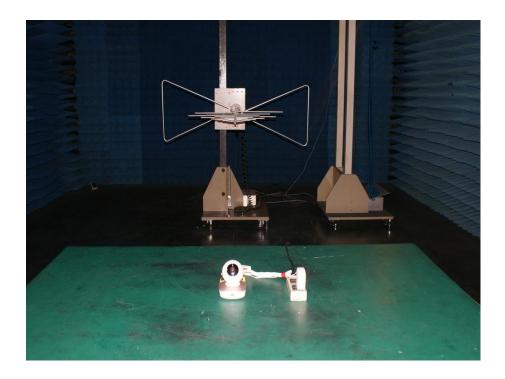
Photograph 3: Set-up for Radiated Spurious Emission (30MHz~1GHz)

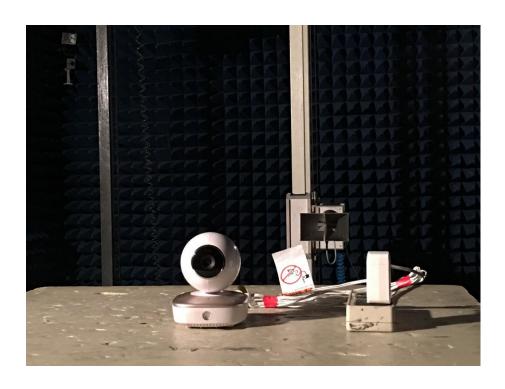
Photograph 4: Set-up for Radiated Spurious Emission (1GHz ~ 18GHz)

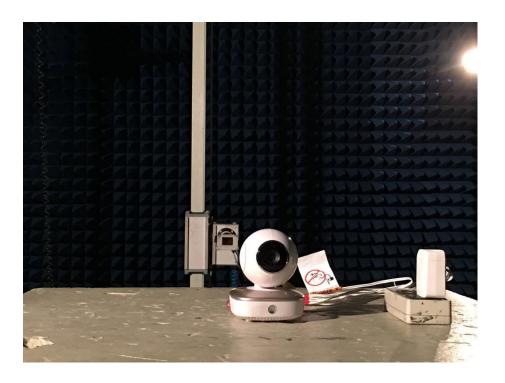
Photograph 5: Set-up for Radiated Spurious Emission (18GHz ~ 26GHz)

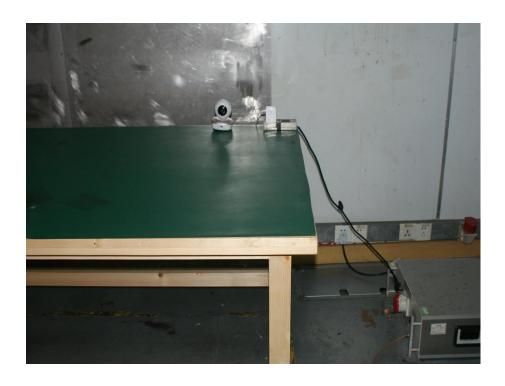
Photograph 6: Set-up for Conducted Emission on AC Mains
