Prüfbericht - Nr.: 50049979 001

6 Photographs of the Test Set-Up

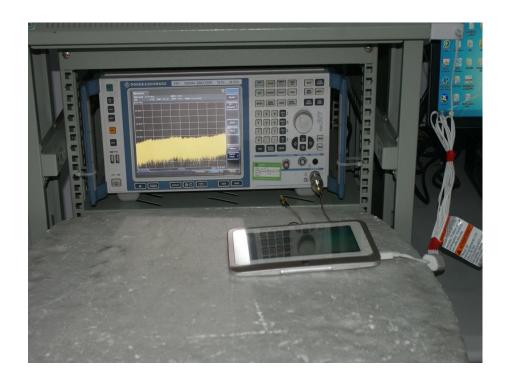
Photograph 1: Set-up for Radio Spectrum Test

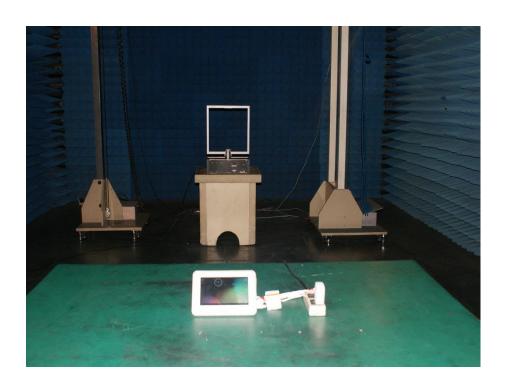
Photograph 2: Set-up for Radiated Spurious Emission (9kHz ~ 30MHz)

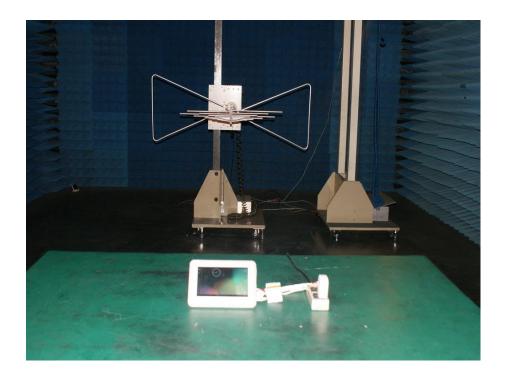
Photograph 3: Set-up for Radiated Spurious Emission (30MHz~1GHz)

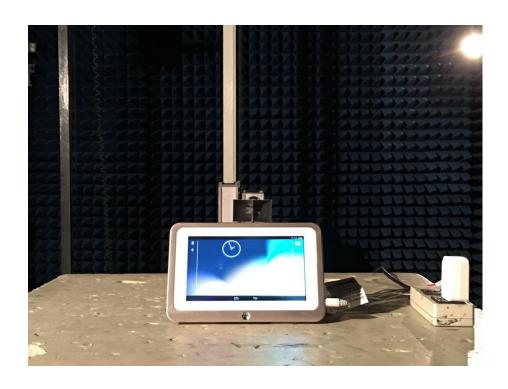
Photograph 4: Set-up for Radiated Spurious Emission (1GHz ~ 18GHz)

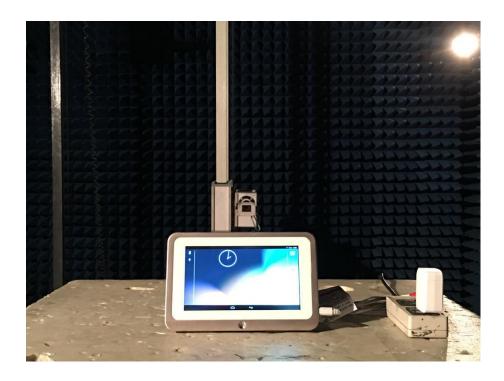
Photograph 5: Set-up for Radiated Spurious Emission (18GHz ~ 26GHz)

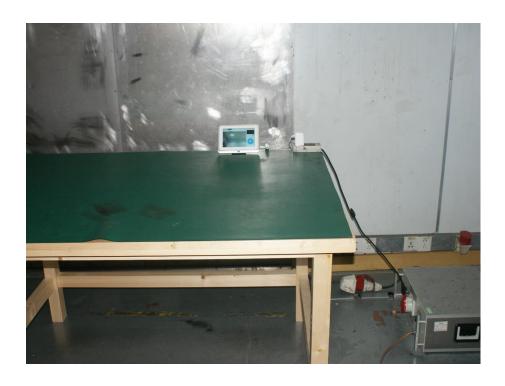
Photograph 6: Set-up for Conducted Emission on AC Mains
