### **APPENDIX 3: Photographs of test setup**

#### **Radiated Spurious Emission**

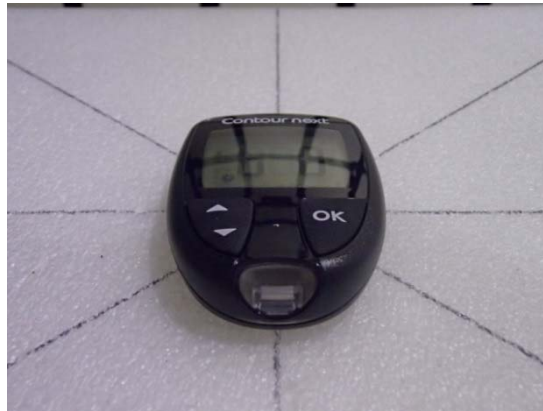
**X-axis**

**Worst Case Position**

(Above 1 GHz: Horizontal: X-axis / Vertical: Y-axis)

(Below 1 GHz: Horizontal: X-axis / Vertical: X-axis)
