APPENDIX 3: Photographs of test setup

Conducted Emission

Radiated Spurious Emission

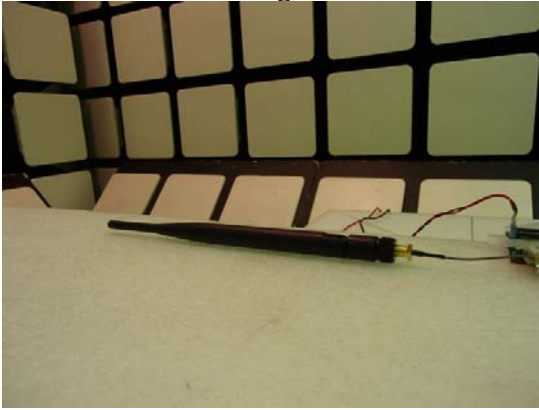
X1(0deg)-axis

Antenna Worst Case Position

(Horizontal: Y1(90deg) / Vertical: Y1(0deg)) (Above 1GHz)
(Horizontal: X1(0deg) / Vertical: X1(0deg)) (Below 1GHz)

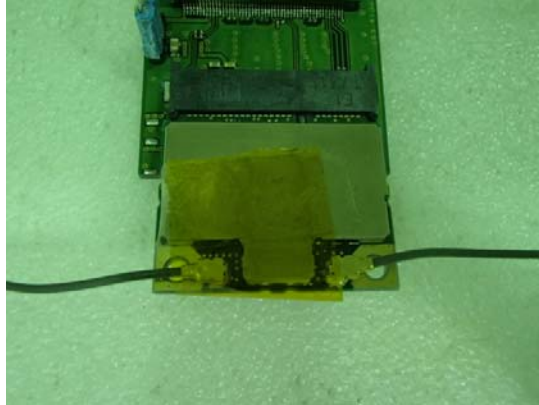
Module Worst Case Position

(Horizontal: X-axis / Vertical: X-axis) (Above 1GHz)
(Horizontal: Y-axis / Vertical: Y-axis) (Below 1GHz)
