APPENDIX 3: Photographs of test setup

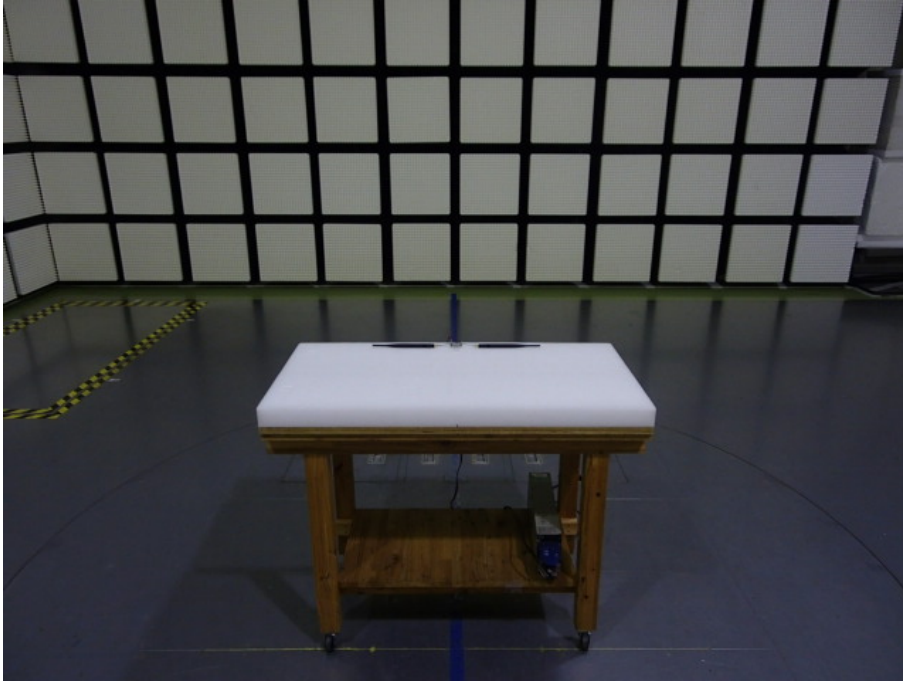
Radiated Spurious Emission
(WLAN)

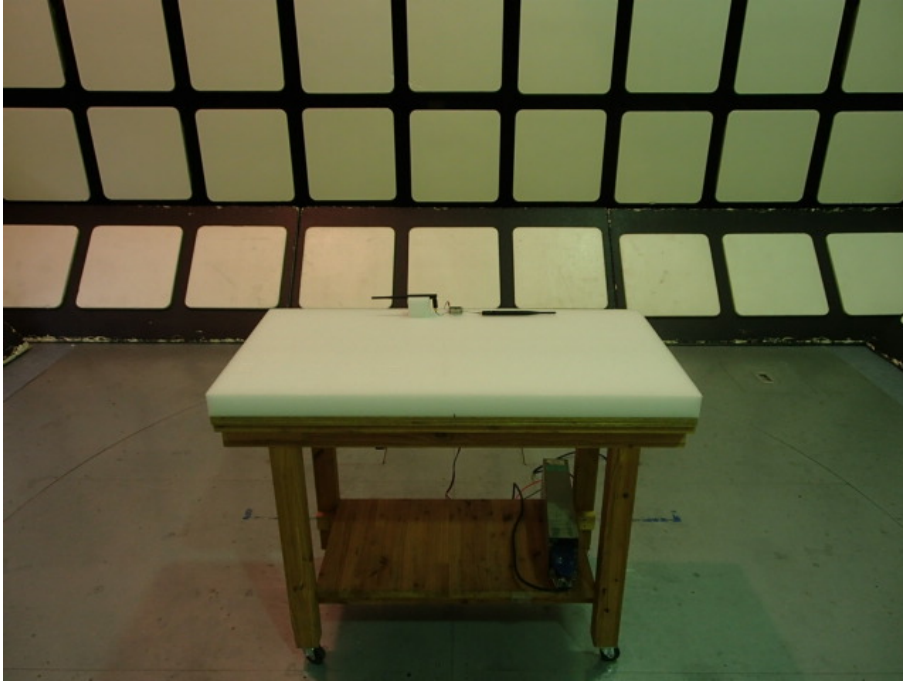
Radiated Spurious Emission
(BT LE)
