APPENDIX 3: Photographs of test setup

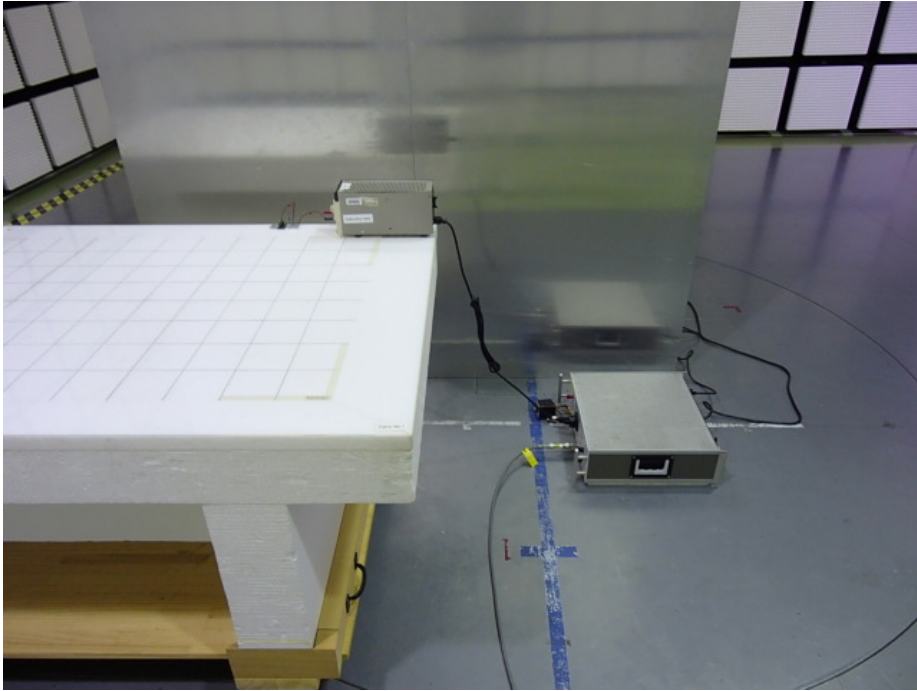
Photo 1

Conducted Emission

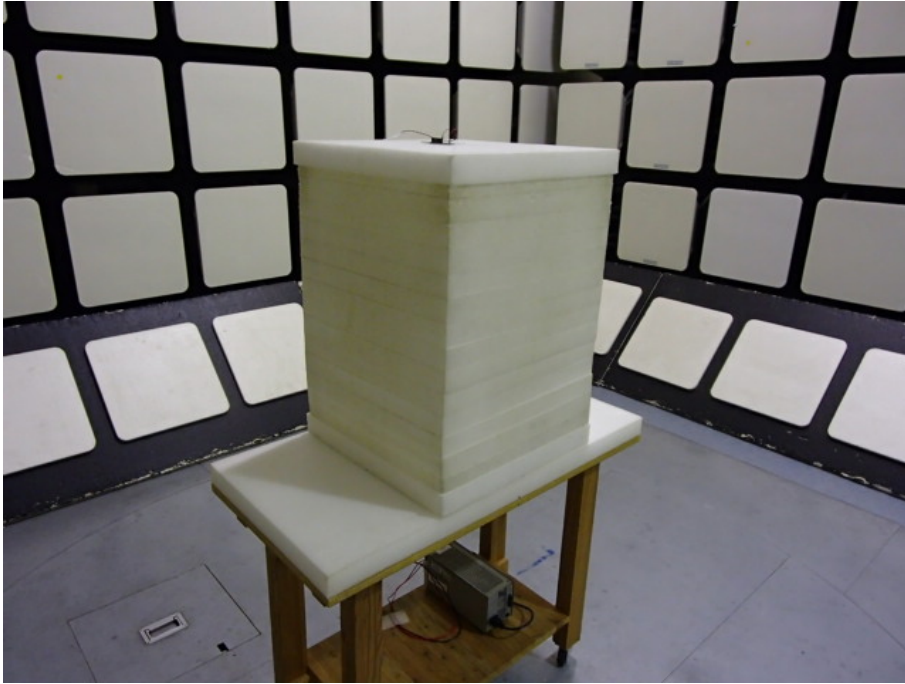
Photo 1

Radiated Spurious Emission

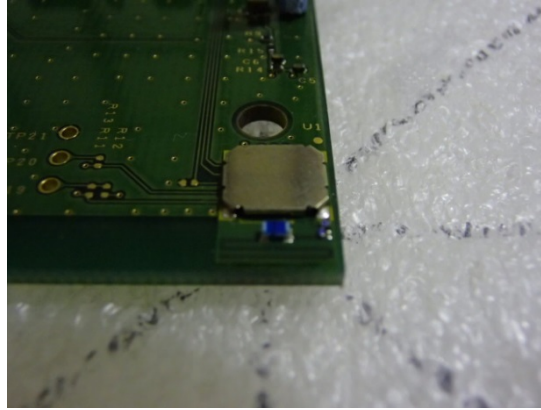
Worst Case Position

Above 1GHz (Horizontal: X-axis/ Vertical: Z-axis)
Below 1GHz (Horizontal: X-axis / Vertical: X-axis)
