APPENDIX 3: Photographs of test setup

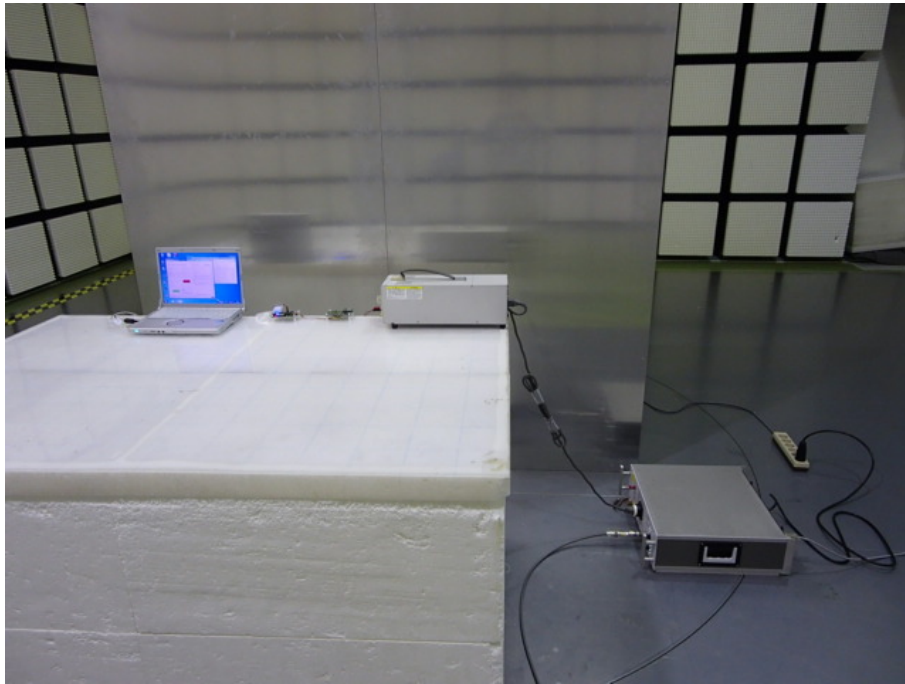
Photo 1

Conducted Emission

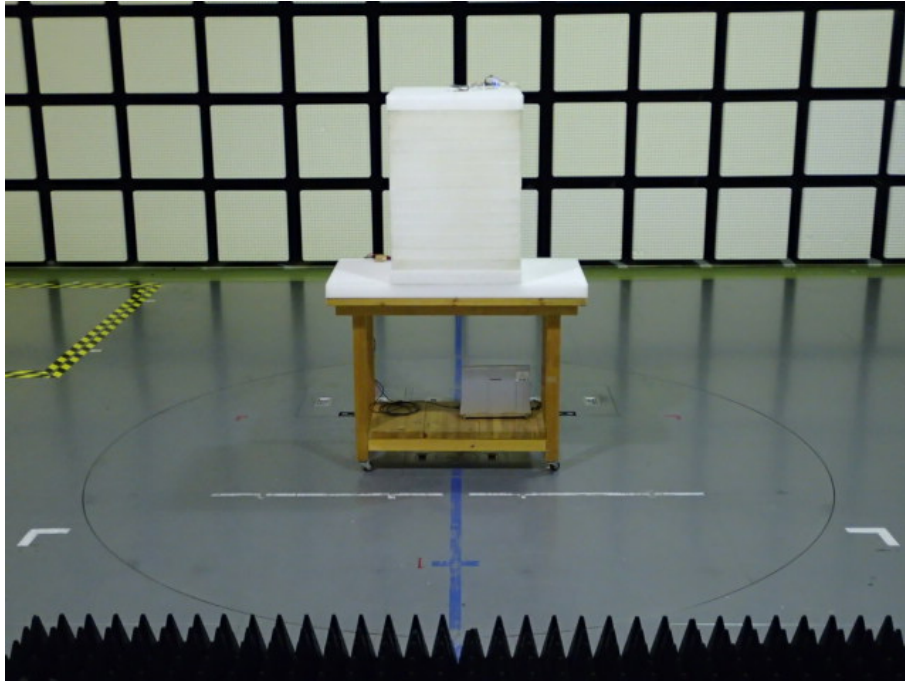
Photo 1

Radiated Spurious Emission

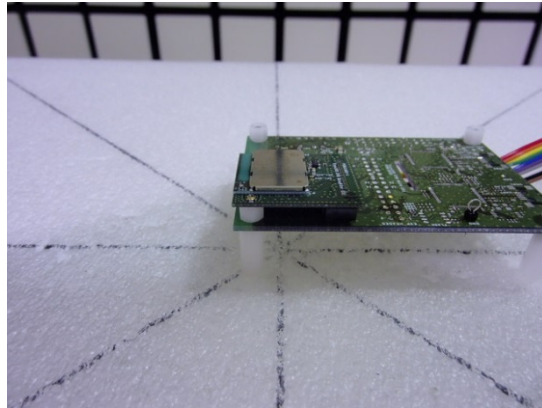
X-axis

Worst Case Position

Horizontal	Vertical
Below 1GHz	X	X
3rd harmonic	Z	Y
Above 1GHz(Other)	X	Y
