APPENDIX 3: Photographs of test setup

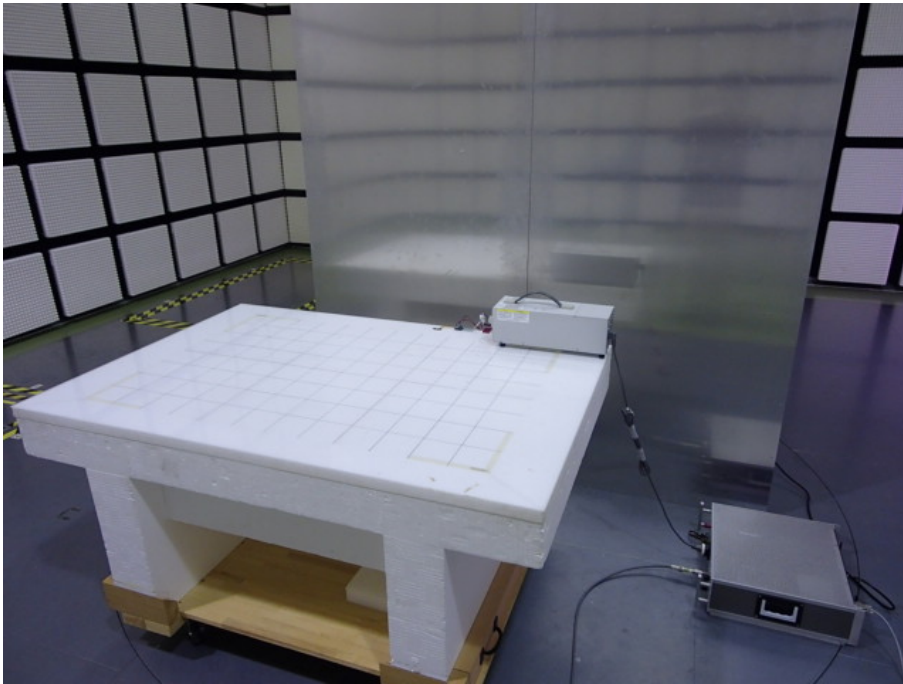
Photo 1

Conducted Emission

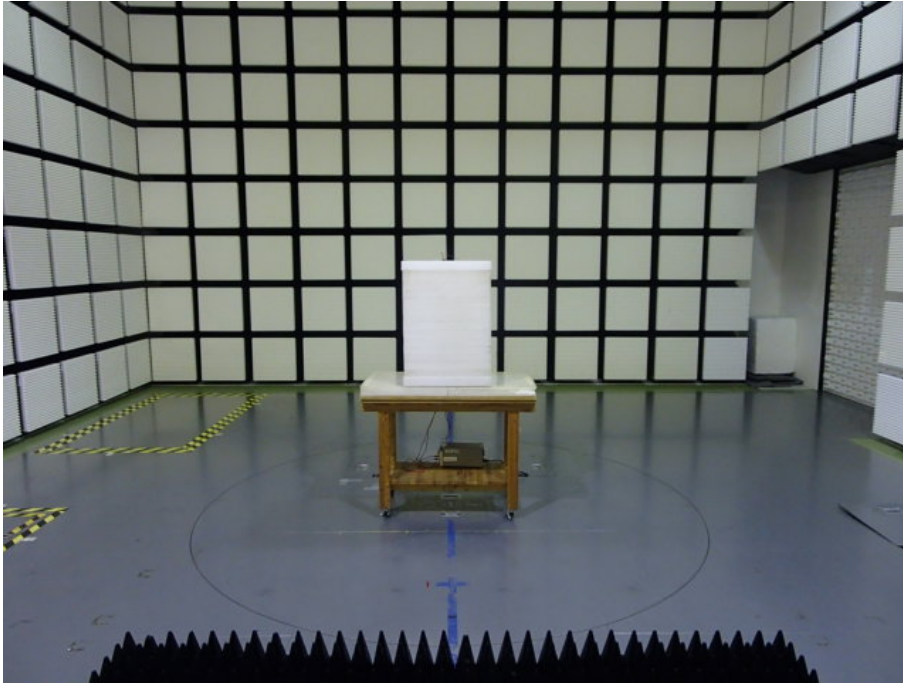
Photo 1

Radiated Spurious Emission

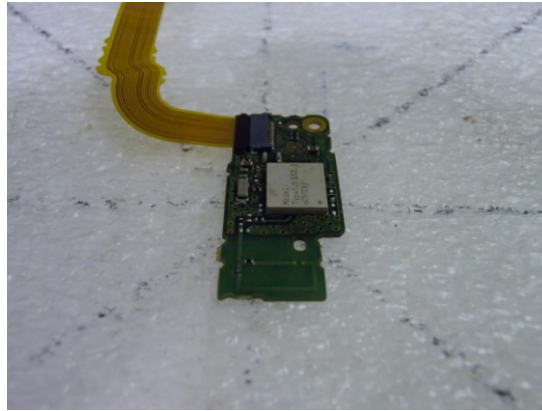
X-axis

Worst Case Position
WLAN (Horizontal: Z-axis/ Vertical: Y-axis)
BT LE (Horizontal: X-axis/ Vertical: Y-axis)
