**APPENDIX 3: Photographs of test setup**

**Radiated Spurious Emission**

**Worst Case Position**

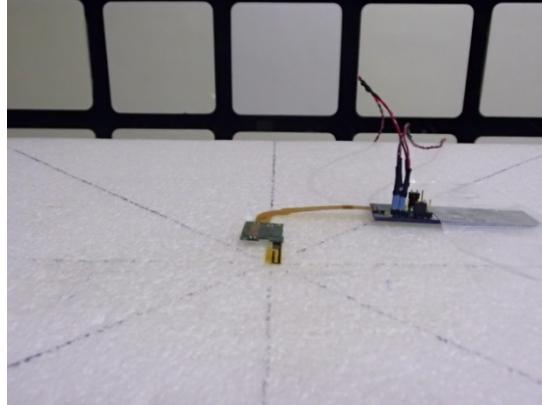
**X-axis**

Below 1GHz (Horizontal: X-axis/ Vertical:Y-axis)

Above 1GHz (Horizontal: X-axis/ Vertical:Y-axis)

Below 1GHz (Horizontal: X-axis/ Vertical:X-axis)
