APPENDIX 3: Photographs of test setup

Conducted Emission

Radiated Spurious Emission

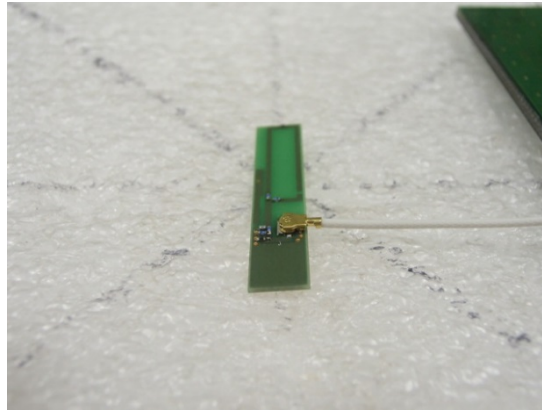
X-axis

Worst Case Position
Antenna (Horizontal: Z-axis/ Vertical:Z-axis)

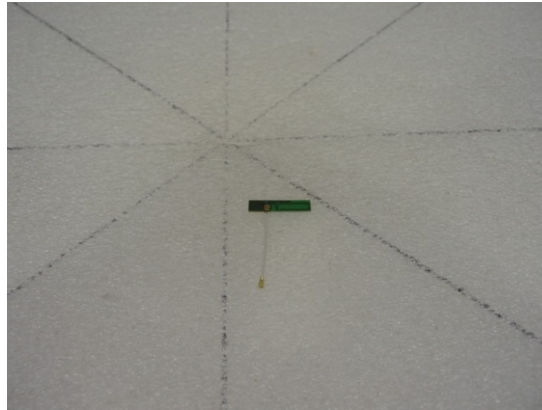
Worst Case Position

30 mm Antenna (Worst)

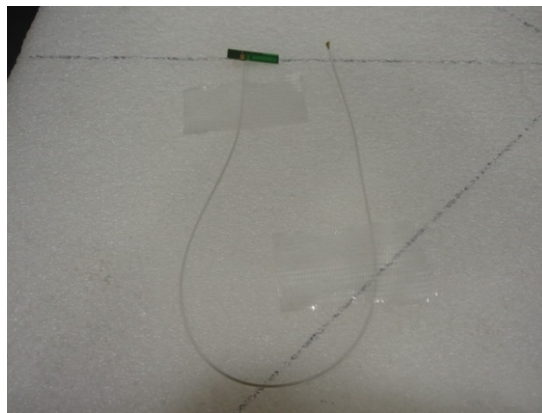
300 mm Antenna
