APPENDIX 3: Photographs of test setup

UL Japan, Inc.

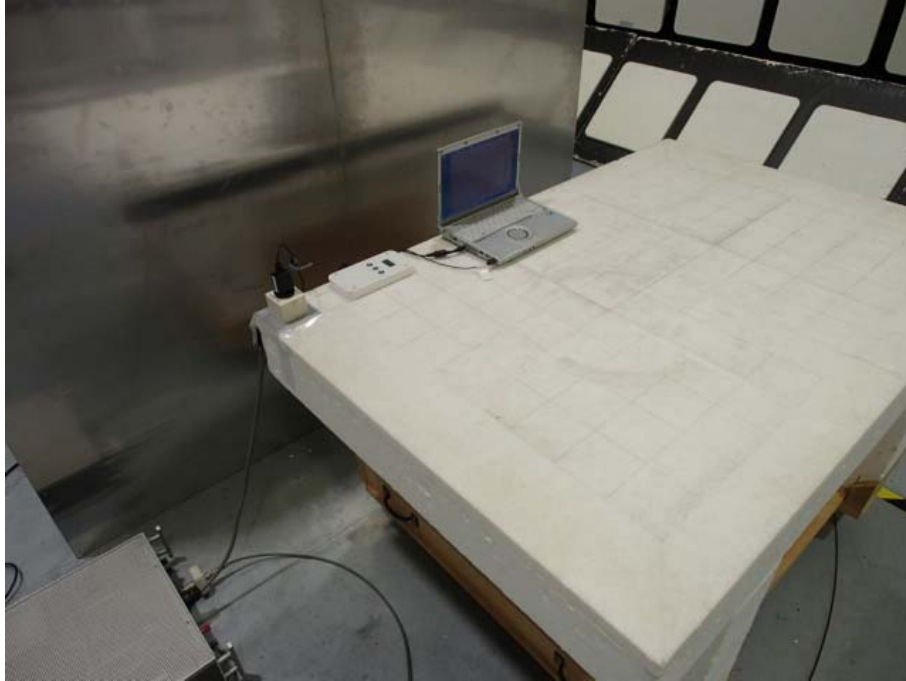
Photo 1

Conducted Emission

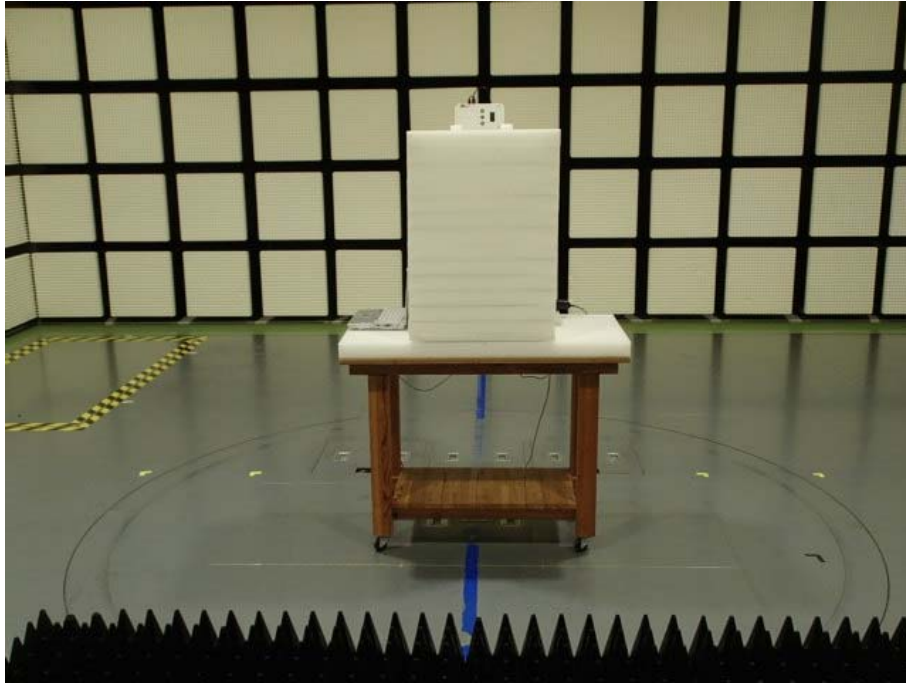
Photo 1

Radiated Spurious Emission

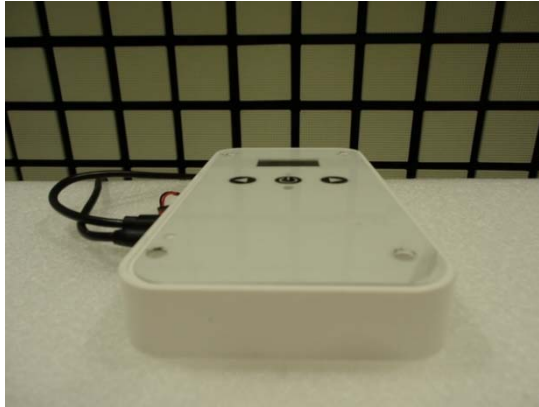
Worst Case Position

Below 1 GHz (Horizontal: X-axis / Vertical: X-axis)

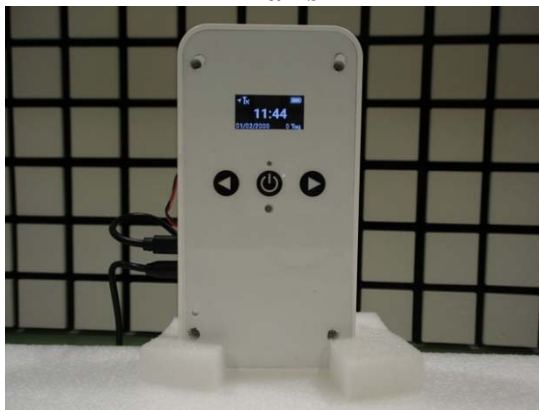
Above 1 GHz (Horizontal: Y-axis / Vertical: Z-axis)

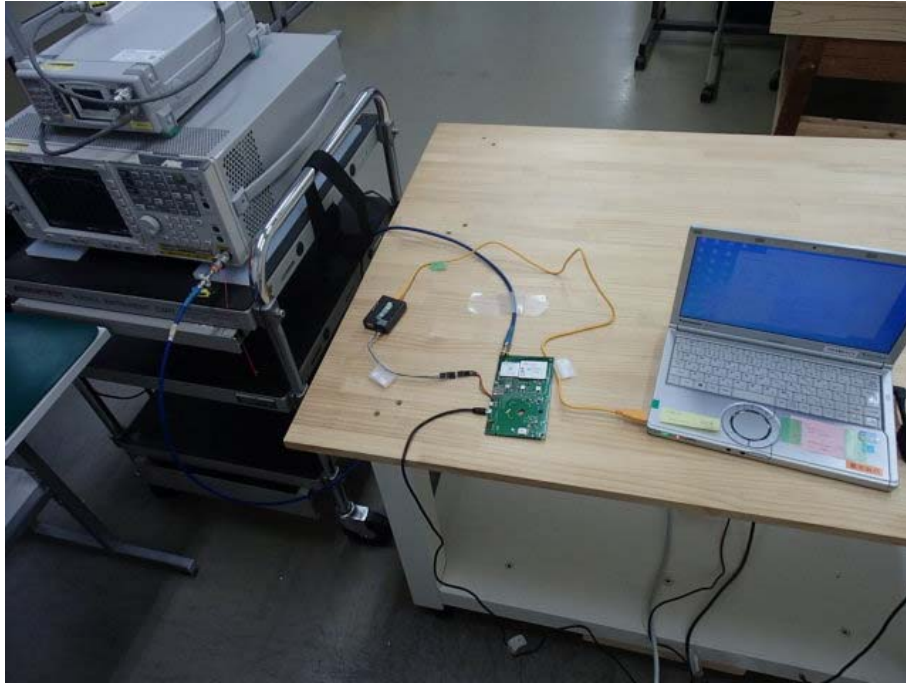
Photo 1

Antenna Terminal Conducted Tests
