APPENDIX 3: Photographs of test setup

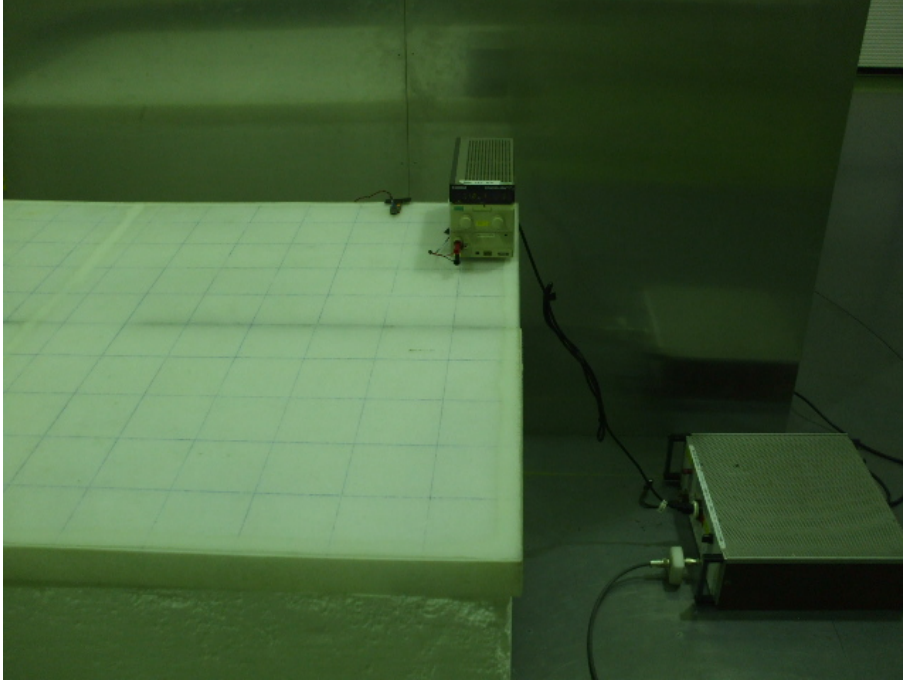
Photo 1

Conducted Emission

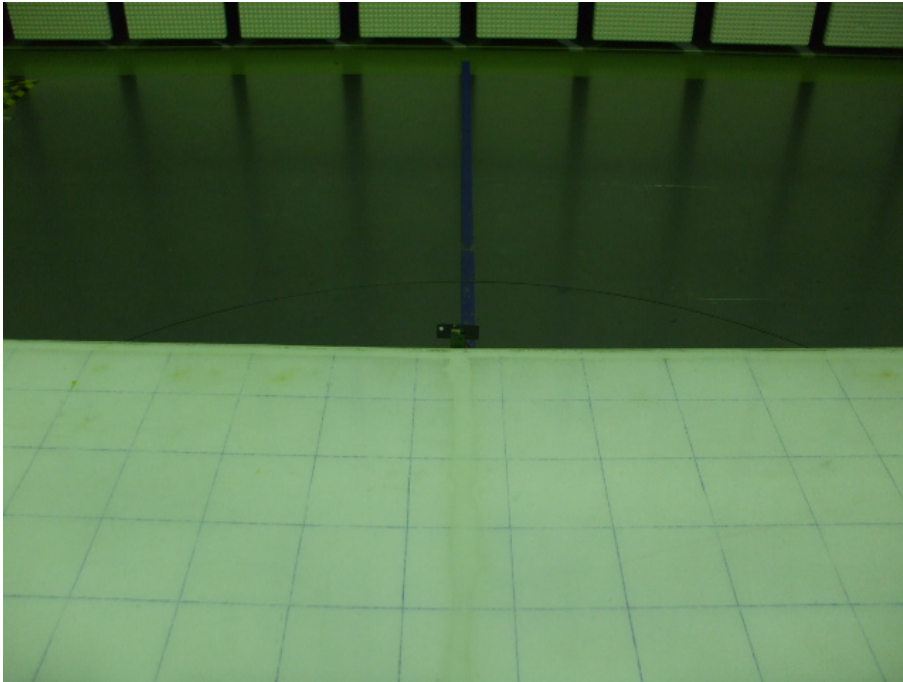
Photo 1

Radiated Spurious Emission

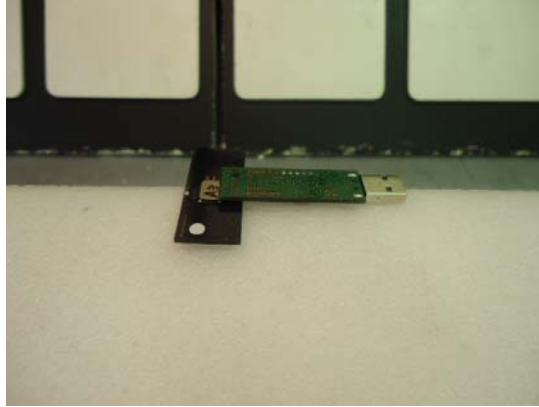
X-axis

Worst Case Position (Horizontal: Y-axis/ Vertical:Z-axis)

* The test was performed on a jig board, on which the stripline design of 9.7 mm of the actual use distance between the module and antenna was made.
