APPENDIX 3: Photographs of test setup

Conducted Emission

Radiated Spurious Emission

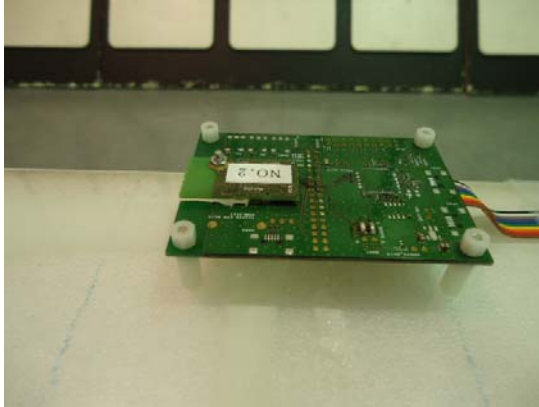
X-axis

Worst Case Position

**Below 1GHz (Horizontal: Z-axis/ Vertical: Z-axis)
Above 1GHz (Horizontal: Y-axis/ Vertical: Z-axis)**

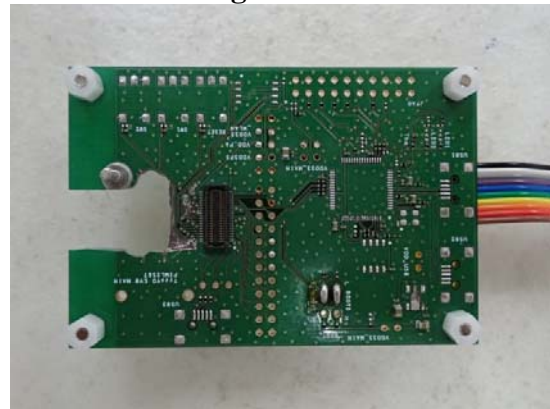
Jig Board*

*Jig board was shaped as shown above so that it does not shield the rear side of the EUT.
