**APPENDIX 3: Photographs of test setup**

**Radiated Spurious Emission**

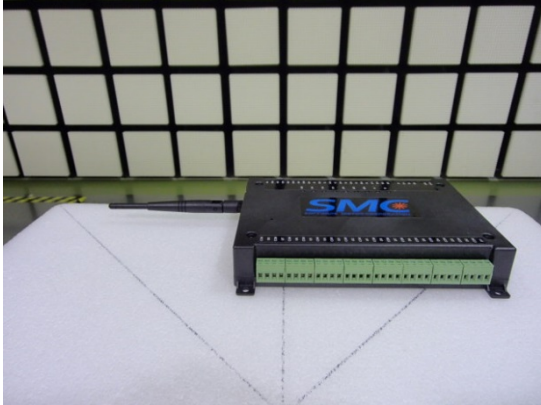
**X0-axis**

**Worst Case Position**

(Horizontal: X0-axis / Vertical: Z0-axis) (Below 1 GHz)  
(Horizontal: Y90-axis / Vertical: Z0-axis) (Above 1 GHz)
