APPENDIX 3: Photographs of test setup

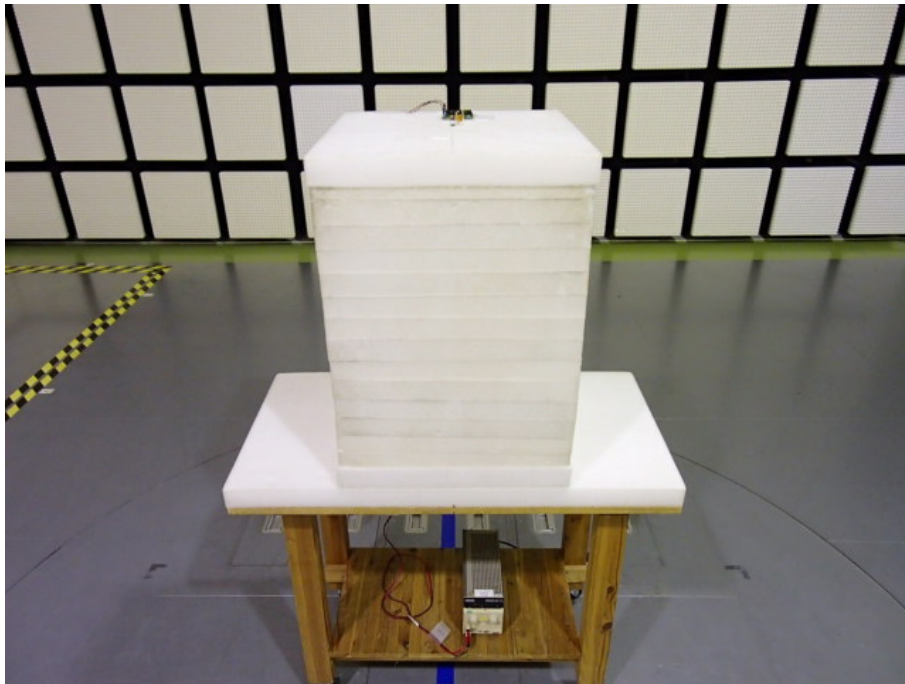
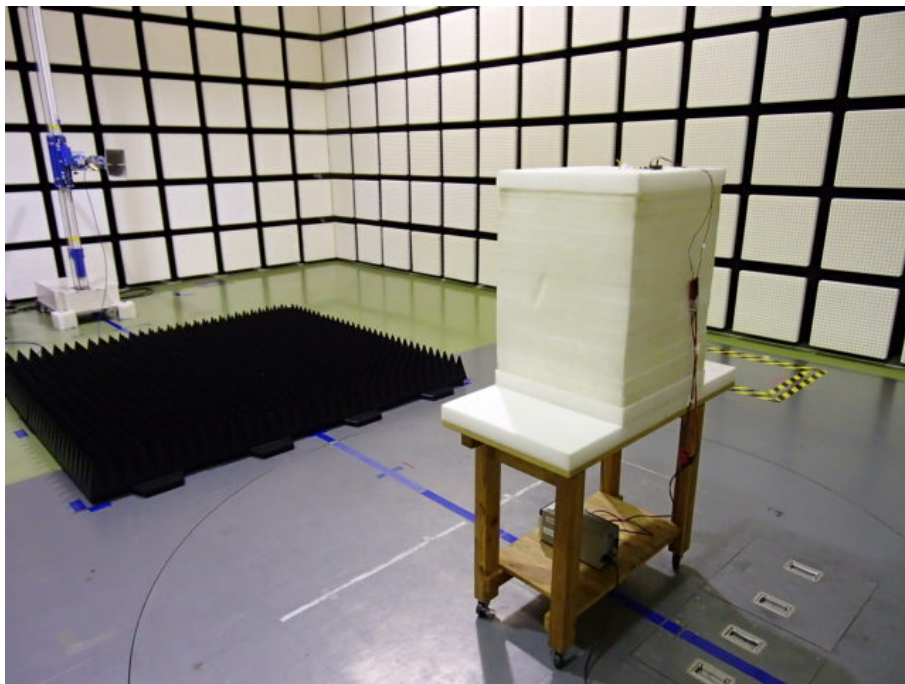
Radiated Spurious Emission

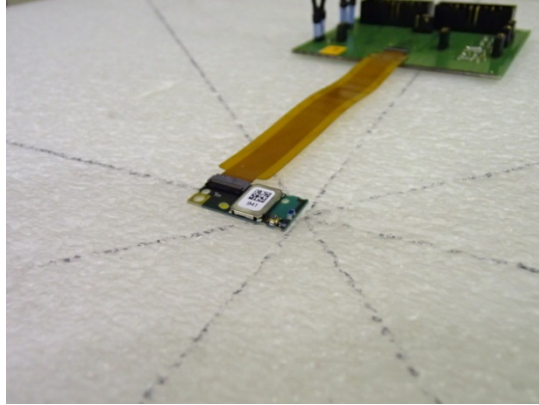
X-axis

Worst Case Position

Below 1 GHz :(Horizontal: X-axis/ Vertical:X-axis)

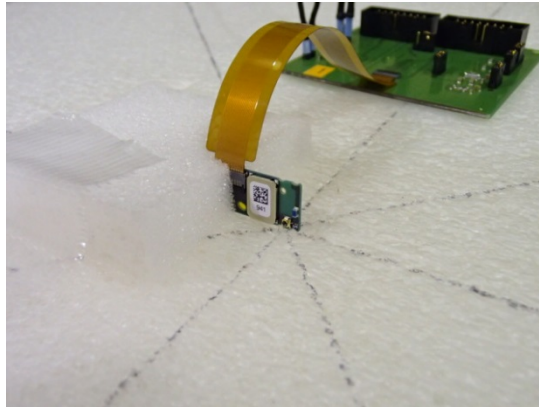
Y-axis

Above 1 GHz :(Horizontal: Z-axis/ Vertical:Y-axis)
