APPENDIX 1: Photographs of test setup

Radiated Emission

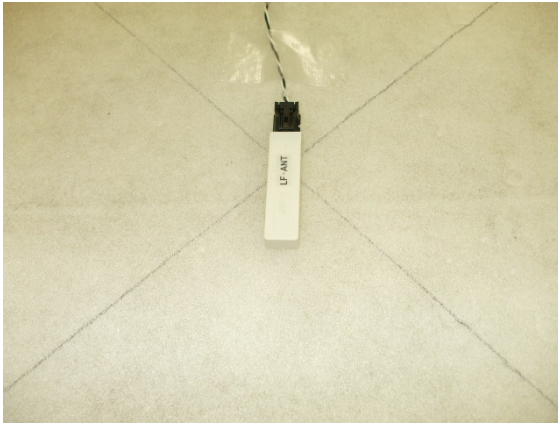
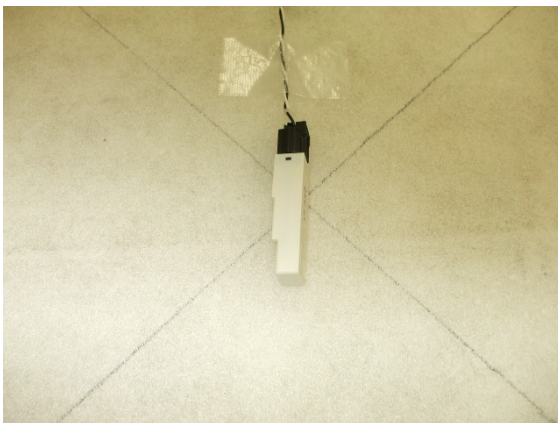
Worst Case Position

Ant
Below30MHz: X-axis
Above30MHz Hori:X / Vert:X
X-axis

Y-axis

Z-axis
