1 Annex A – Test setup

1.1 List of Pictures

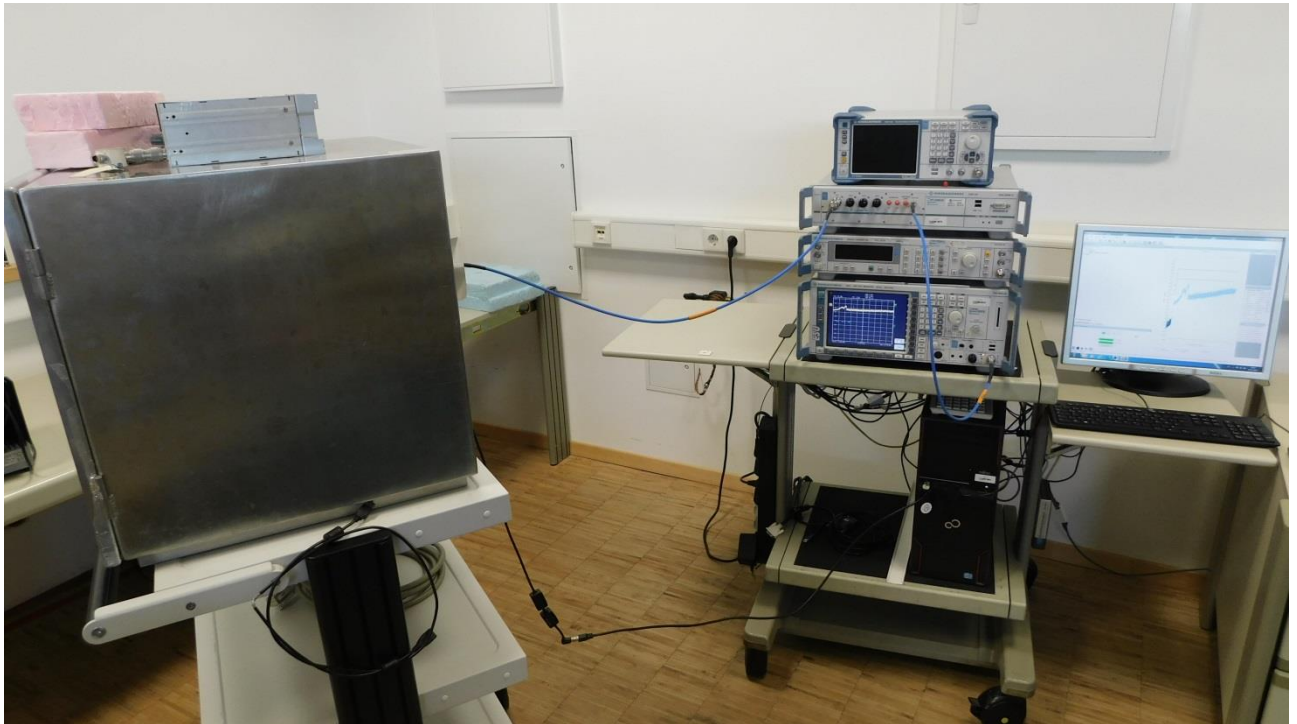
Picture 9: Conducted measurements

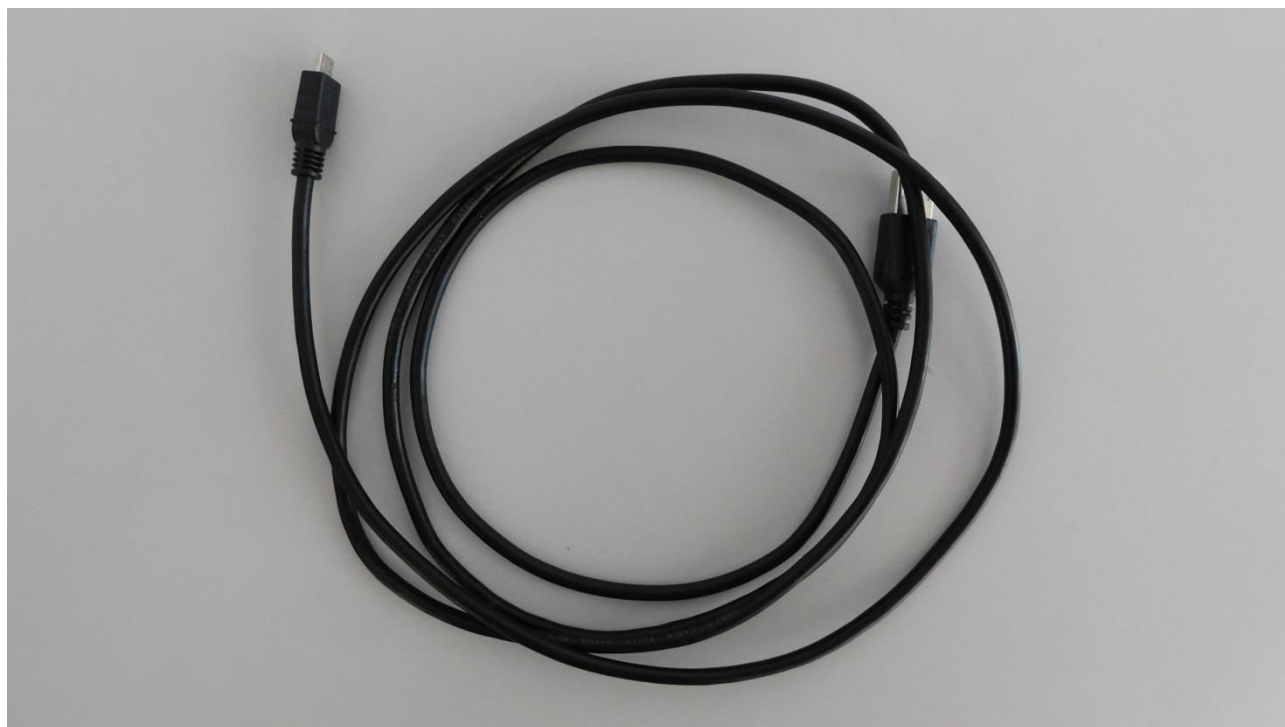
Picture 13:Used USB-cable
