1 Conducted emissions

Exhibit 7

Test Setup Photos

Test report # : 560101-CC-1-a

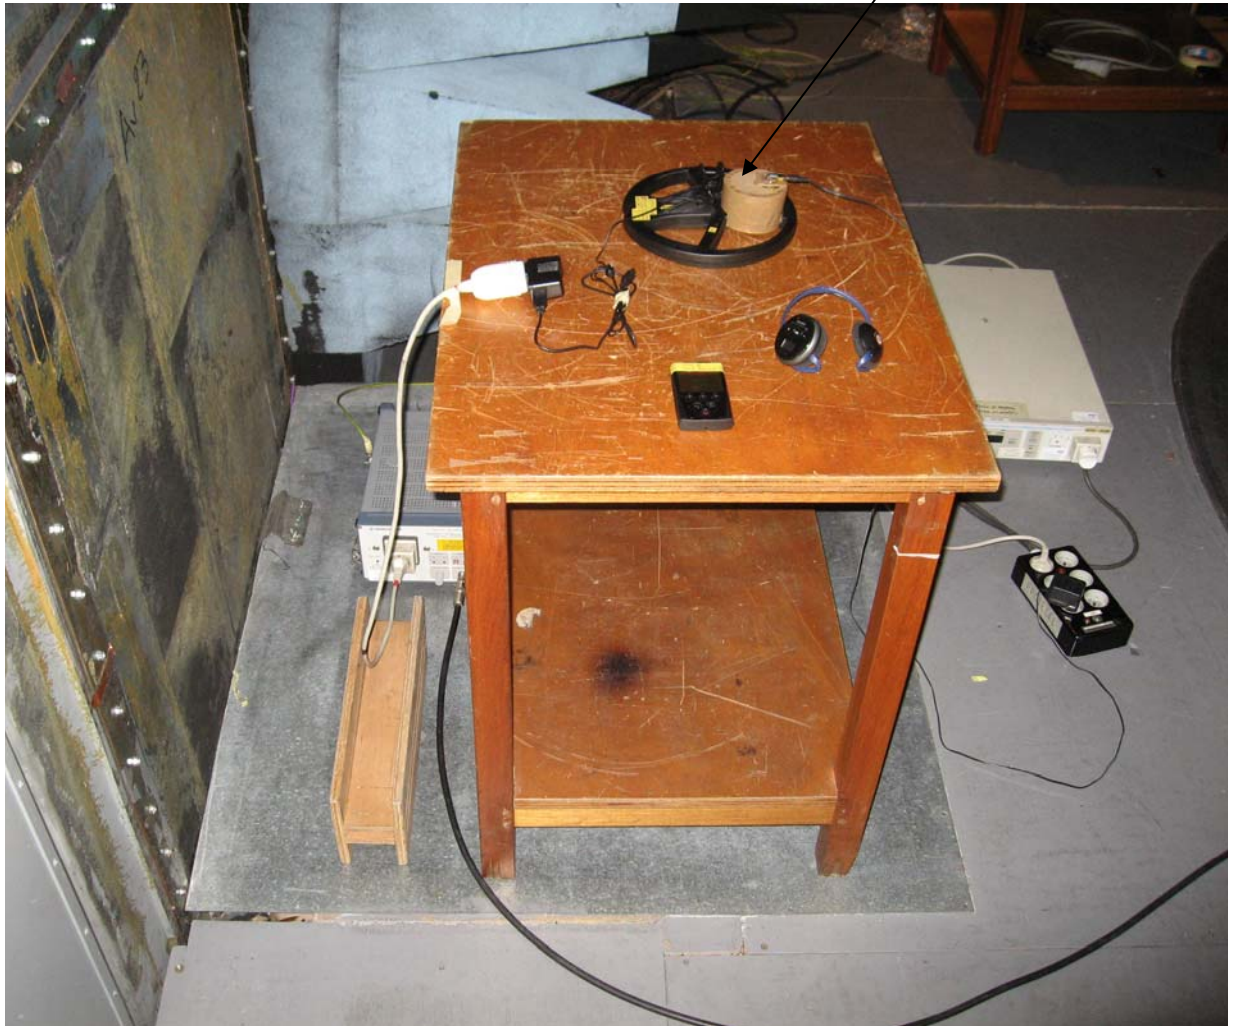
With power supply box

Note : the final plastic clips for the charging connector was not ready for the test

This plastic clip will replace the cardboard made fixation.

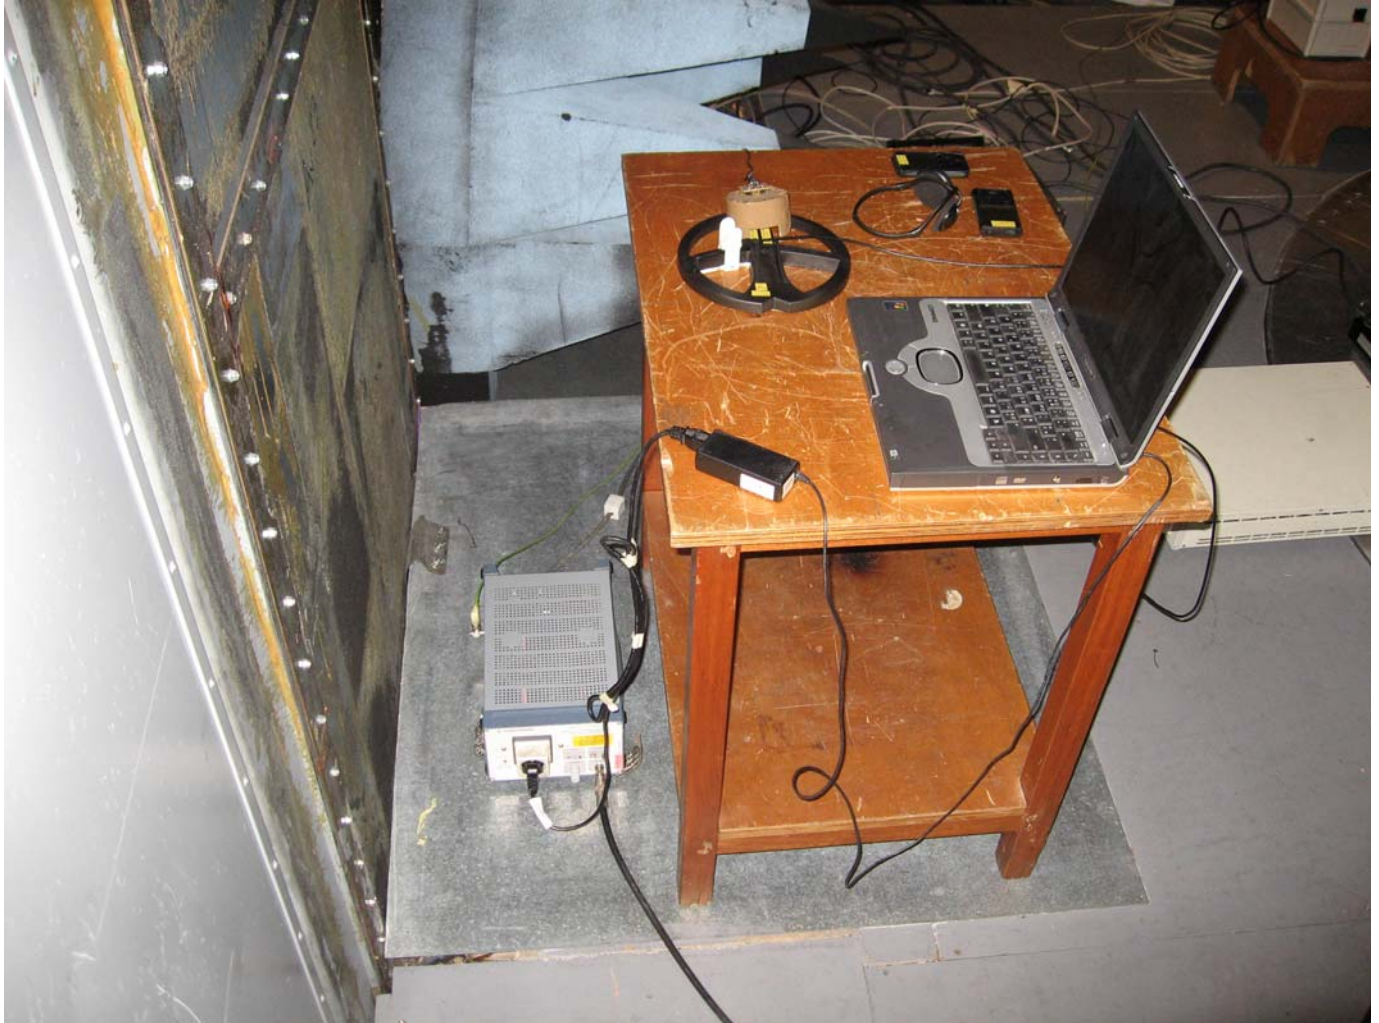
With PC power supply

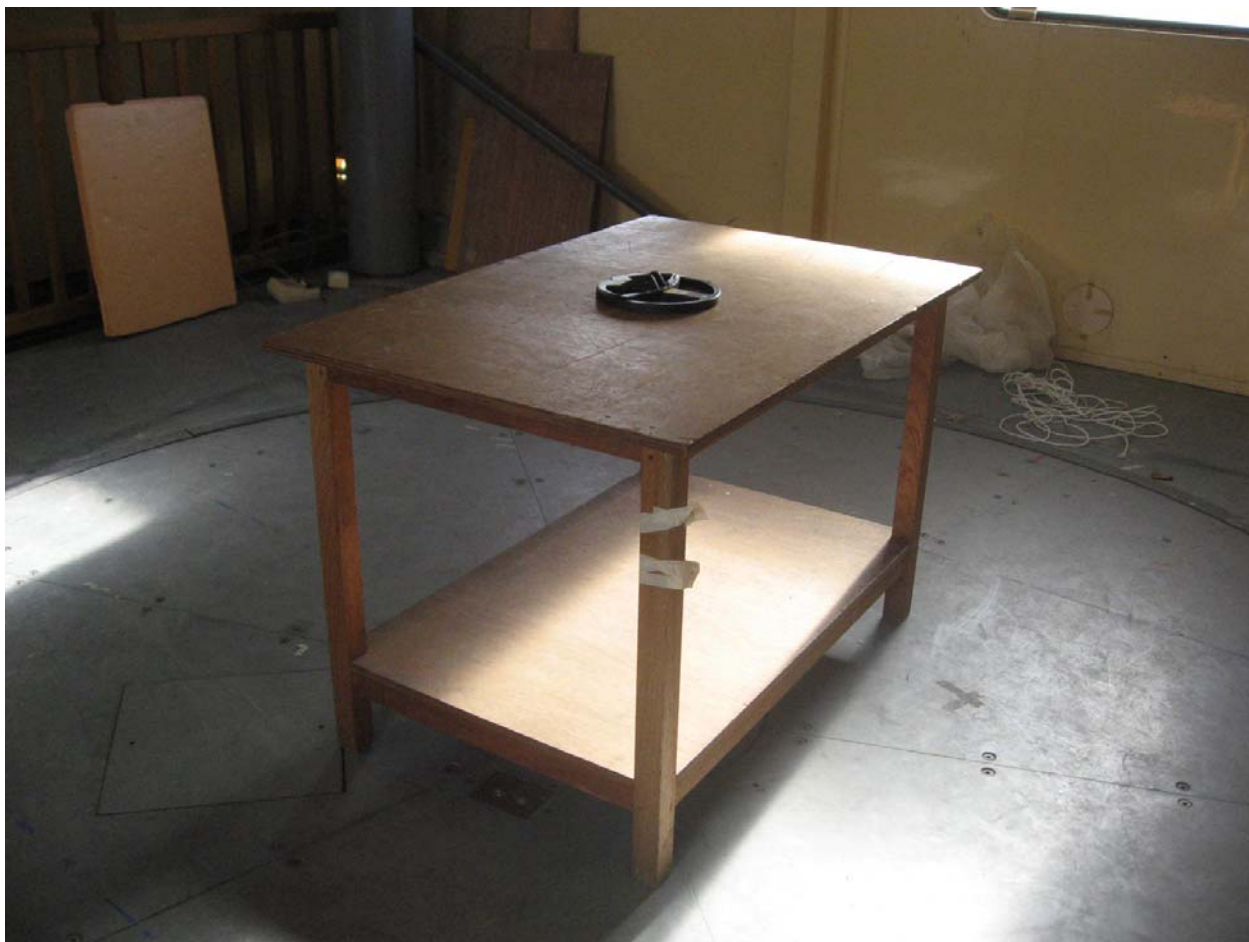
2 Radiated emissions

Magnetic sensor head

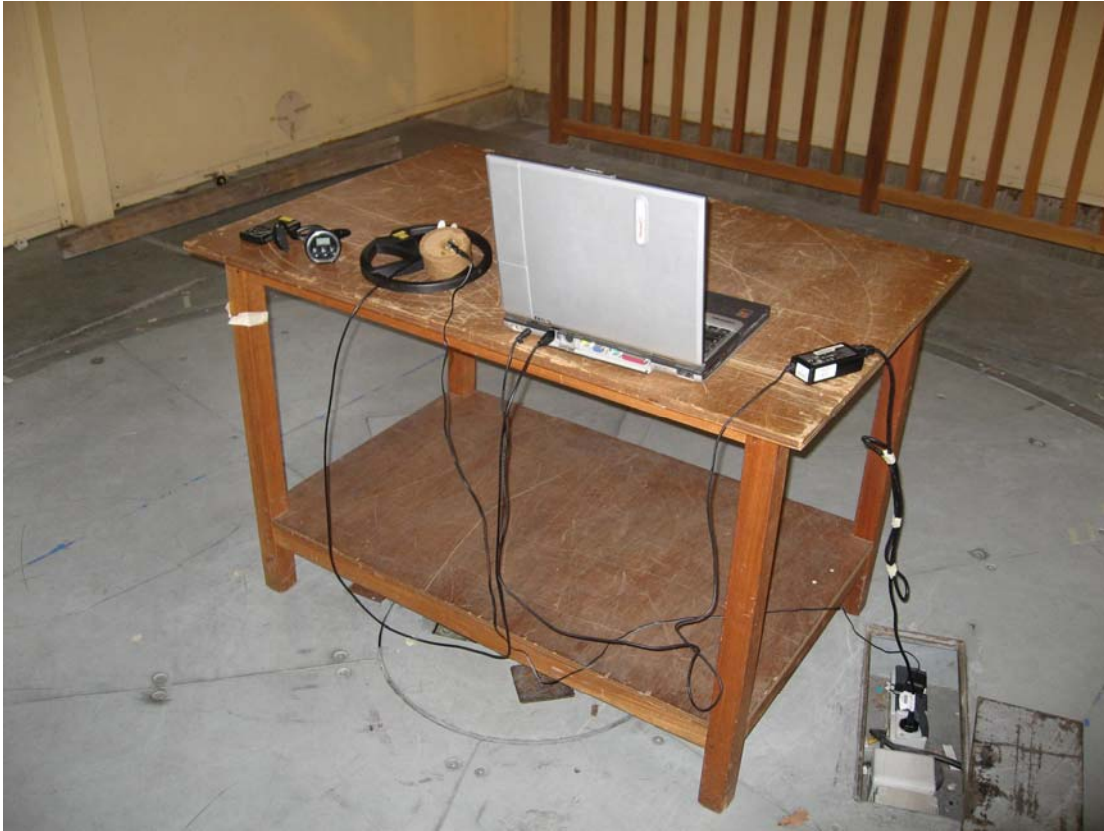
3 Radiated emissions (full configuration)
