PUBLIC ENTERPRISE TESTING CENTER «OMEGA»

**TEST REPORT No. 11/652
Issue 2
Corrosion and Oil Resistance tests
for compliance with items 5.1.5.10, 5.1.5.8 IEC 61097-12 First edition 1996-11**

**Model: V100
FCC ID XYEV100
Manufacturer: Ocean Signal Ltd., Great Britain**

**ANNEX 1.
CORROSION TEST**

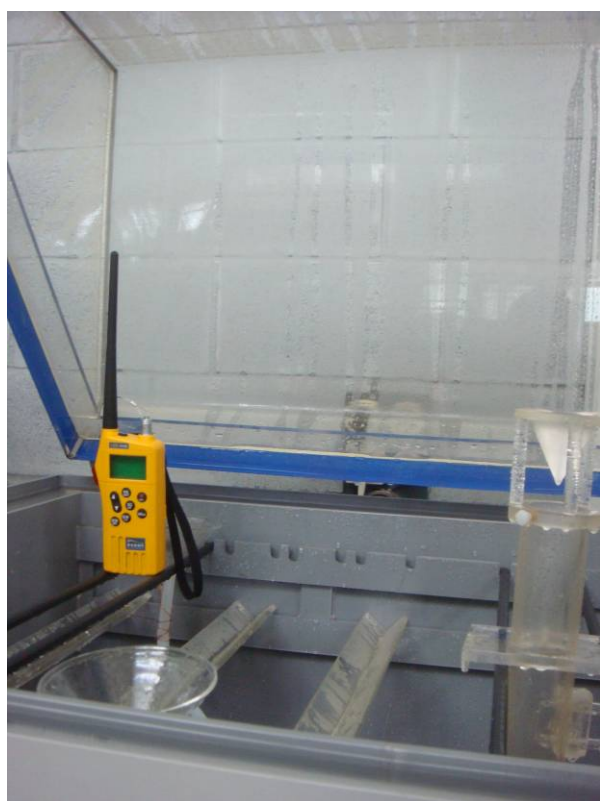
The EUT was placed in a chamber and sprayed with a salt solution for 2 h at normal temperature. The salt solution was prepared by dissolving (5 ± 1) parts by weight of sodium chloride (NaCl) in 95 parts by weight of distilled or demineralized water.

Figure 1.4 – EUT in the salt fog chamber

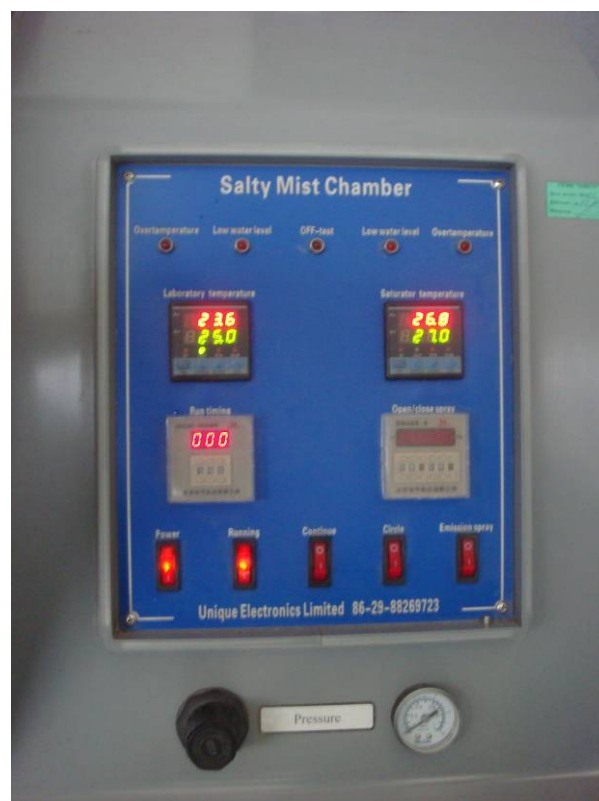
Figure 1.5 – View temperature of salt solution into reservoir

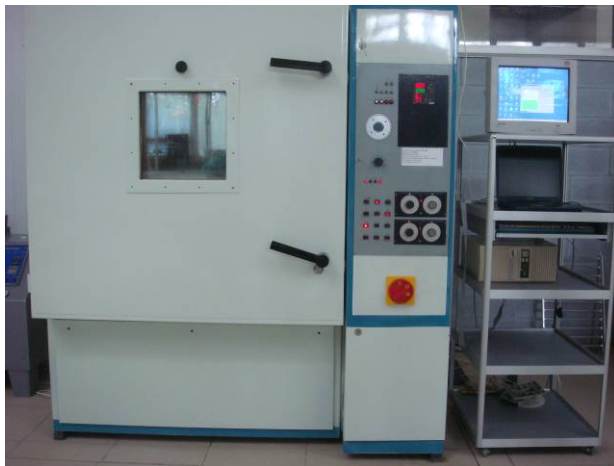
At the end of the spraying period, the EUT was placed in a chamber and was maintained at a temperature of $40 \text{ }^{\circ}\text{C} \pm 2 \text{ }^{\circ}\text{C}$, and a relative humidity between 90 % and 95 % for a period of seven days.

Figure 1.6 – EUT in climatic chamber

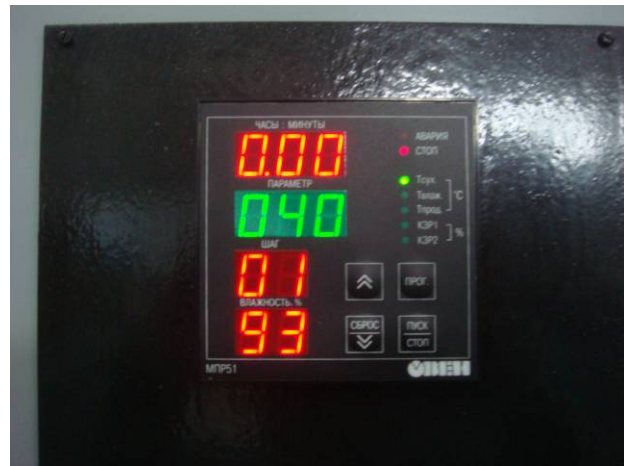
Figure 1.7 – Temperature and humidity in climatic chamber

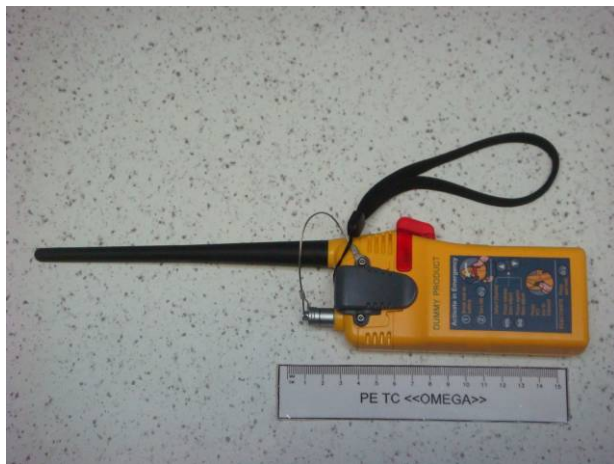
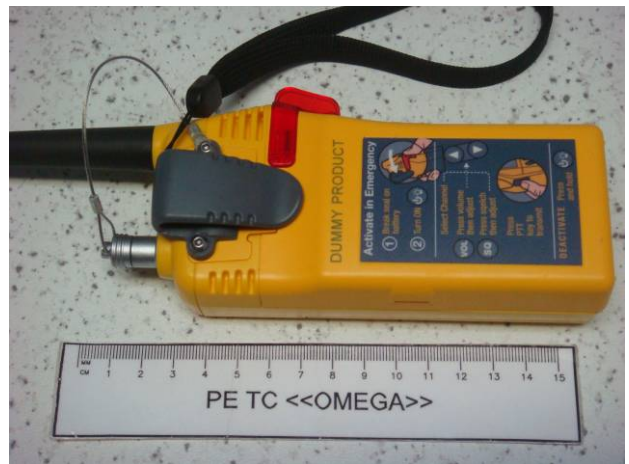
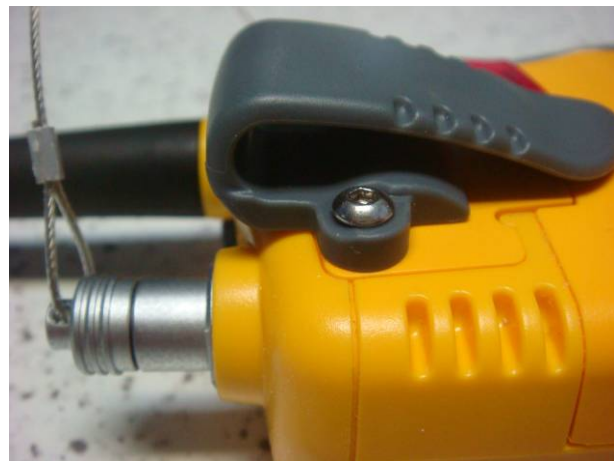
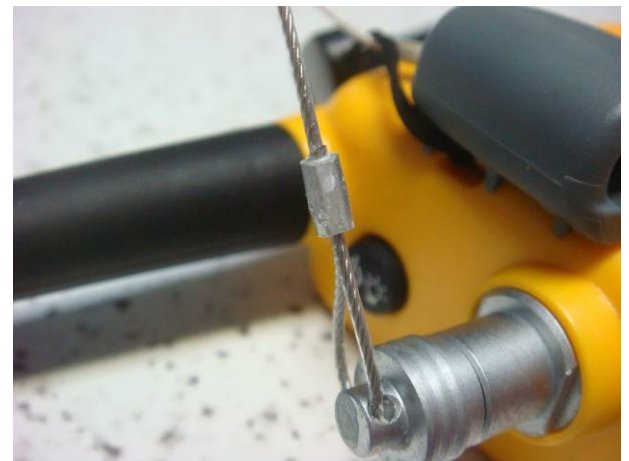
There is deterioration of clamp (Figures 1.8, 1.9, 1.11).

Figure 1.8 – Detail photo of parts of VHF Radio after the test.
There are no corrosion, and other signs of deterioration

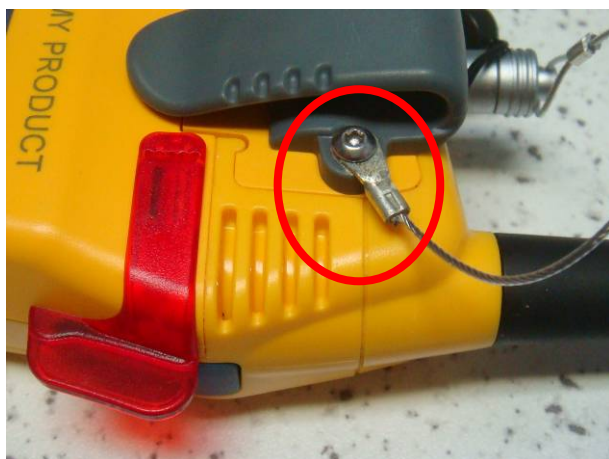
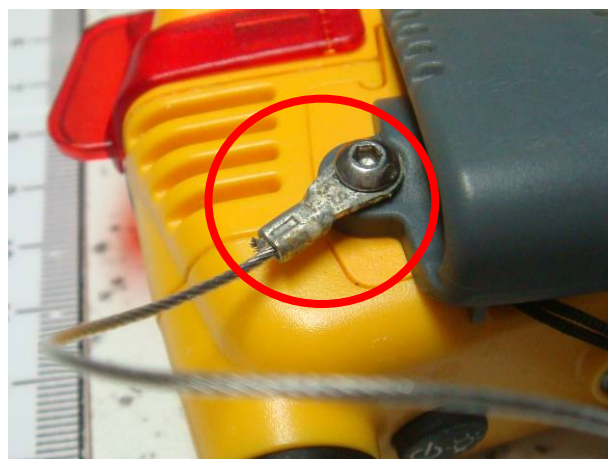
No signs of deterioration or corrosion of metal parts were founded except for clamp that fixes line of dust cap to the EUT case on the Accessory socket variant.

V100 with Accessory Socket (Variant): Fail.

Figure 1.9 – Detail photo of parts of VHF Radio after the test.
There are signs of deterioration of clamp

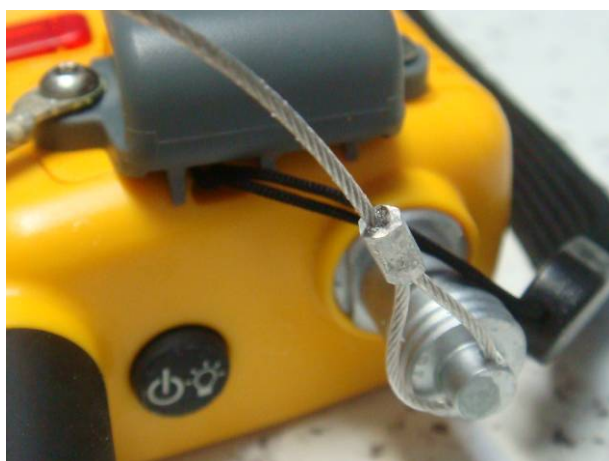
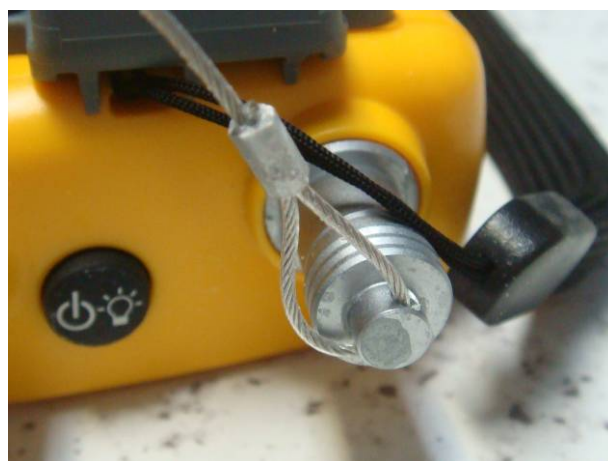
Figure 1.10 – Detail photo of parts of VHF Radio after the test.
There are no corrosion, and other signs of deterioration

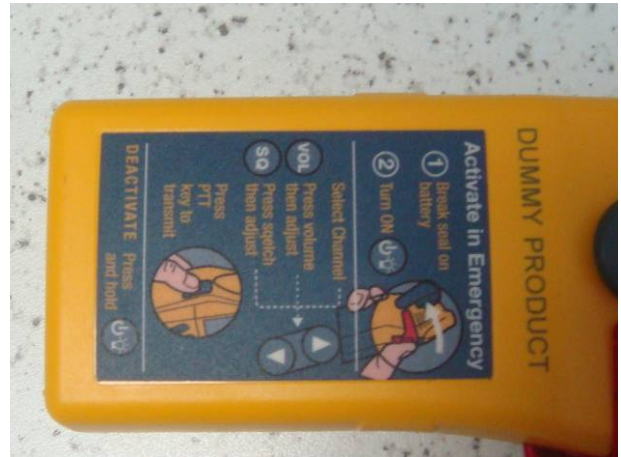
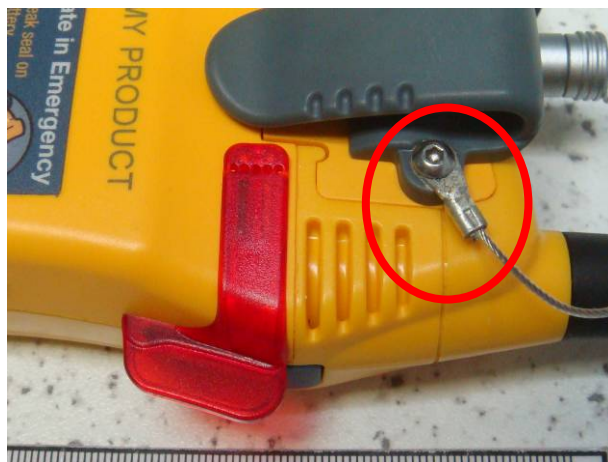
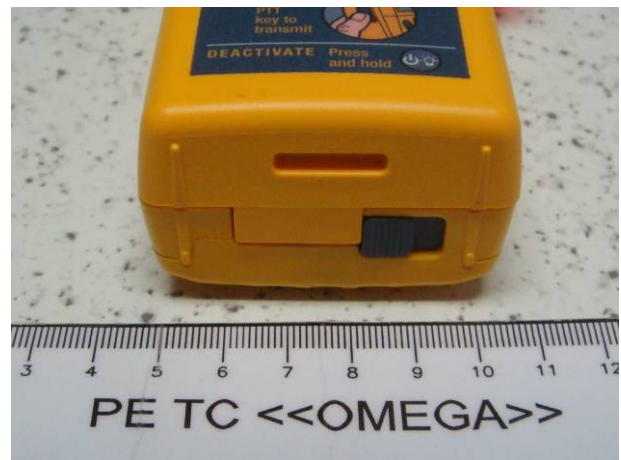
* Fail for V100 with Accessory Socket (Variant) – there are signs of deterioration only on the accessory socket dust cap cable clamp.

Figure 1.11 – Detail photo of parts of VHF Radio after the test
 There are no corrosion, and other signs of deterioration on all parts, except for the accessory socket dust cap cable clamp.

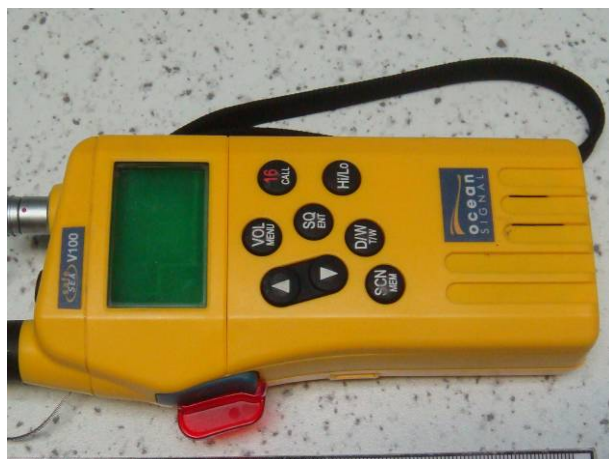
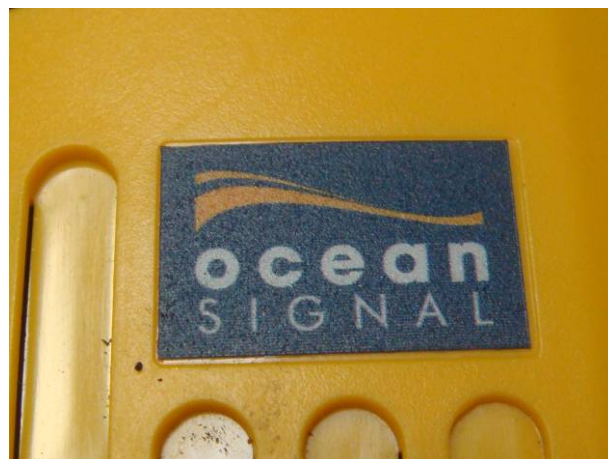
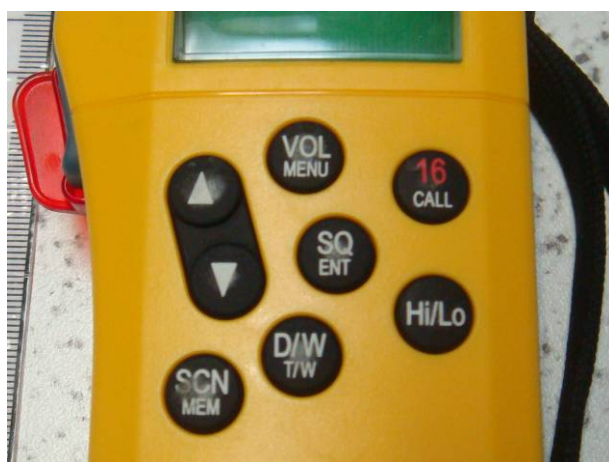
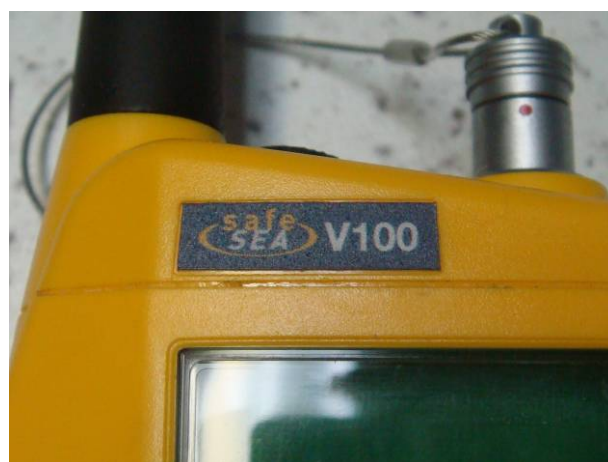
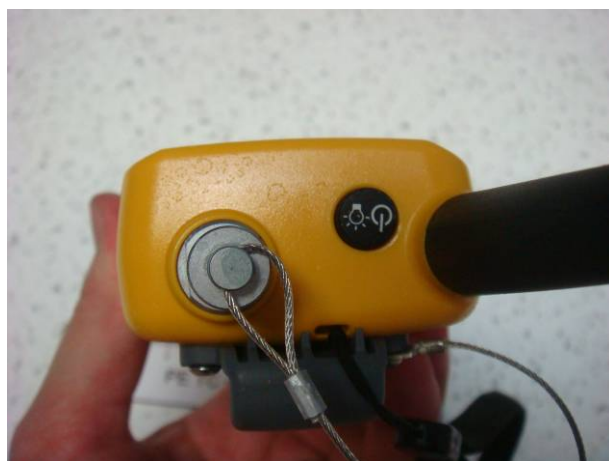
Figure 1.12 – Detail photo of parts of VHF Radio after the test
There are no corrosion, and other signs of deterioration

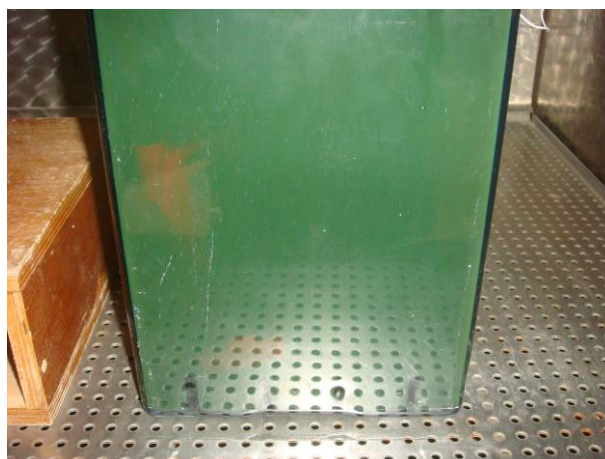
The EUT was immersed at a temperature of $19\text{ }^{\circ}\text{C} \pm 5\text{ }^{\circ}\text{C}$ for 3 h in a mineral oil.

Figure 2.4 –EUT immersed in a tank with oil.

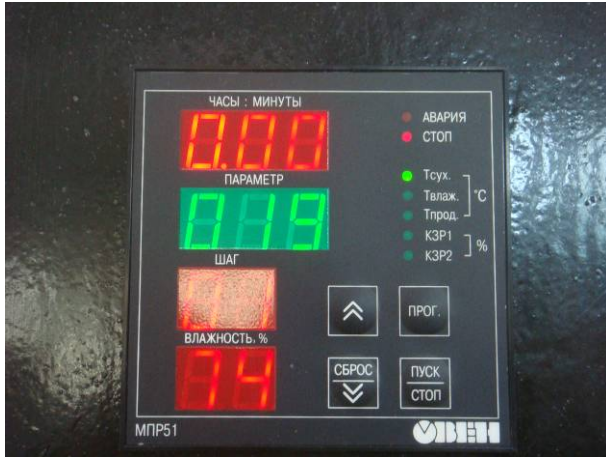
Figure 2.5 – Temperature in climatic chamber

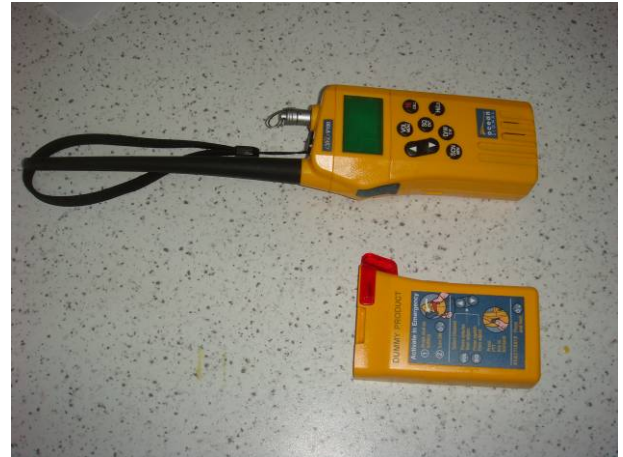
Figure 2.6 – Detail photo of parts of VHF Radio after the test

No.	Parameter	Measured value and check		Results
		before oil test	after oil test	
1.	Visual inspection	no signs of damage such as shrinking, cracking, swelling, dissolution or change of mechanical characteristics	no signs of damage such as shrinking, cracking, swelling, dissolution or change of mechanical characteristics	Pass
