Test report No.
 FCC_RF_SL17021501-SPC-003_B25 Rev 1.0

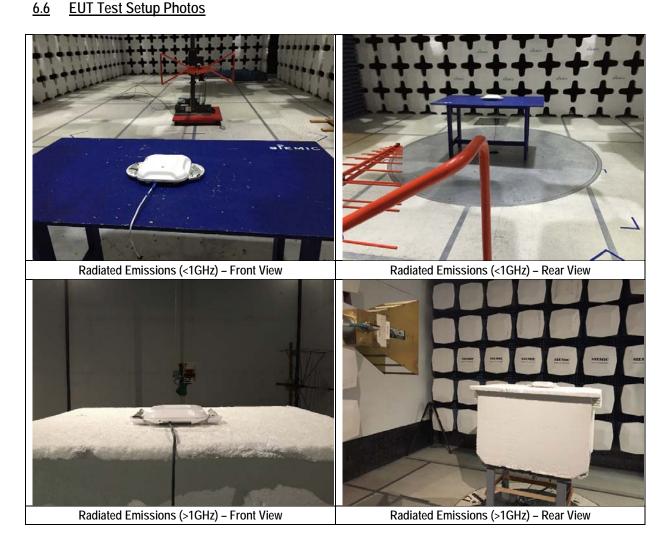
Note: The spurious emission in different EUT orientation was investigated, including the EUT standing up position and the laying down position. The EUT orientation shown in above setup photo is the worst case position.
