| Test report No. | FCC_RF_SL16031001-SPC-003_0412 |

6.6 EUT Test Setup Photos

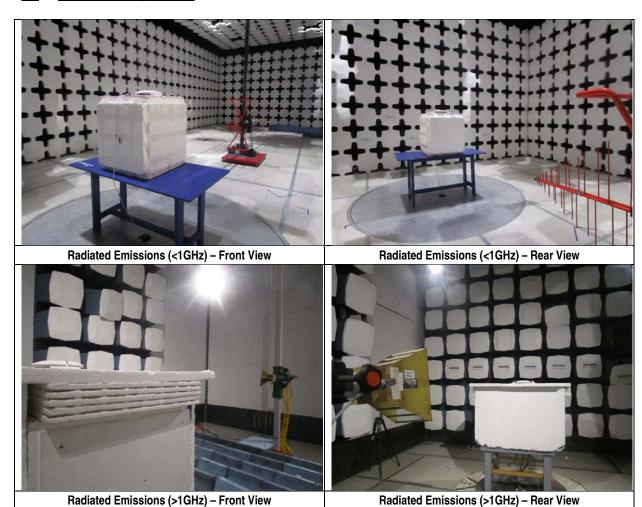
Note: The spurious emission in different EUT orientation was investigated, including the EUT standing up position and the laying down position. The EUT orientation shown in above setup photo is the worst case position.
