Test report No.	FCC_RF_SL16072901-SPC-007_0205
Page	11 of 69

6.6 EUT Test Setup Photos

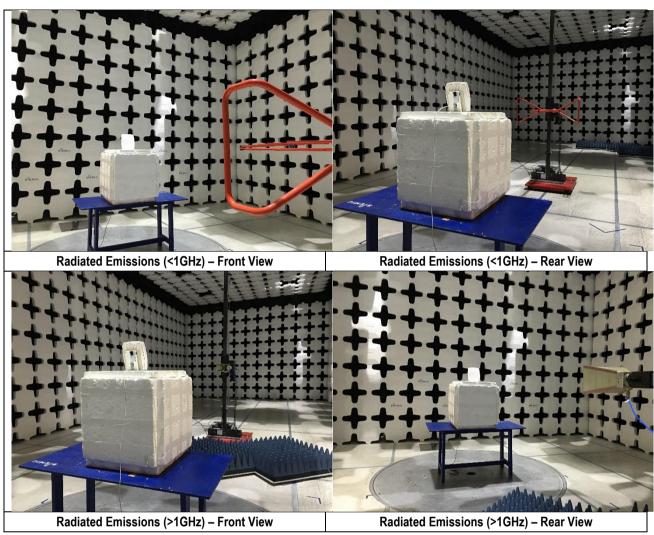
Internal Antenna:

Note: The spurious emission in different EUT orientation was investigated, including the EUT standing up position and the laying down position. The EUT orientation shown in above setup photo is the worst case position.

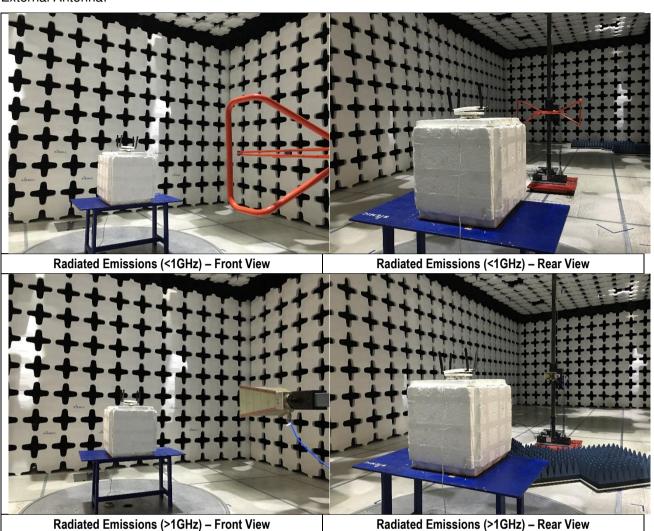
External Antenna:

Note: The spurious emission in different EUT orientation was investigated, including the EUT standing up position and the laying down position. The EUT orientation shown in above setup photo is the worst case position.
