Test report No.	FCC_RF_SL16103101-SPC-006-LAA
Page	10 of 75

## 6.5 EUT Test Setup Photos

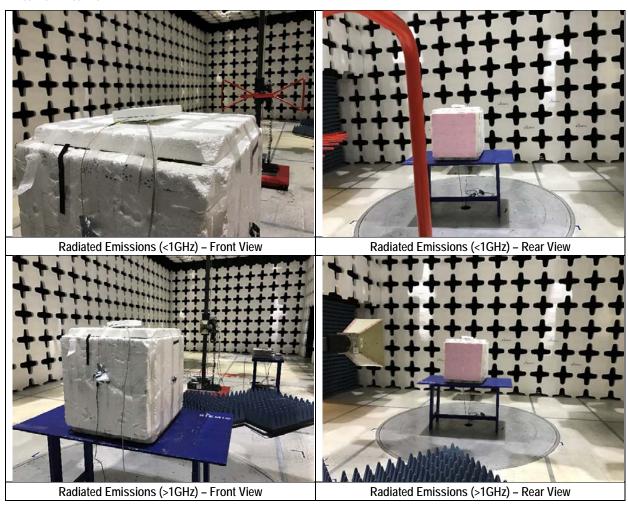
## **Internal Antenna:**

Note: The spurious emission in different EUT orientation was investigated, including the EUT standing up position and the laying down position. The EUT orientation shown in above setup photo is the worst case position.

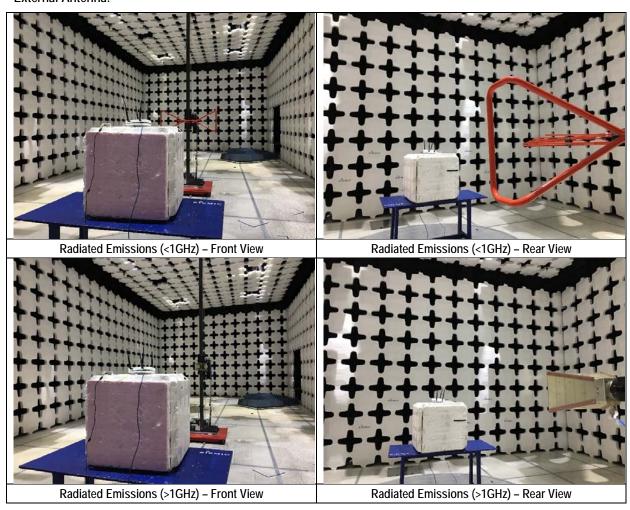
## **External Antenna:**

Note: The spurious emission in different EUT orientation was investigated, including the EUT standing up position and the laying down position. The EUT orientation shown in above setup photo is the worst case position.
