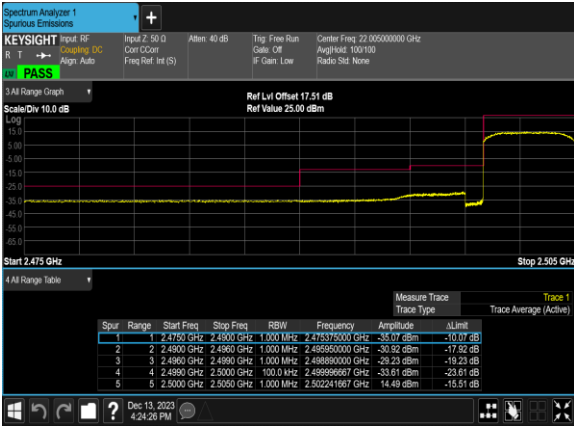
B7_5M_QPSK_25@0_CH_20775

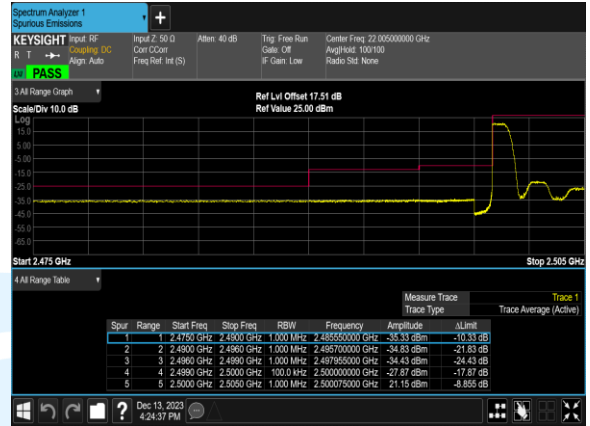
B7_5M_16QAM_1@0_CH_20775

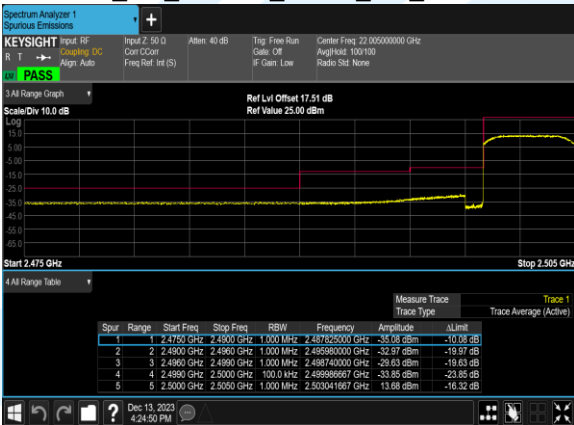
B7_5M_16QAM_25@0_CH_20775

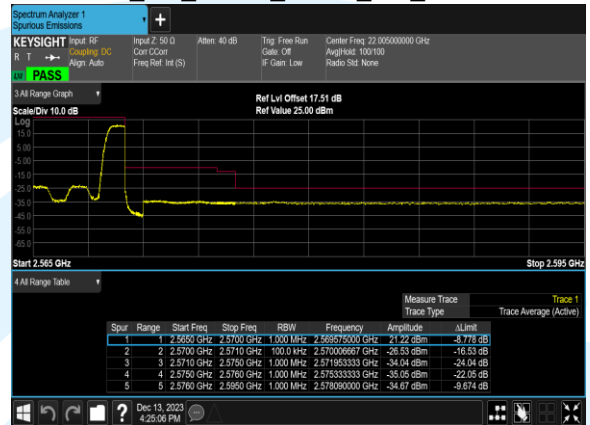
B7_5M_QPSK_1@24_CH_21425

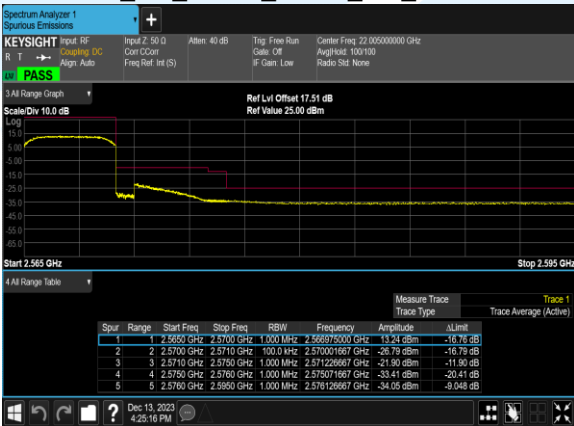
B7_5M_QPSK_25@0_CH_21425

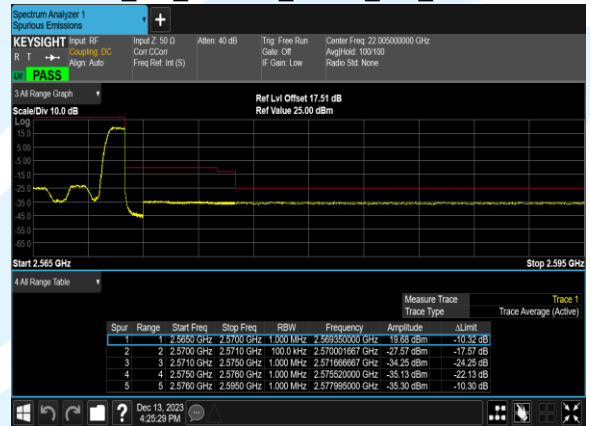
B7_5M_16QAM_1@24_CH_21425

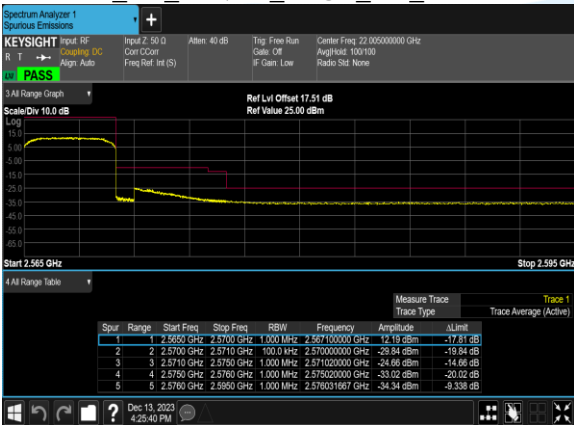
B7_5M_16QAM_25@0_CH_21425
