UTTR-RF-RSS247-V1.1

## A.5 DFS DETECTION THRESHOLDS

## A.6 CHANNEL MOVE TIME AND CHANNEL CLOSING TRANSMISSION TIME

## A.7 NON-OCCUPANCY PERIOD

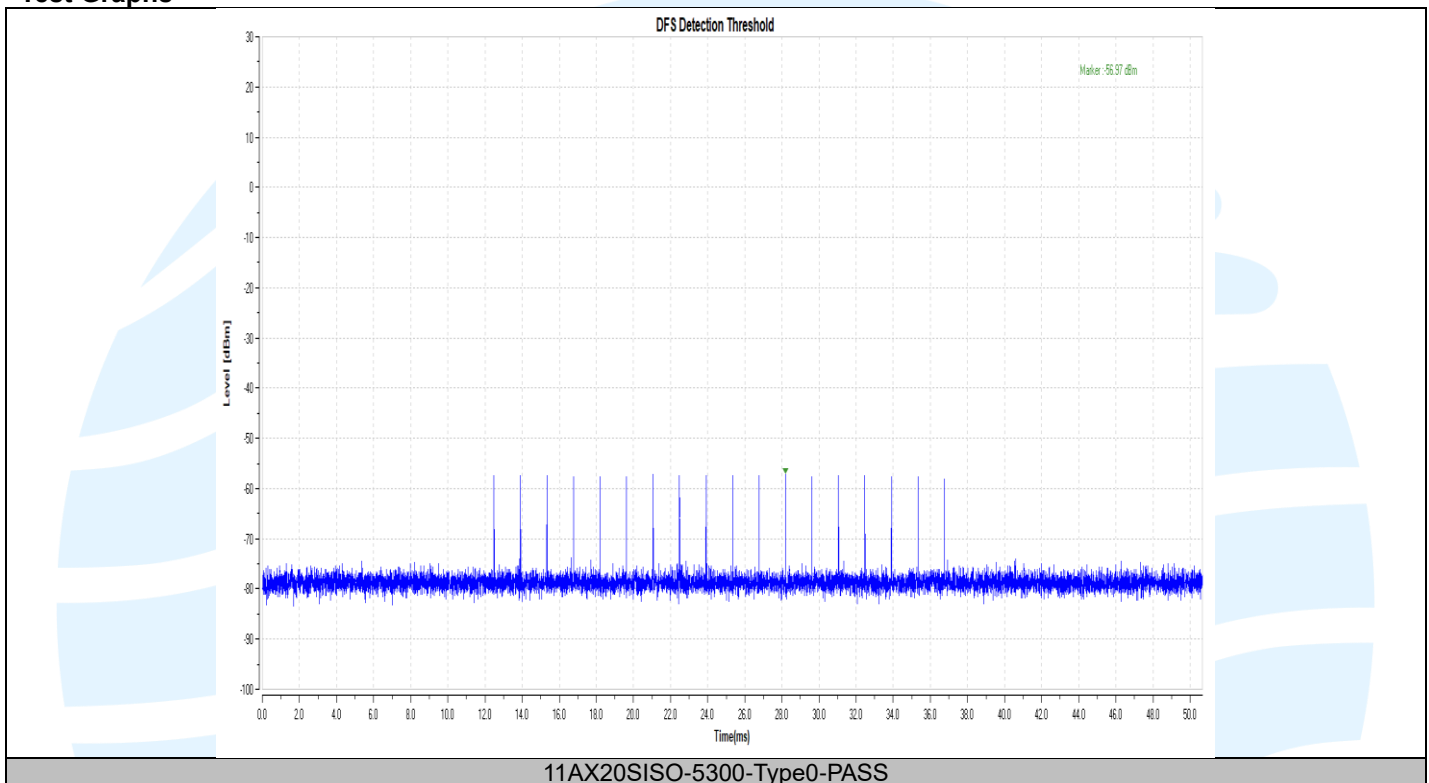
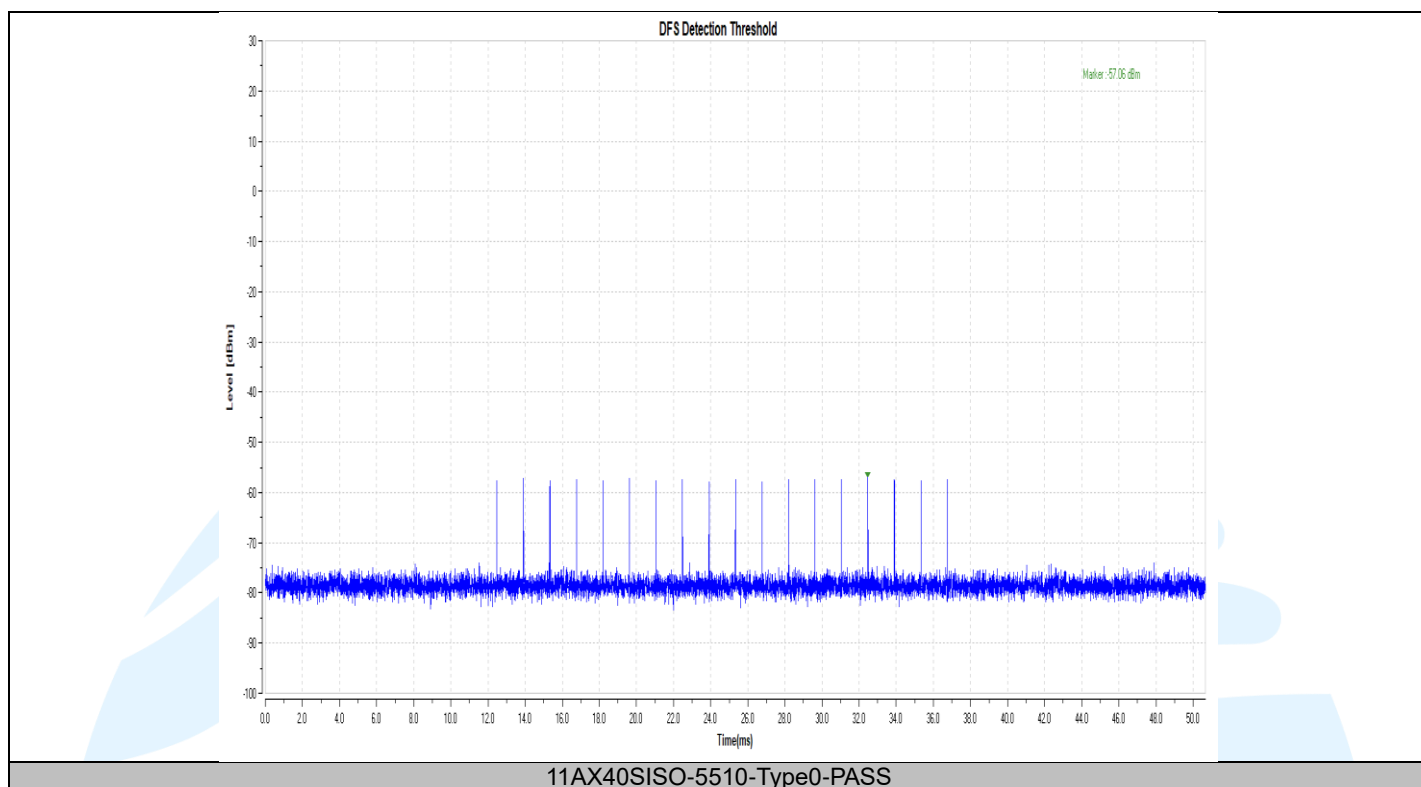
| Test Mode | Frequency[dbm] | Radar Type | Result | Limit[dbm] | Verdict |
| 11AX20SISO | 5300 | Type0 | -56.97 | -56.68 | PASS |
| 11AX40SISO | 5510 | Type0 | -57.06 | -56.68 | PASS |

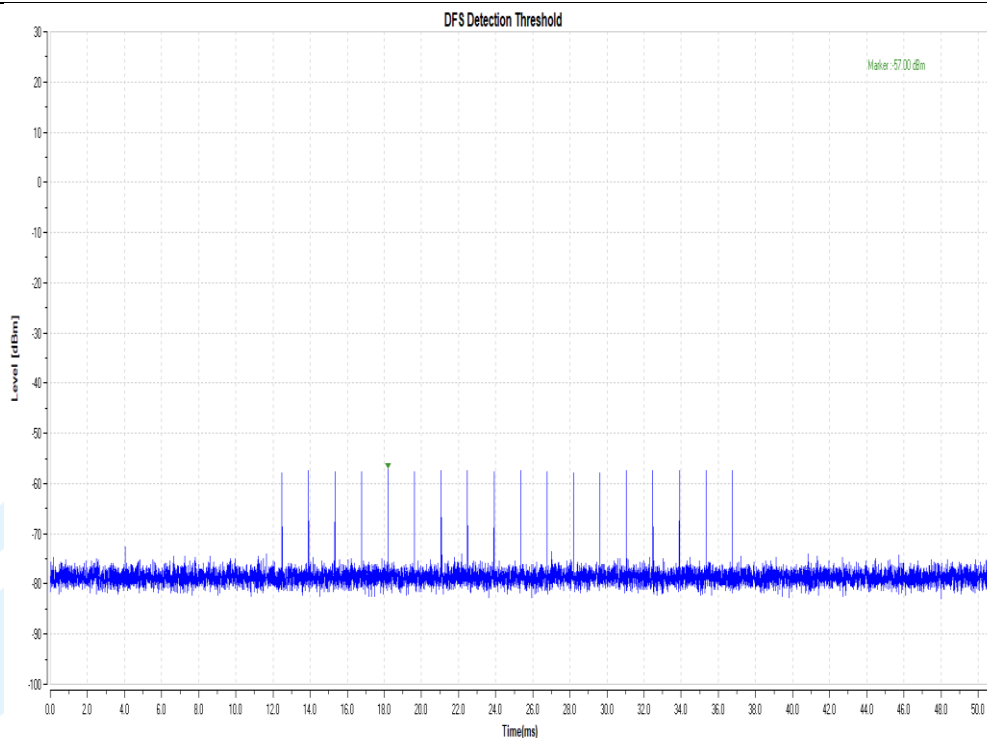
11AX20SISO-5500-Type0-PASS

| Test Mode | Frequency[dbm] | Radar Type | Result | Limit[dbm] | Verdict |
|---|---|---|---|---|---|
| 11AX20SISO | 5500 | Type0 | -57.00 | -56.68 | PASS |

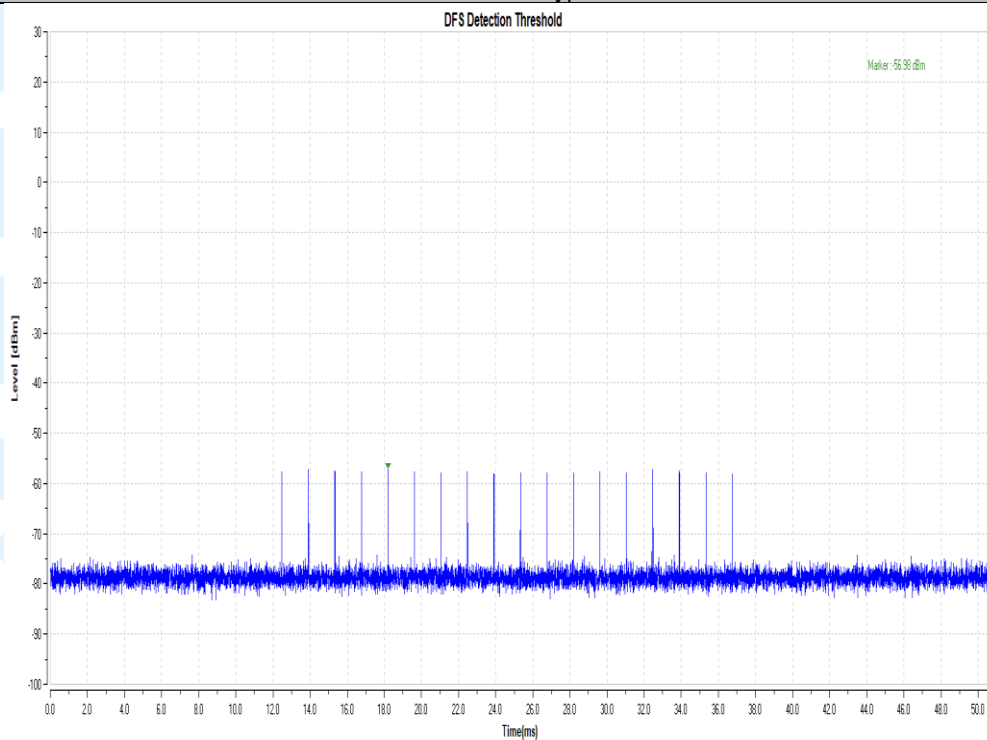
11AX40SISO-5310-Type0-PASS

| Test Mode | Frequency[dbm] | Radar Type | Result | Limit[dbm] | Verdict |
|---|---|---|---|---|---|
| 11AX40SISO | 5310 | Type0 | -56.98 | -56.68 | PASS |

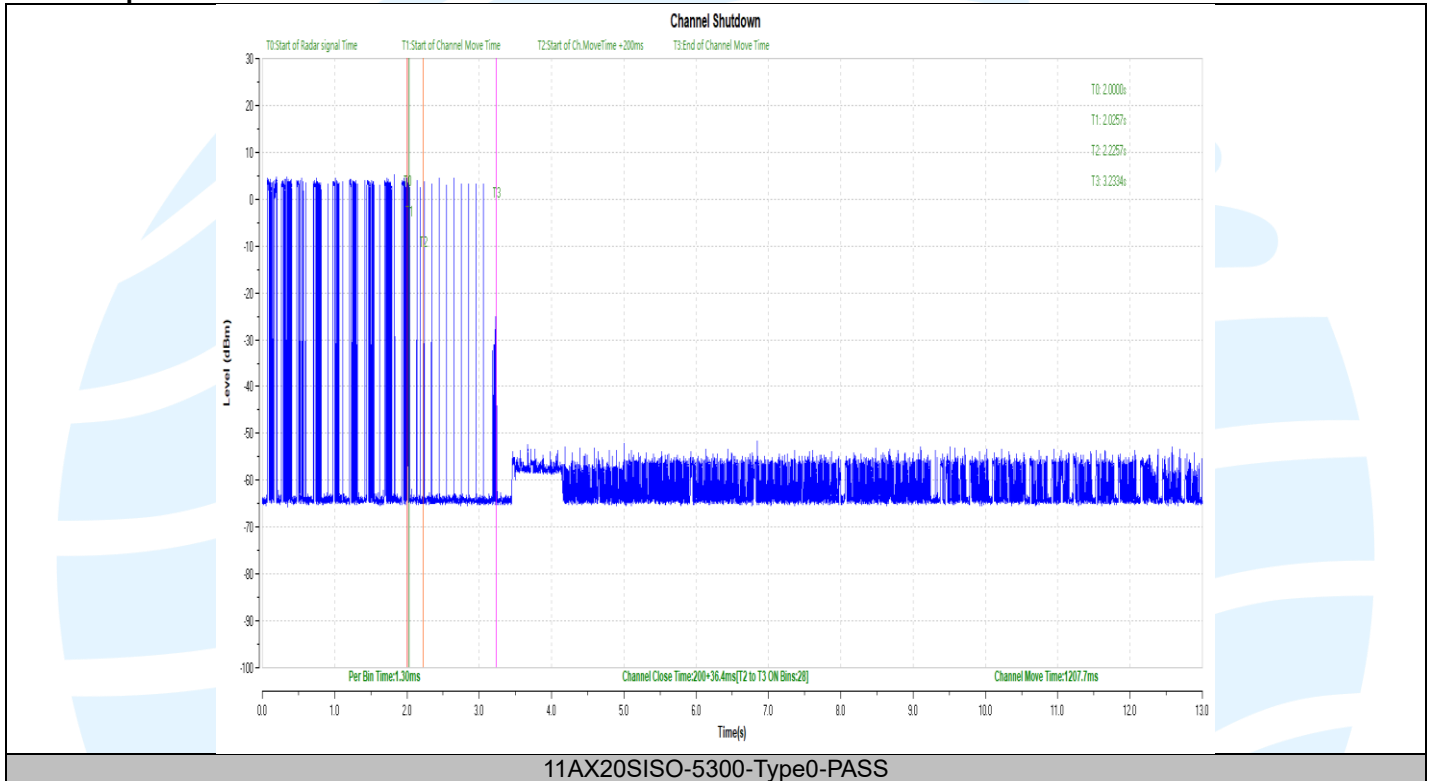
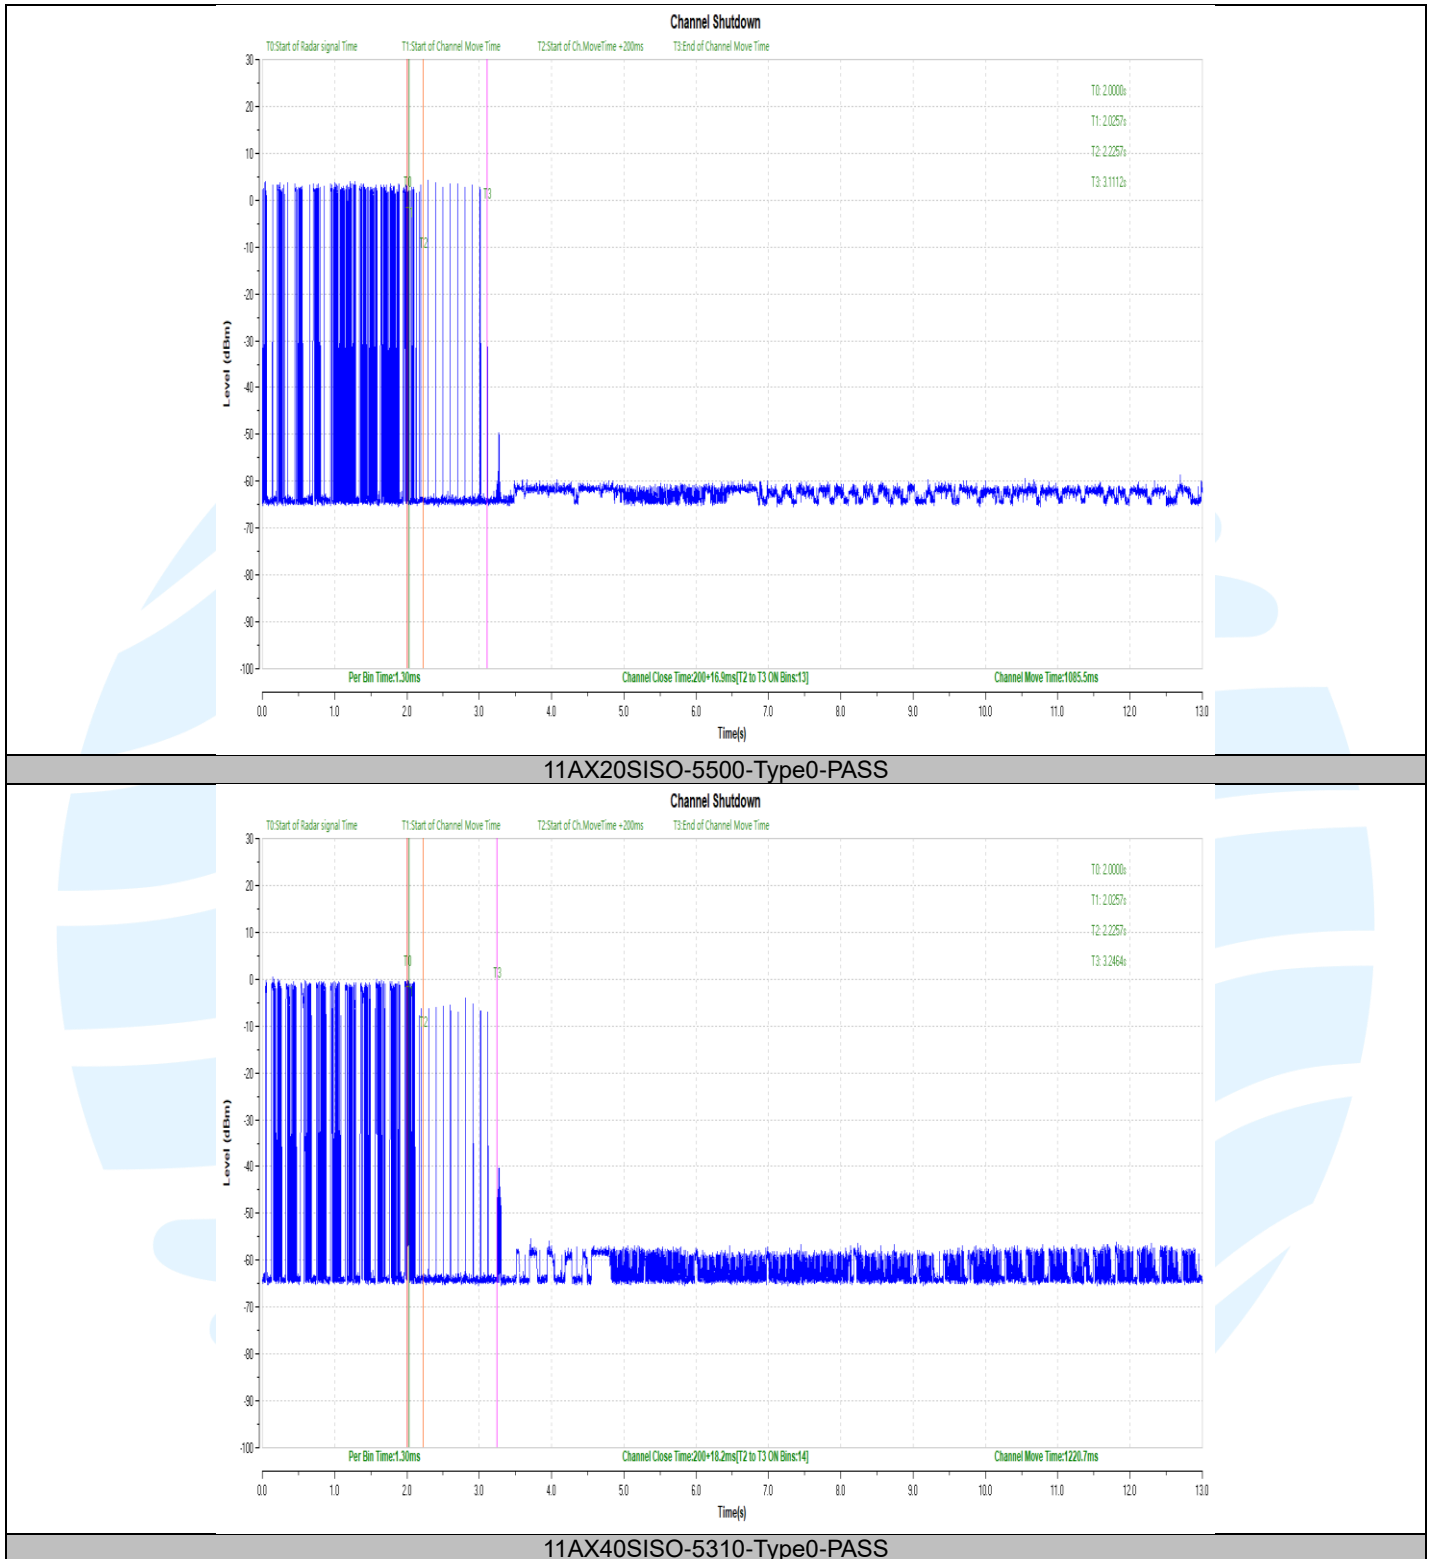
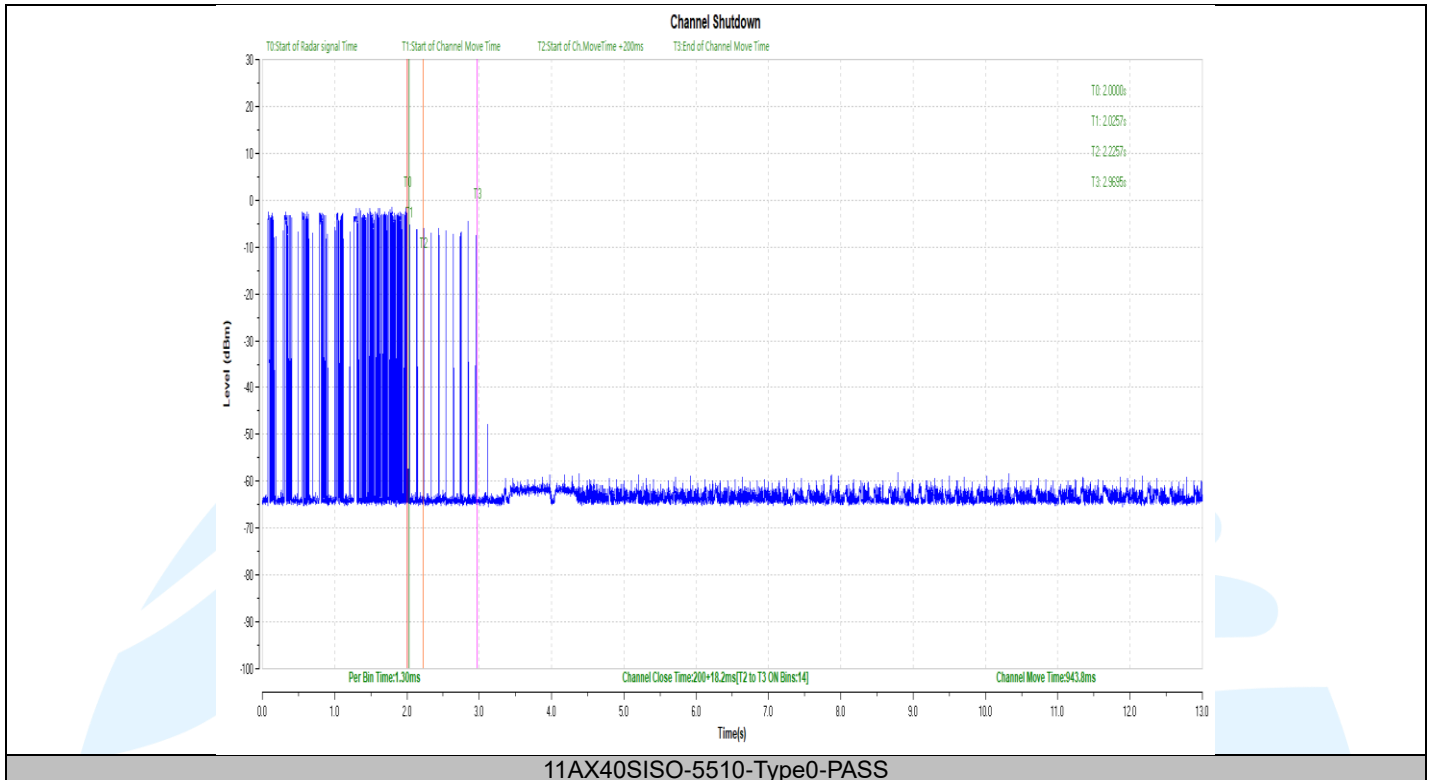
| Test Mode | Frequency[MHz] | CCTT[ms] | Limit[ms] | CMT[ms] | Limit[ms] | Verdict |
| 11AX20SISO | 5300 | 200+36.4 | 200+60 | 1207.7 | 10000 | PASS |
| 11AX20SISO | 5500 | 200+16.9 | 200+60 | 1085.5 | 10000 | PASS |
| 11AX40SISO | 5310 | 200+18.2 | 200+60 | 1220.7 | 10000 | PASS |
| 11AX40SISO | 5510 | 200+18.2 | 200+60 | 943.8 | 10000 | PASS |

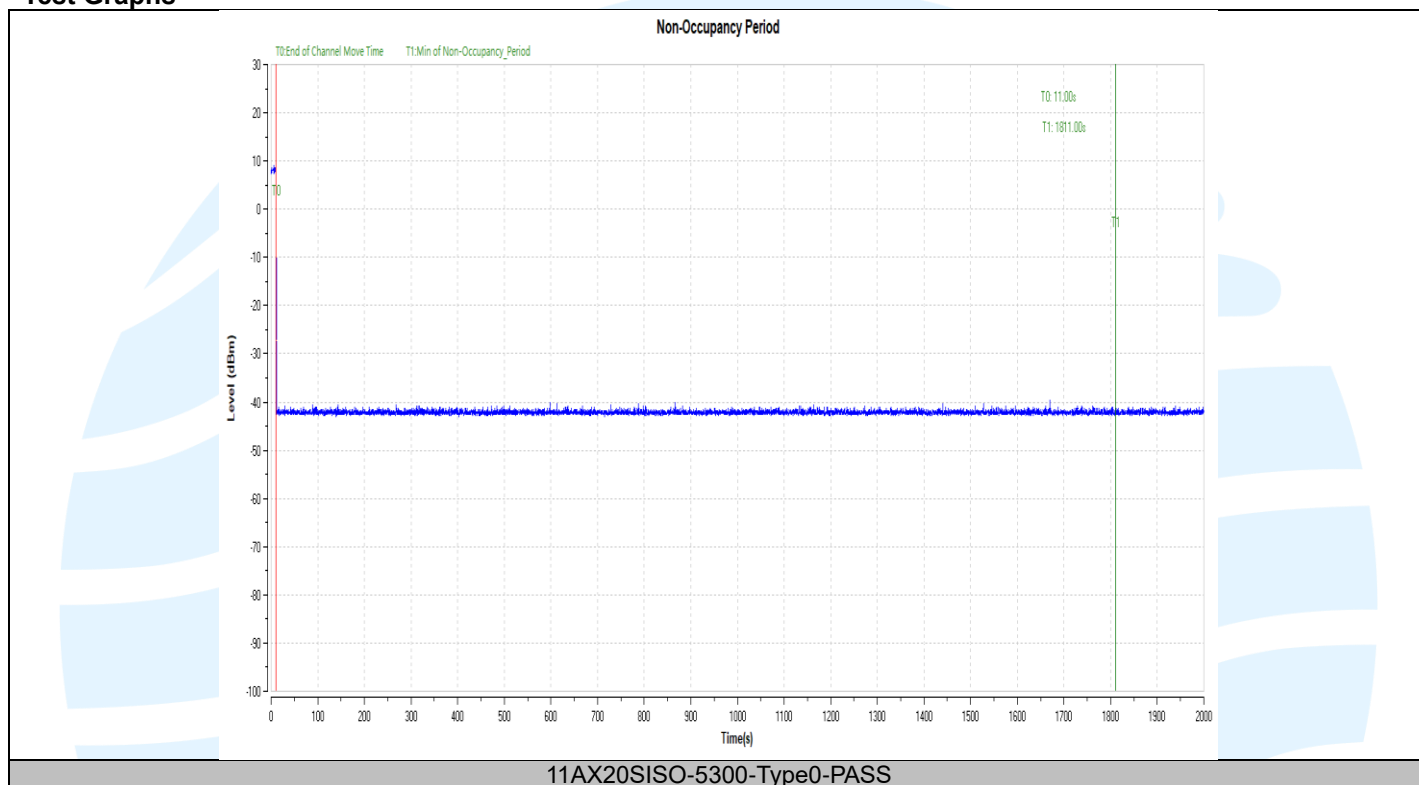
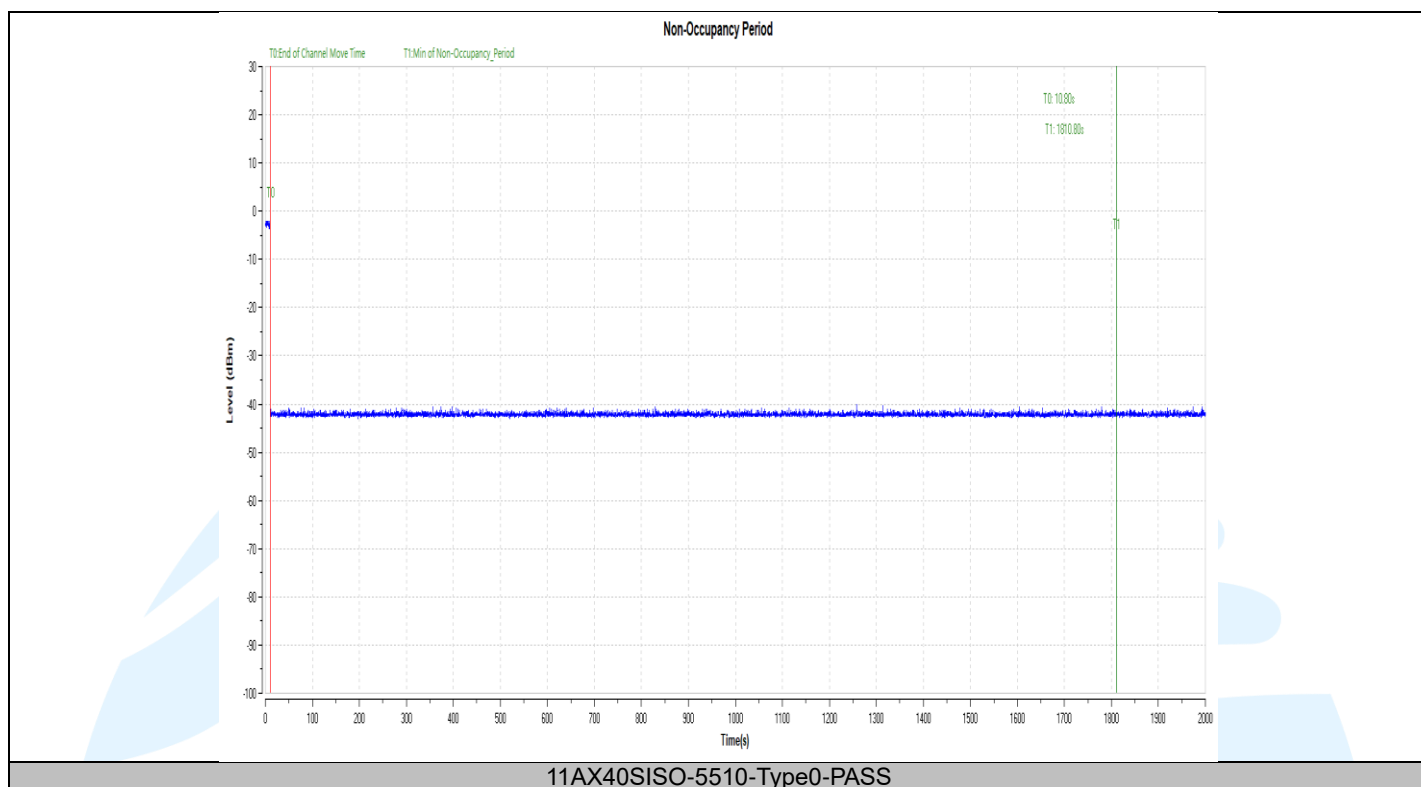
| Test Mode | Frequency[MHz] | Result | Limit[s] | Verdict |
| 11AX20SISO | 5300 | see test graph | ≥1800 | PASS |
| 11AX40SISO | 5510 | see test graph | ≥1800 | PASS |

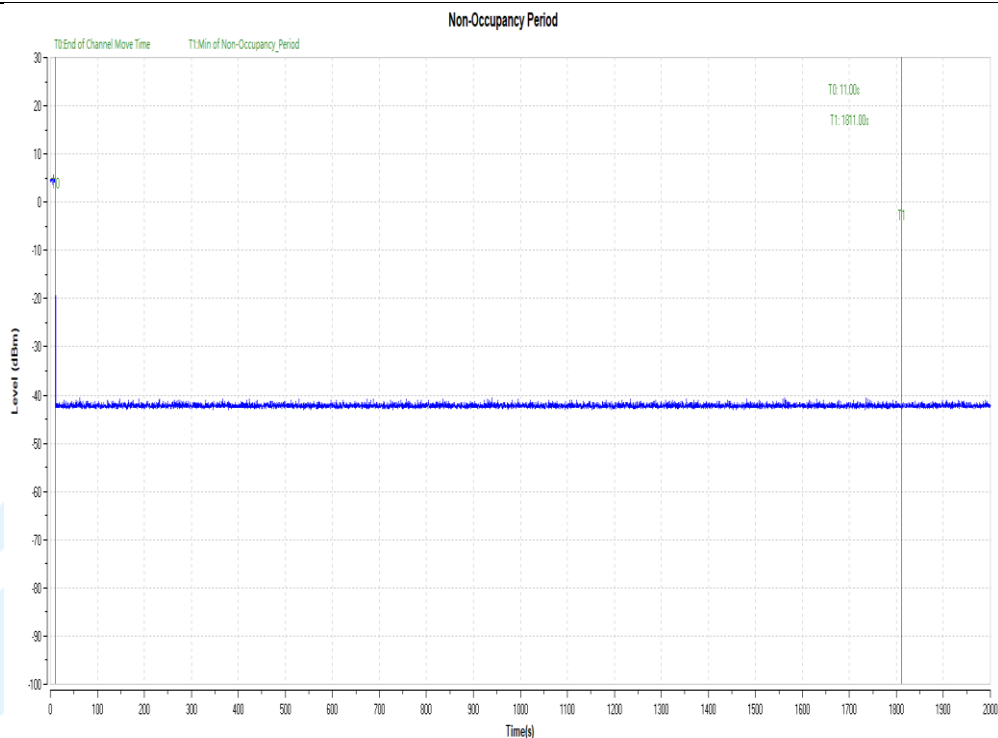
11AX20SISO-5500-Type0-PASS

| Test Mode | Frequency[MHz] | Result | Limit[s] | Verdict |
|---|---|---|---|---|
| 11AX20SISO | 5500 | see test graph | ≥1800 | PASS |

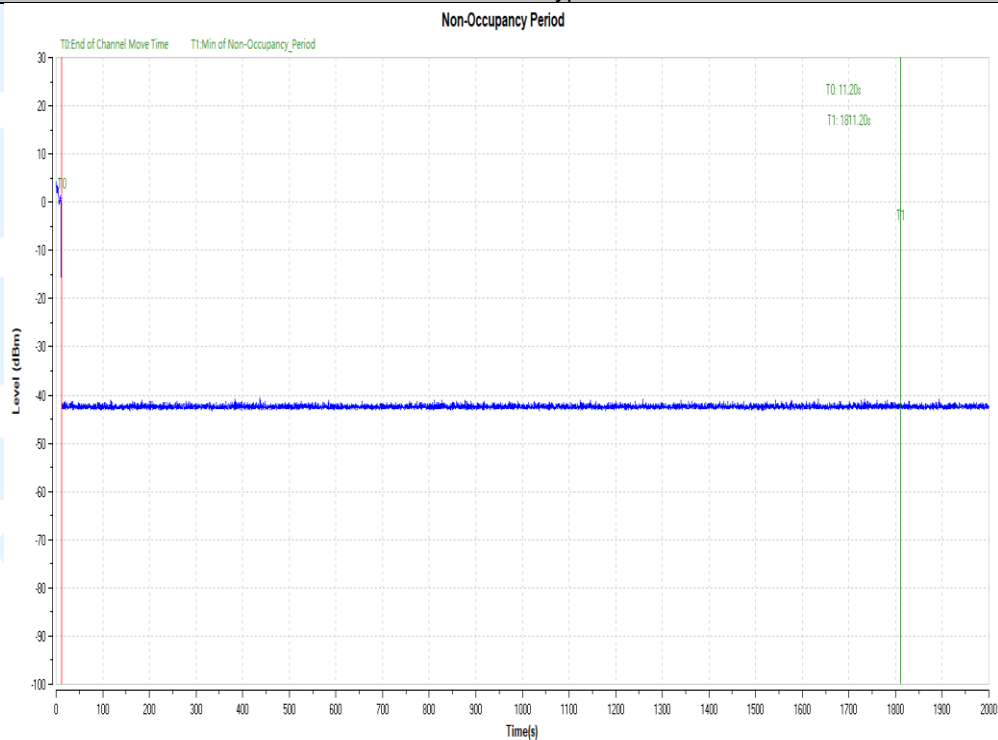
11AX40SISO-5310-Type0-PASS

| Test Mode | Frequency[MHz] | Result | Limit[s] | Verdict |
|---|---|---|---|---|
| 11AX40SISO | 5310 | see test graph | ≥1800 | PASS |
