Report No. : EED32P80440601 Page 47 of 71

9 PHOTOGRAPHS OF TEST SETUP

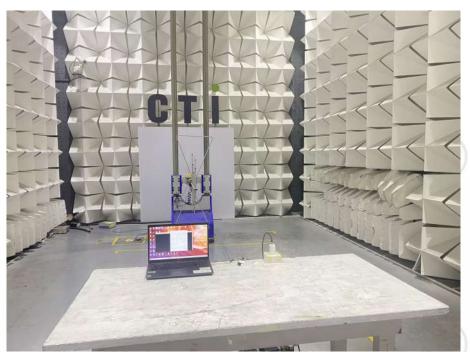
Radiated spurious emission Test Setup-1 With camera(Below 1GHz)

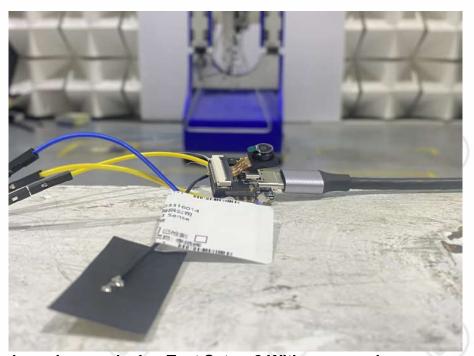
Radiated spurious emission Test Setup-2 With camera close up (Below 1GHz)

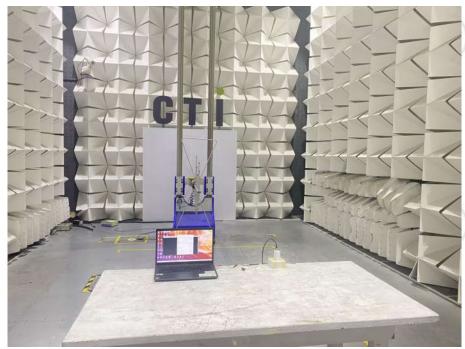
Radiated spurious emission Test Setup-3 Without camera(Below 1GHz)

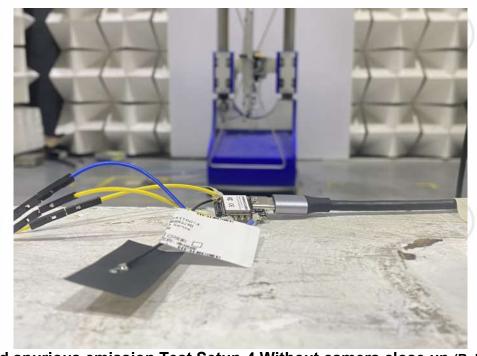
Radiated spurious emission Test Setup-4 Without camera close up (Below 1GHz)

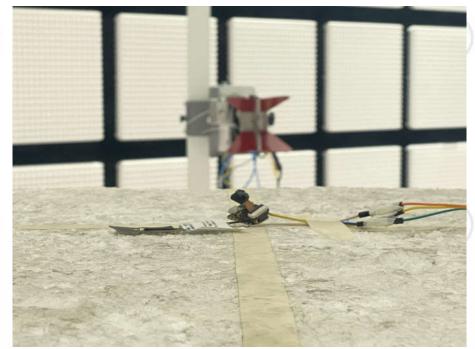
Radiated spurious emission Test Setup-5 With camera (Above 1GHz)

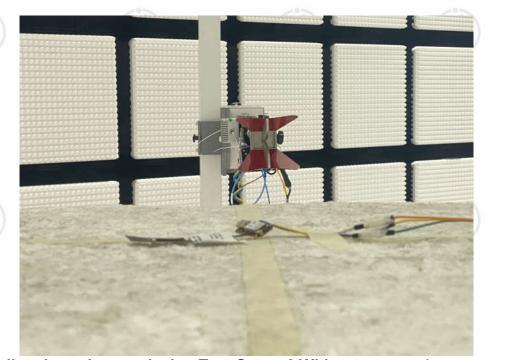
Radiated spurious emission Test Setup-6 Without camera (Above 1GHz)

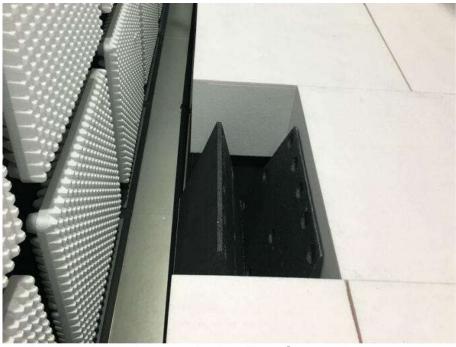
Radiated spurious emission Test Setup-7(Above 1GHz) There are absorbing materials under the ground.

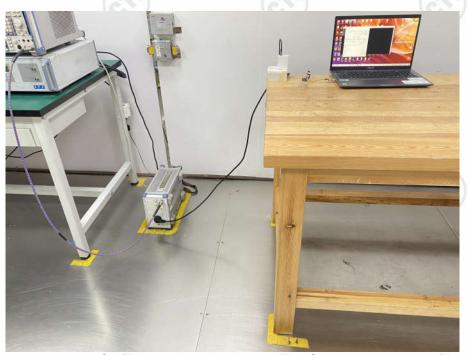
Conducted Emissions Test Setup-1
