Appendix B: photographs of test setup

Reference to the test report no. BLA-EMC-202404-A5601

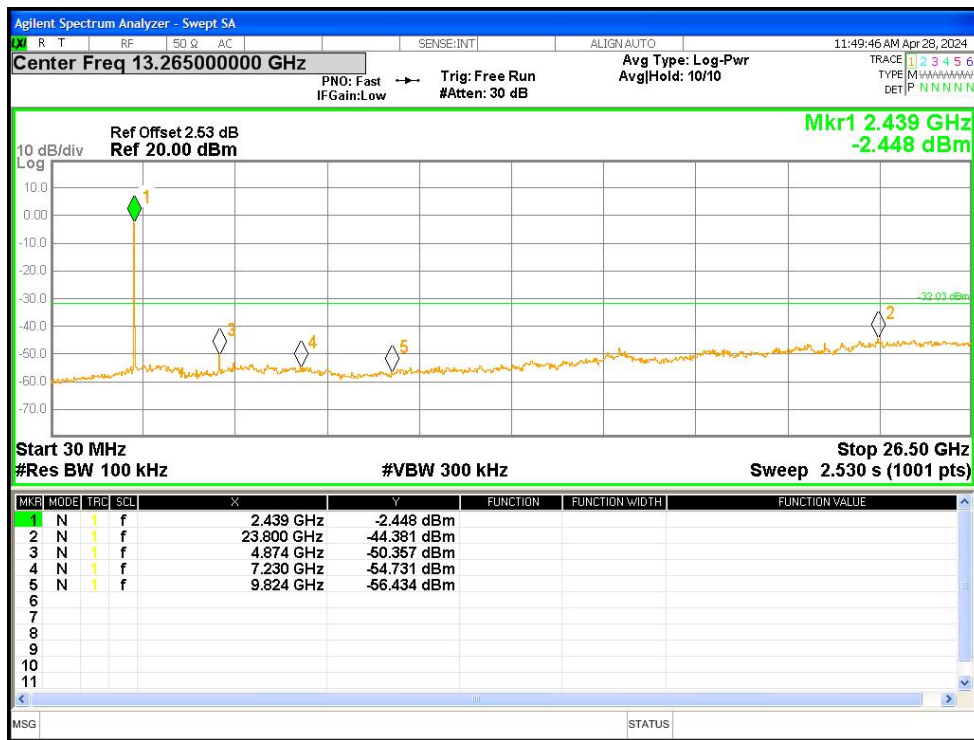
Tx. Spurious NVNT n20 2462MHz Ant1 Ref

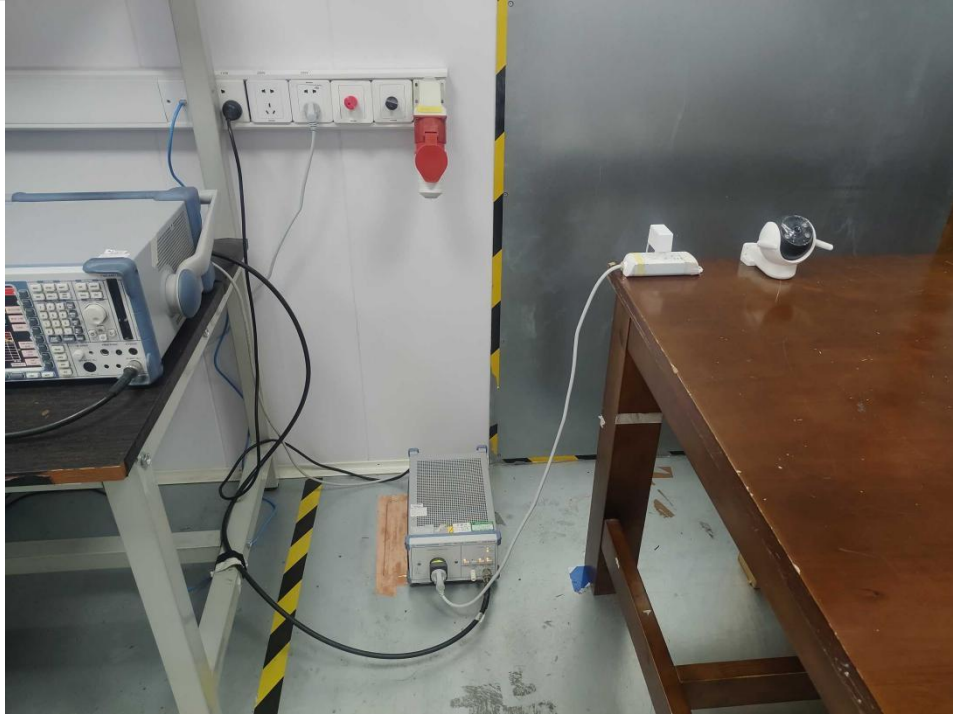
Conducted emissions at AC power line (150kHz-30MHz)

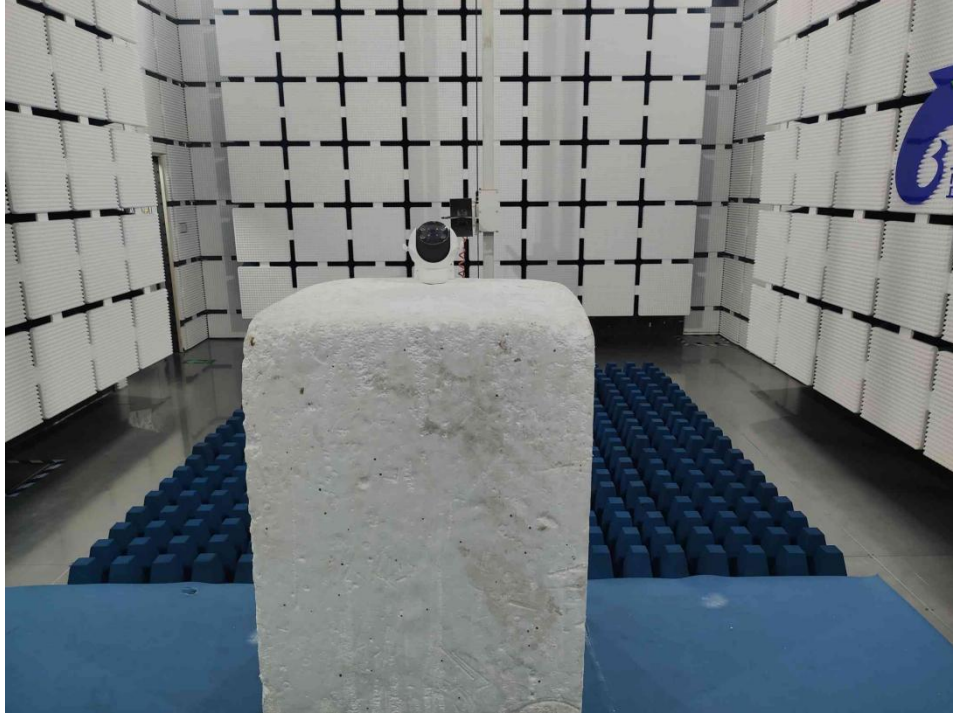
Radiated Emissions (above 1GHz)
