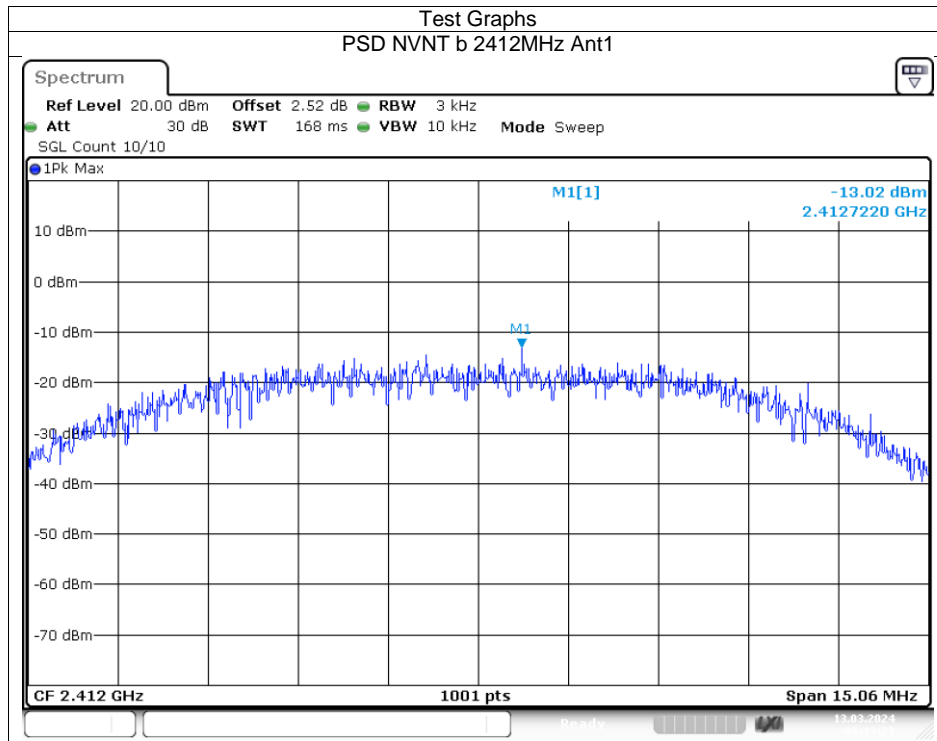
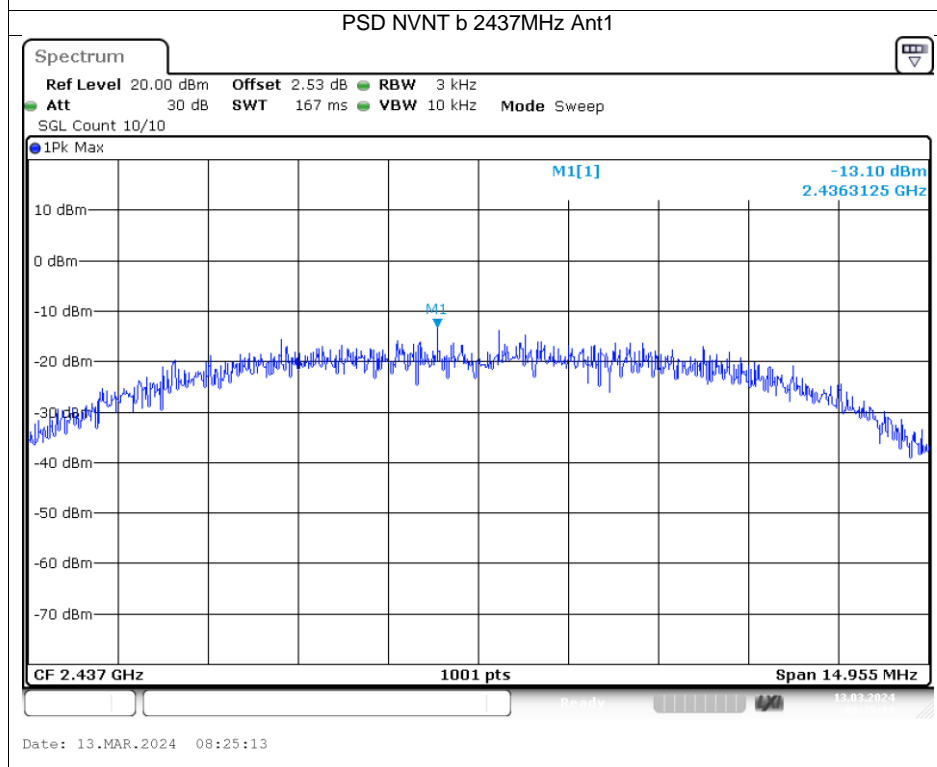
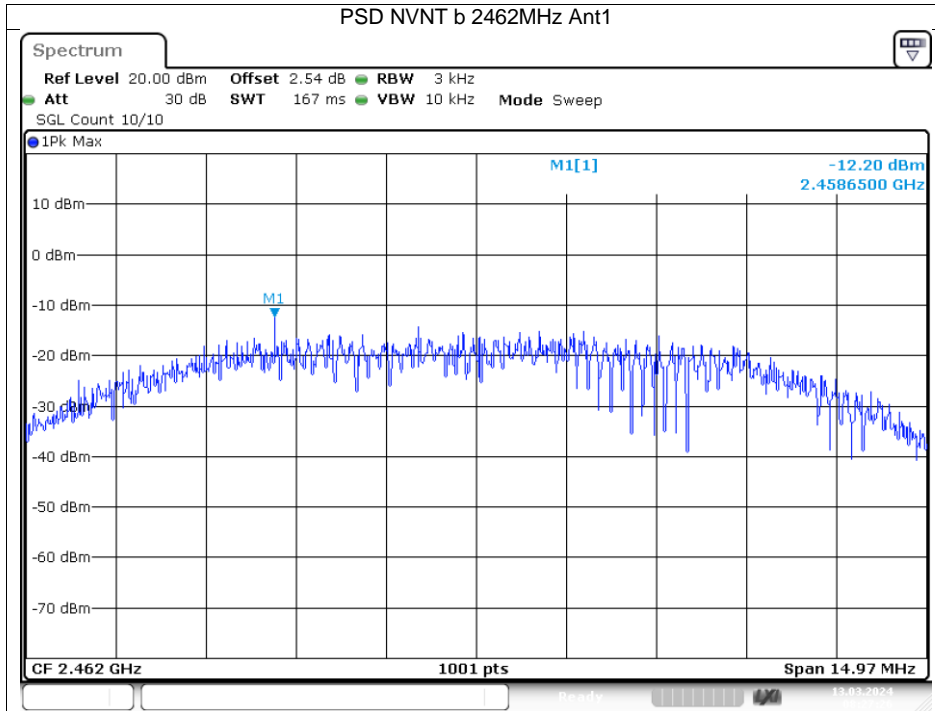
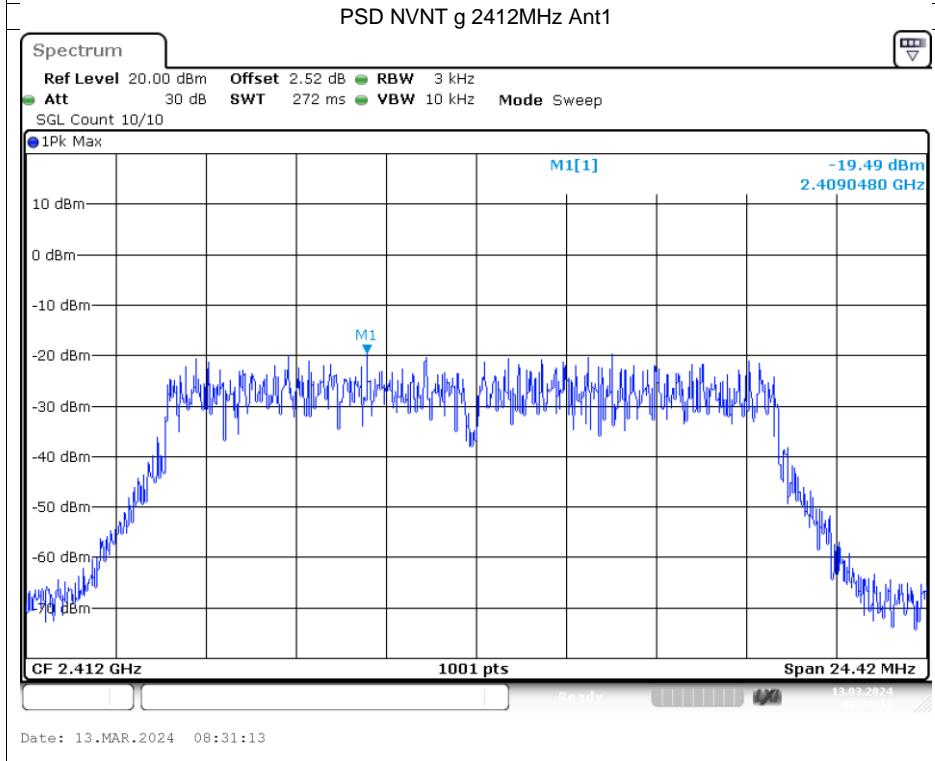
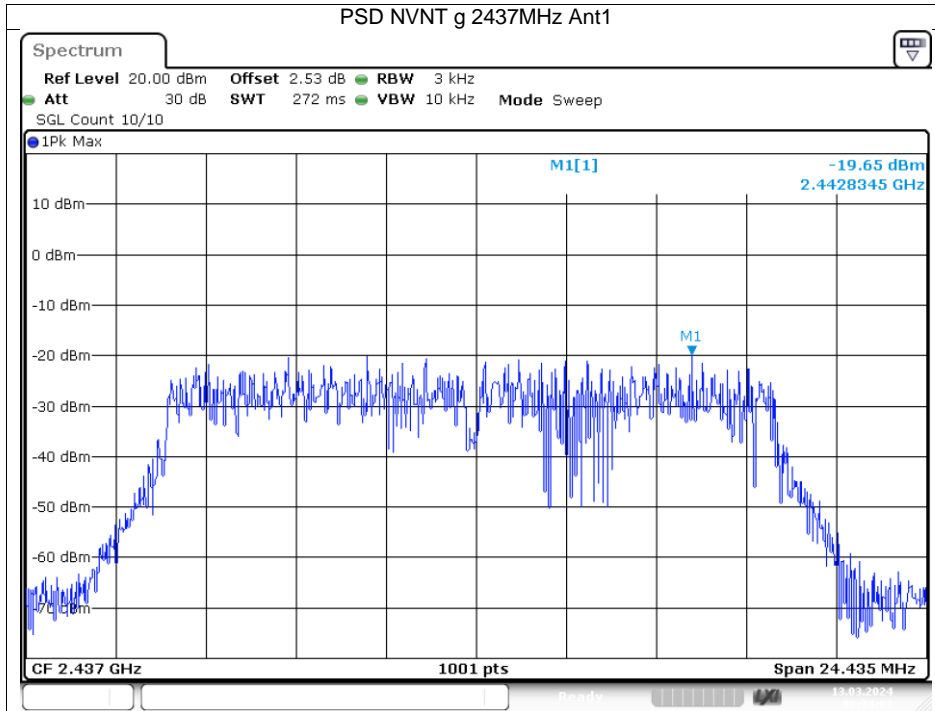
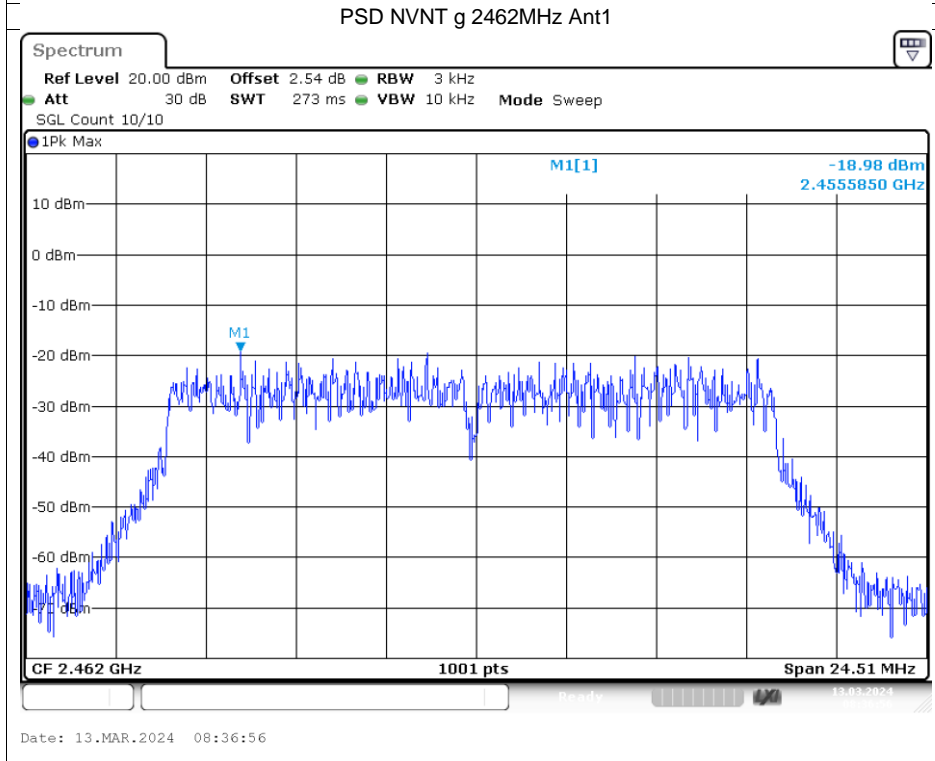
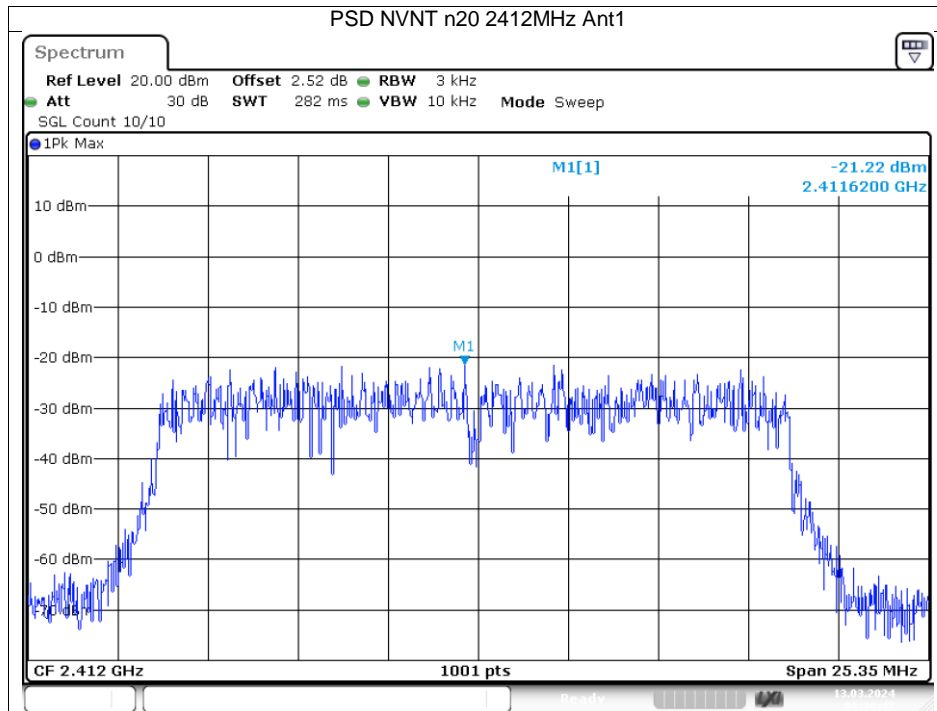
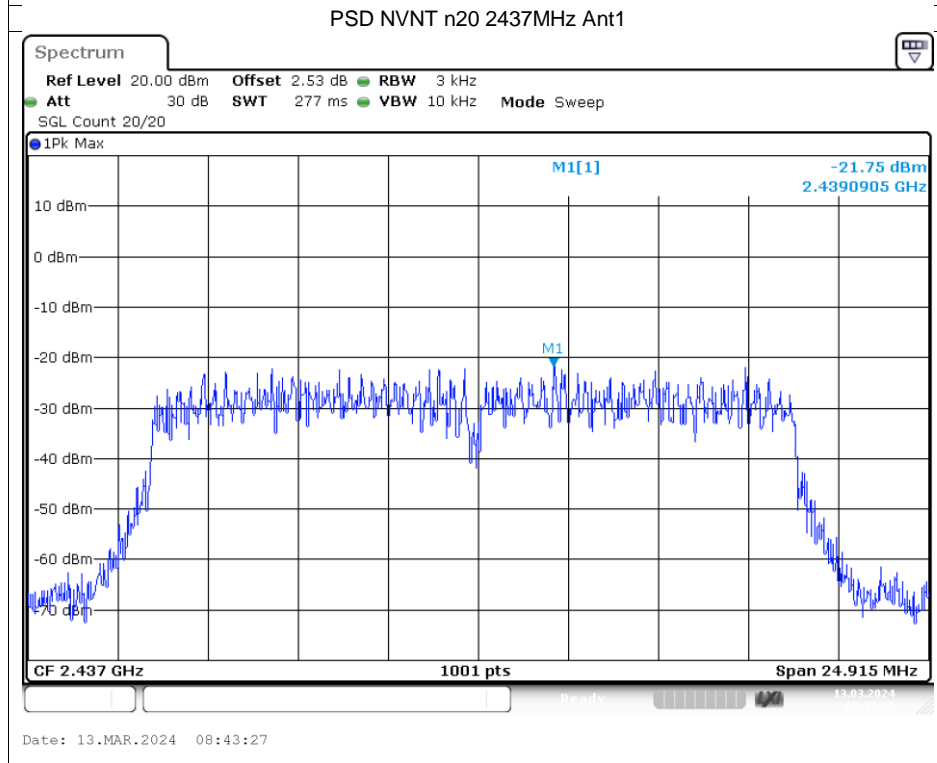
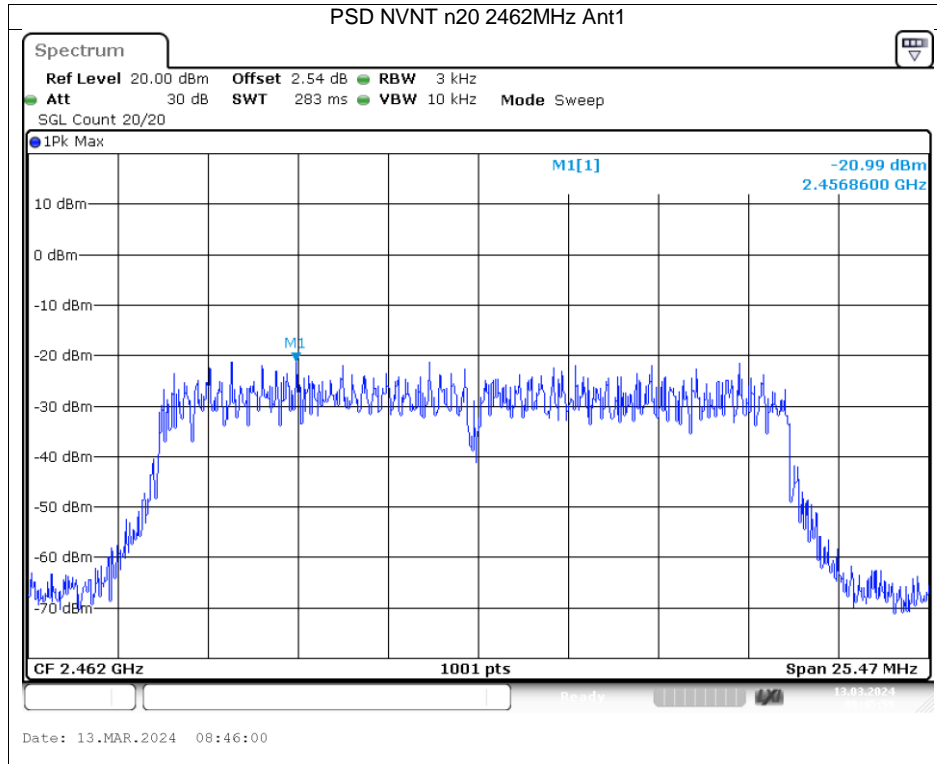
Maximum Power Spectral Density Level

Condition	Mode	Frequency (MHz)	Antenna	Conducted PSD (dBm/3kHz)	Limit (dBm/3kHz)	Verdict
NVNT	b	2412	Ant1	-13.02	8	Pass
NVNT	b	2437	Ant1	-13.1	8	Pass
NVNT	b	2462	Ant1	-12.2	8	Pass
NVNT	g	2412	Ant1	-19.49	8	Pass
NVNT	g	2437	Ant1	-19.65	8	Pass
NVNT	g	2462	Ant1	-18.98	8	Pass
NVNT	n20	2412	Ant1	-21.22	8	Pass
NVNT	n20	2437	Ant1	-21.75	8	Pass
NVNT	n20	2462	Ant1	-20.99	8	Pass

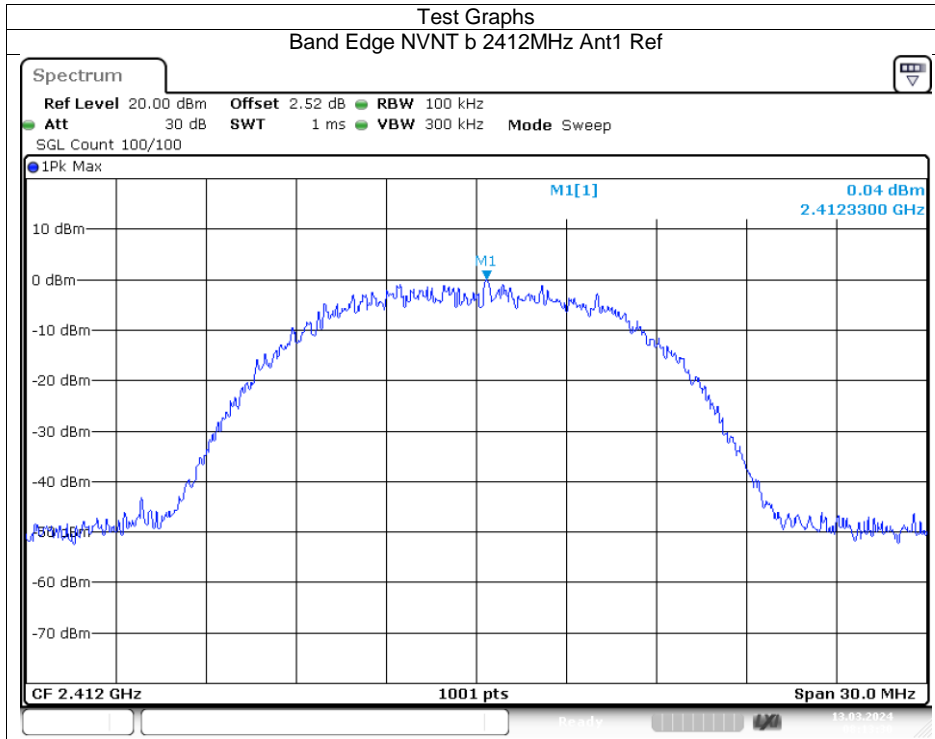
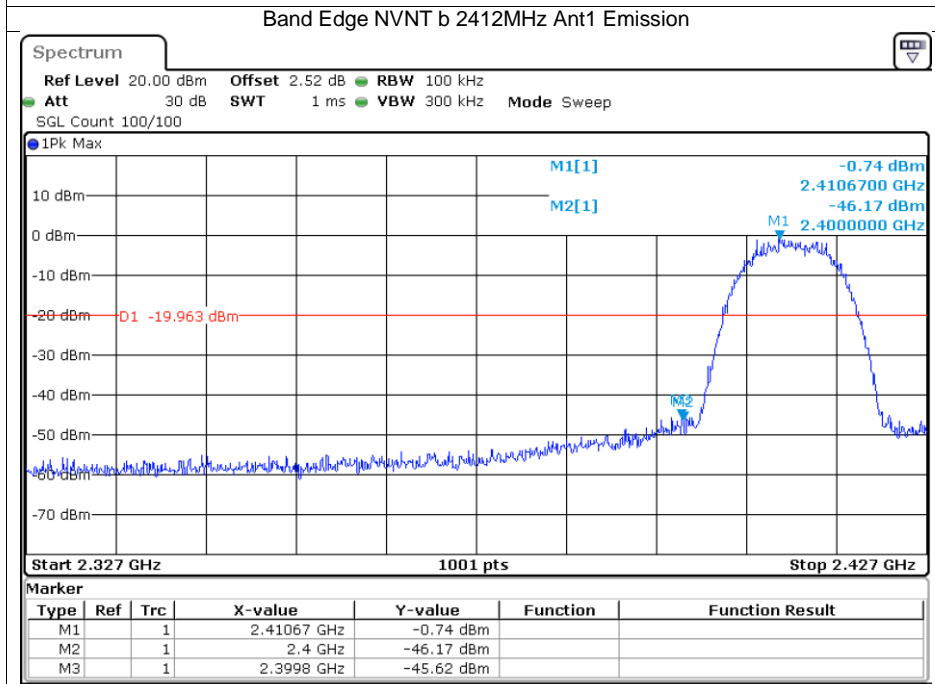
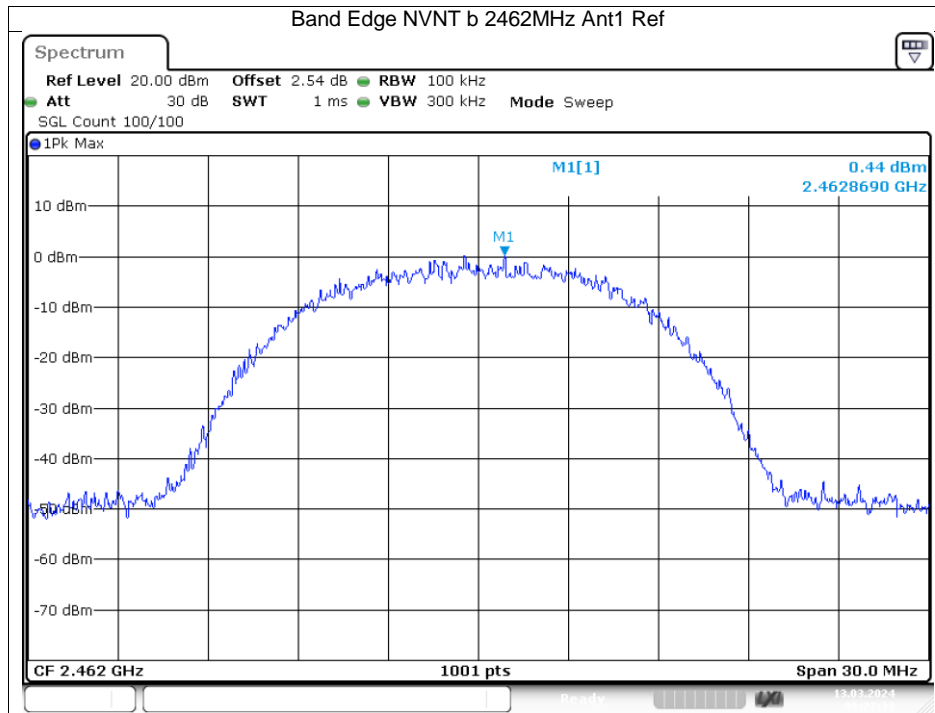
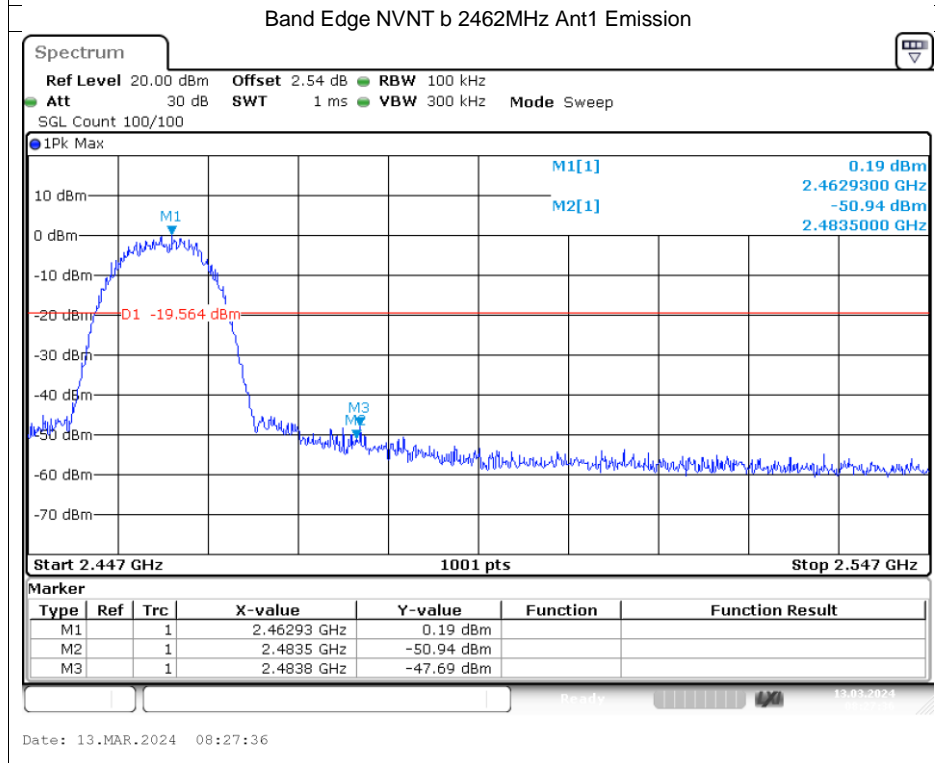
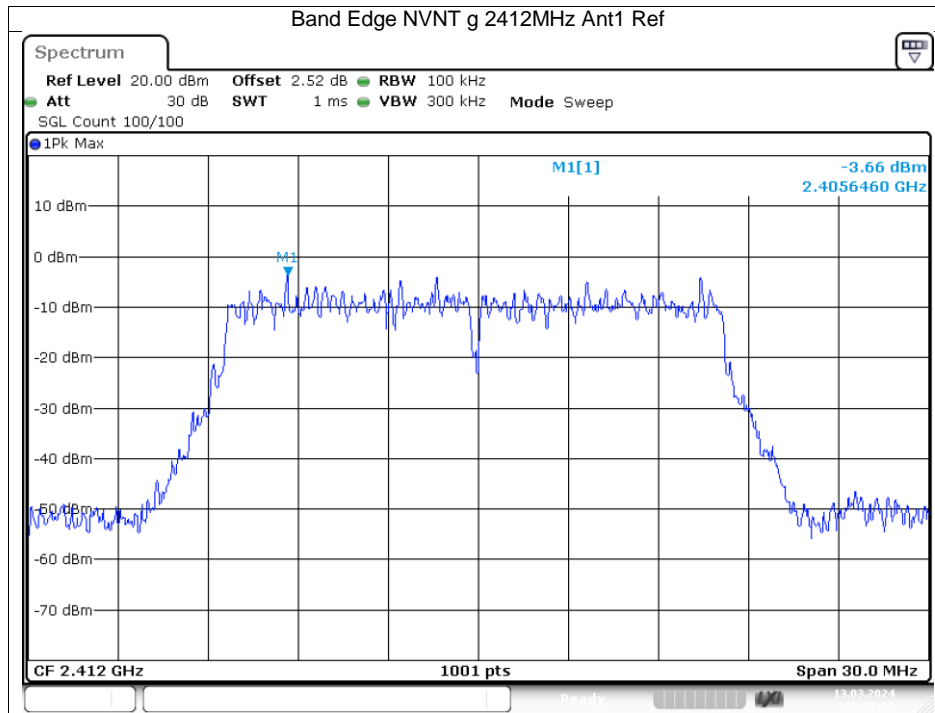
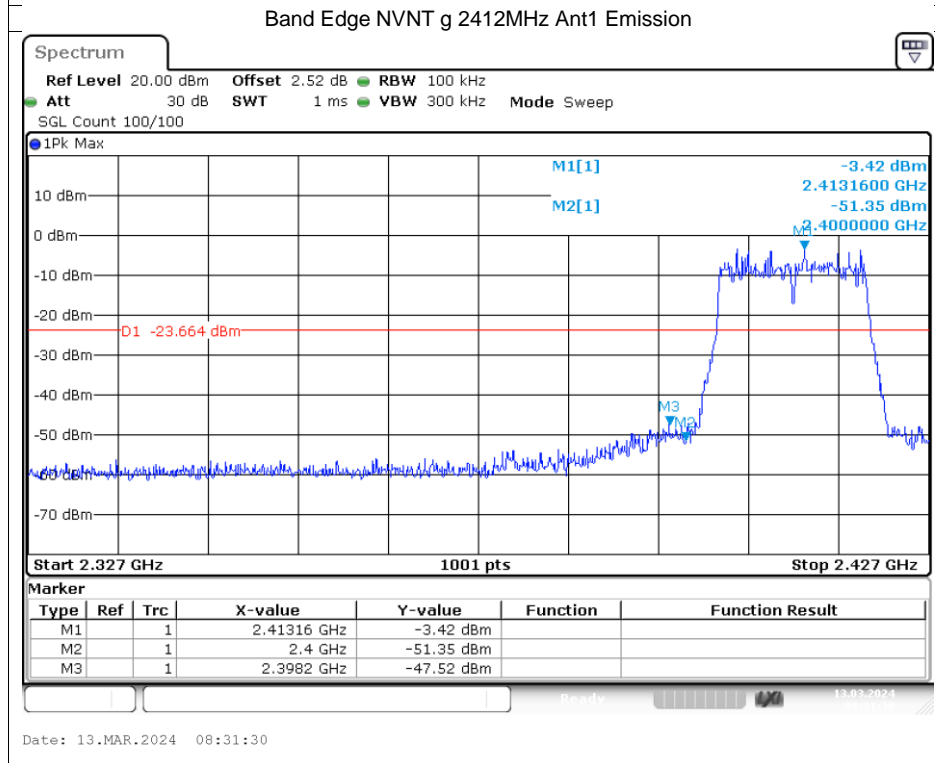
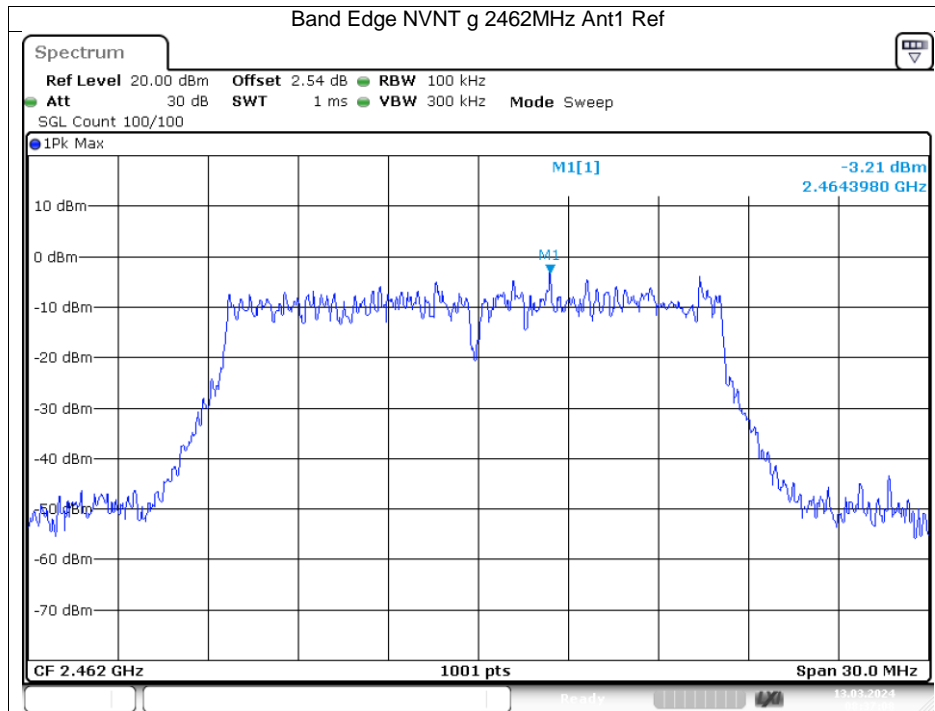
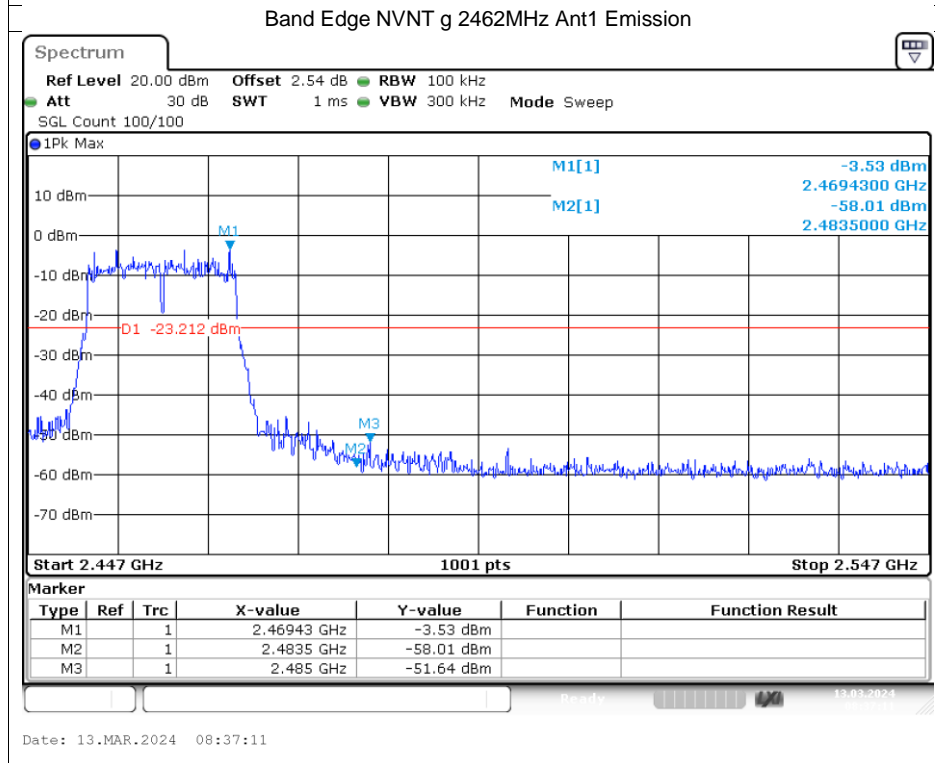
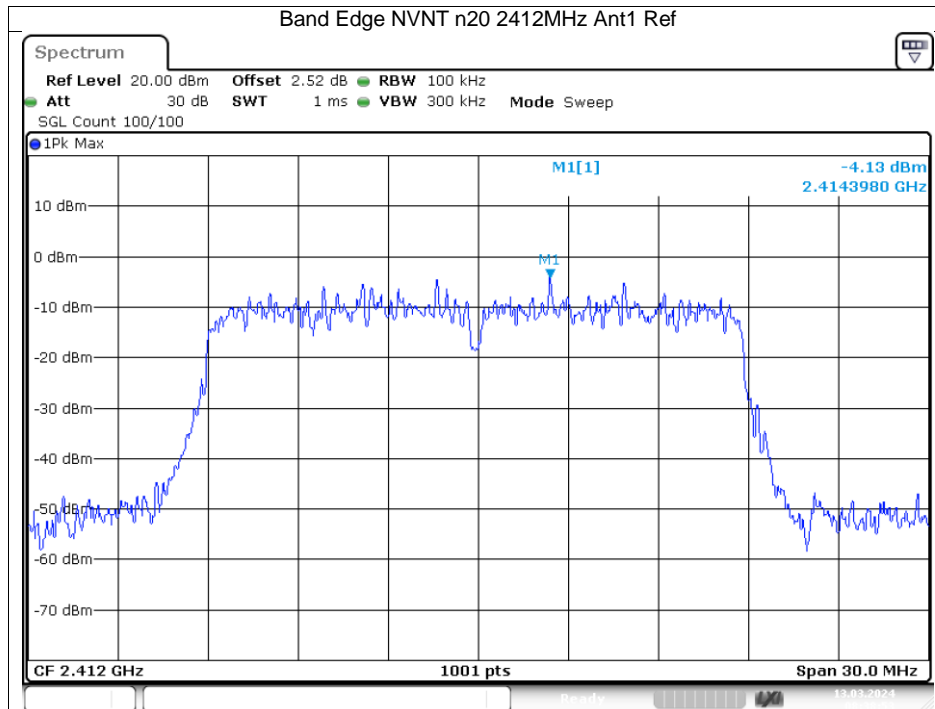
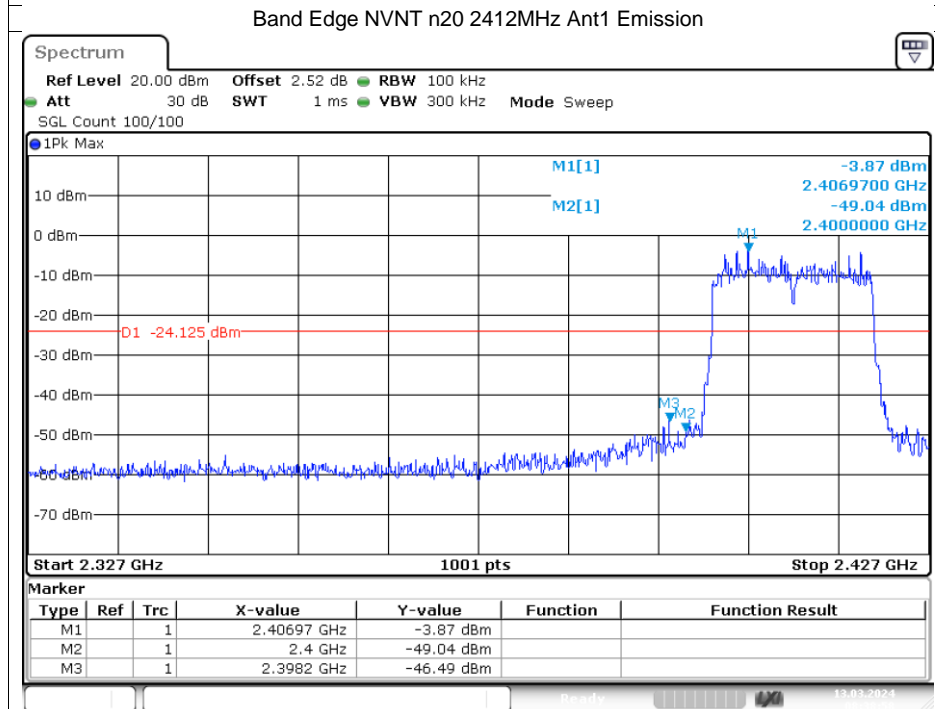
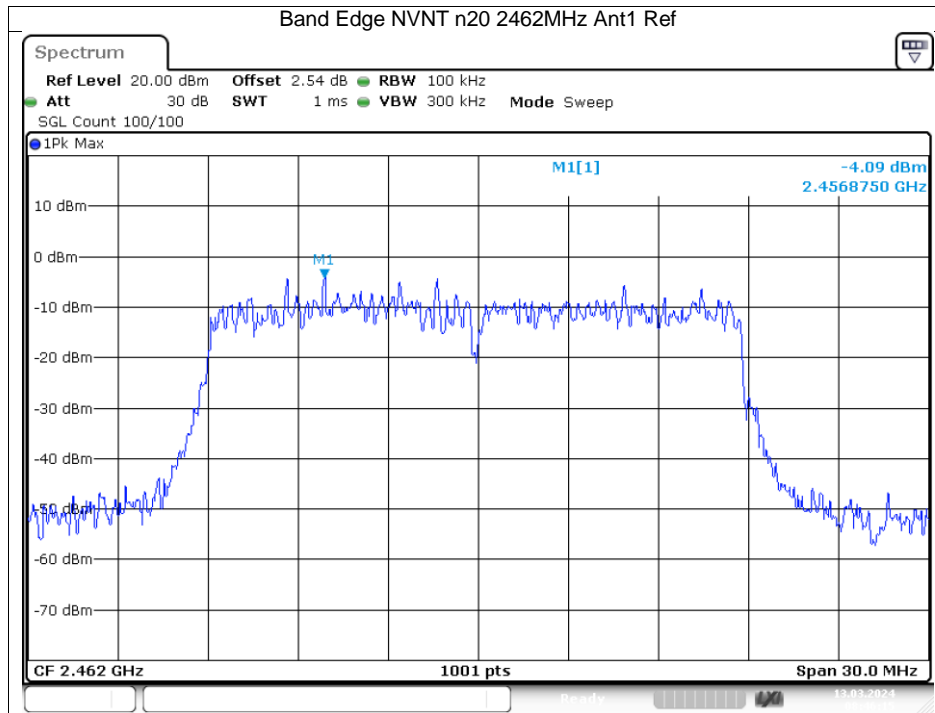
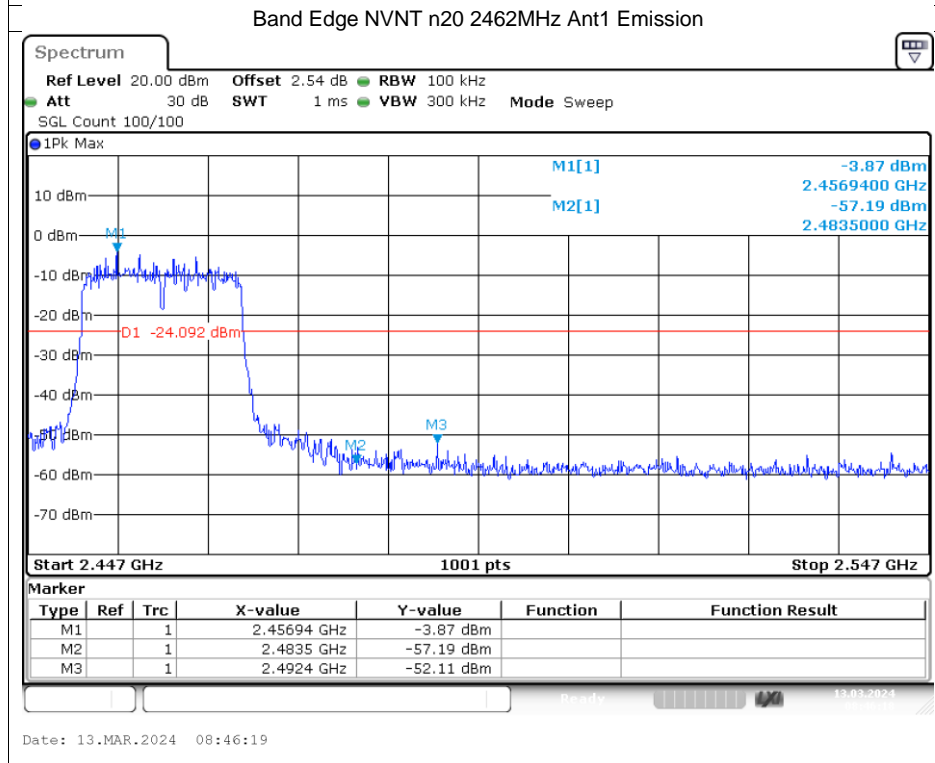
Band Edge

Condition	Mode	Frequency (MHz)	Antenna	Max Value (dBc)	Limit (dBc)	Verdict
NVNT	b	2412	Ant1	-45.66	-20	Pass
NVNT	b	2462	Ant1	-48.13	-20	Pass
NVNT	g	2412	Ant1	-43.86	-20	Pass
NVNT	g	2462	Ant1	-48.43	-20	Pass
NVNT	n20	2412	Ant1	-42.36	-20	Pass
NVNT	n20	2462	Ant1	-48.02	-20	Pass
