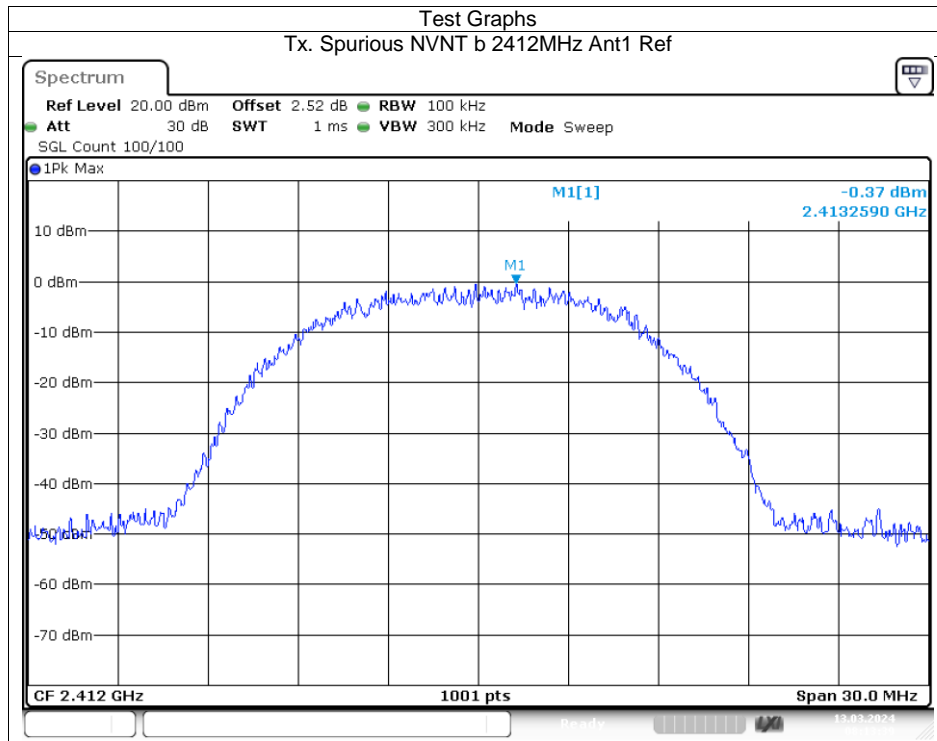
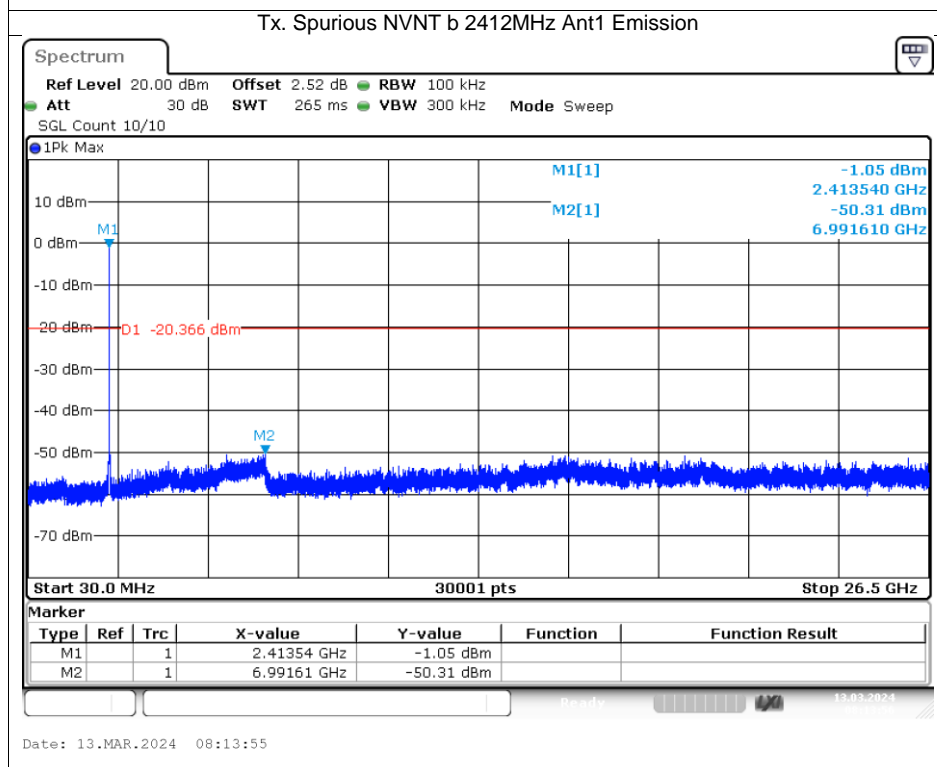
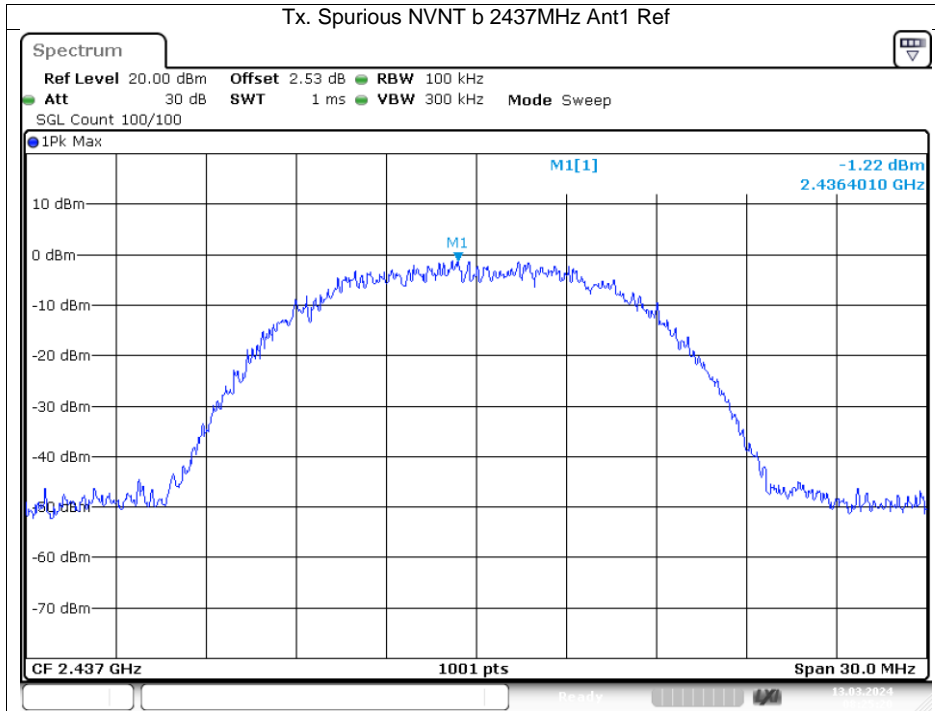
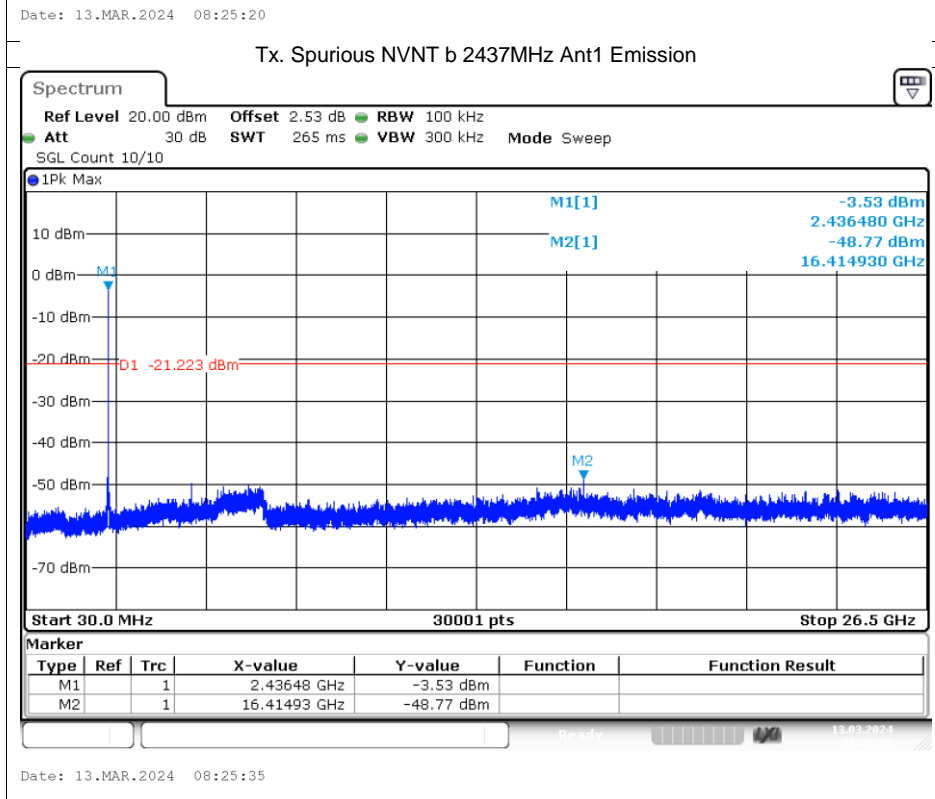
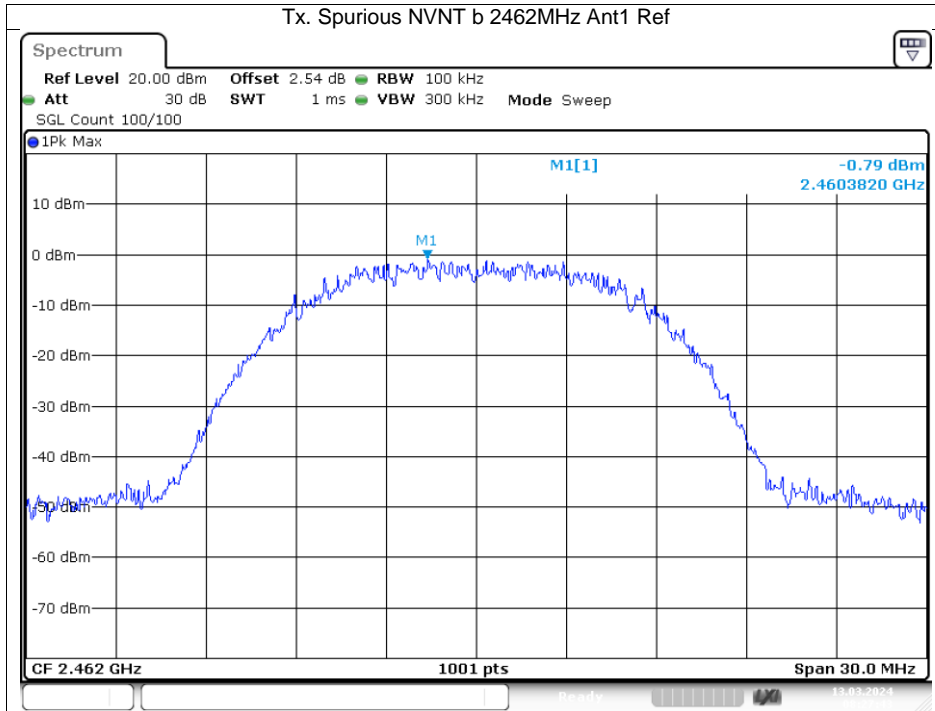
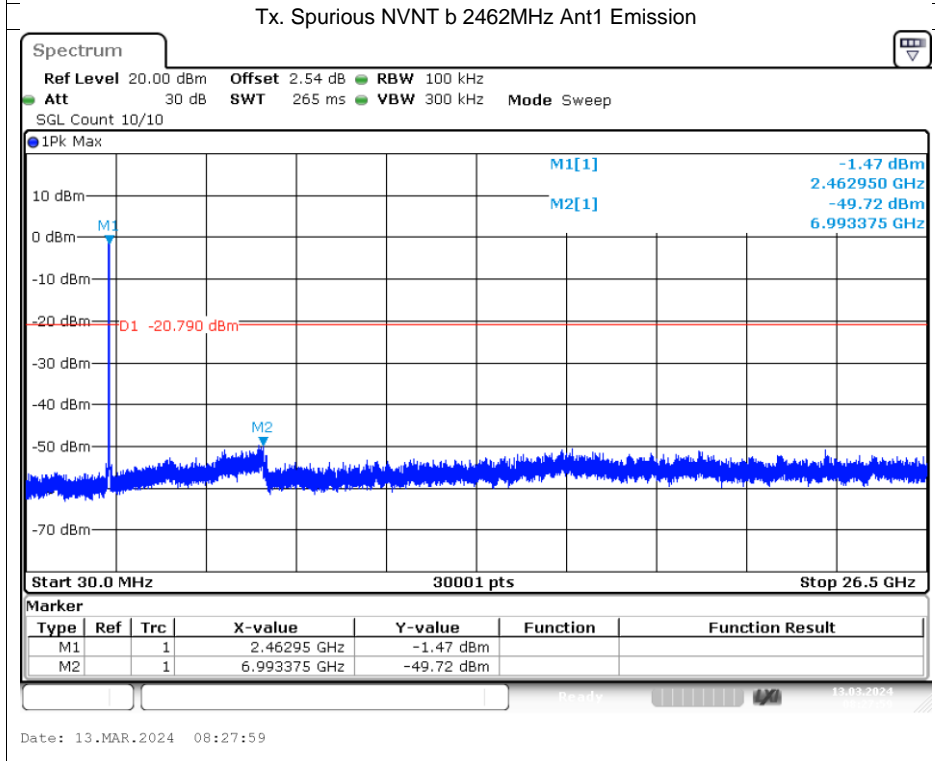
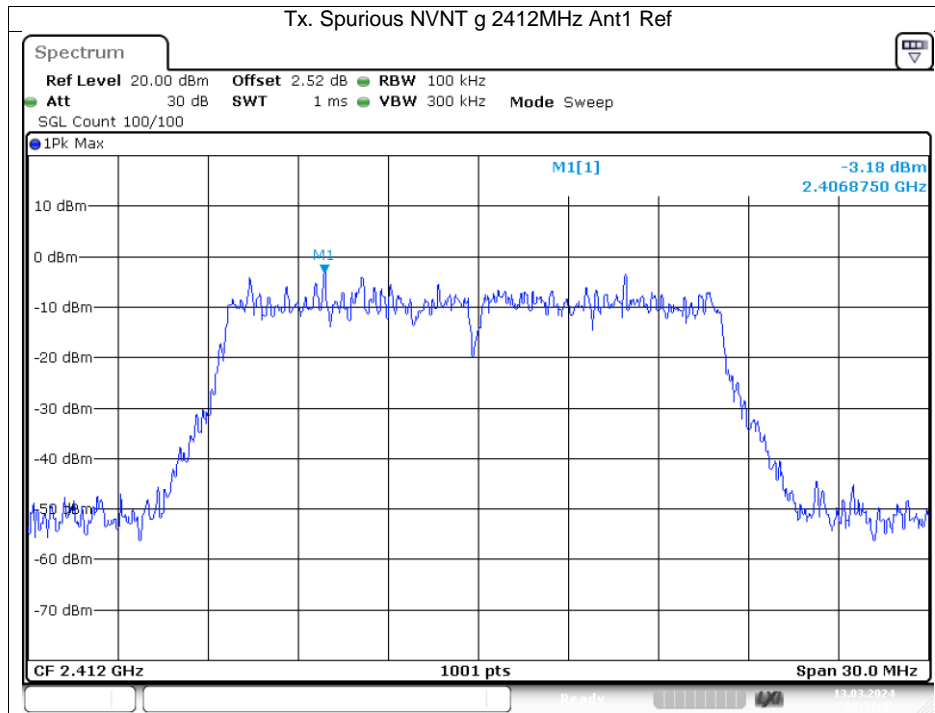
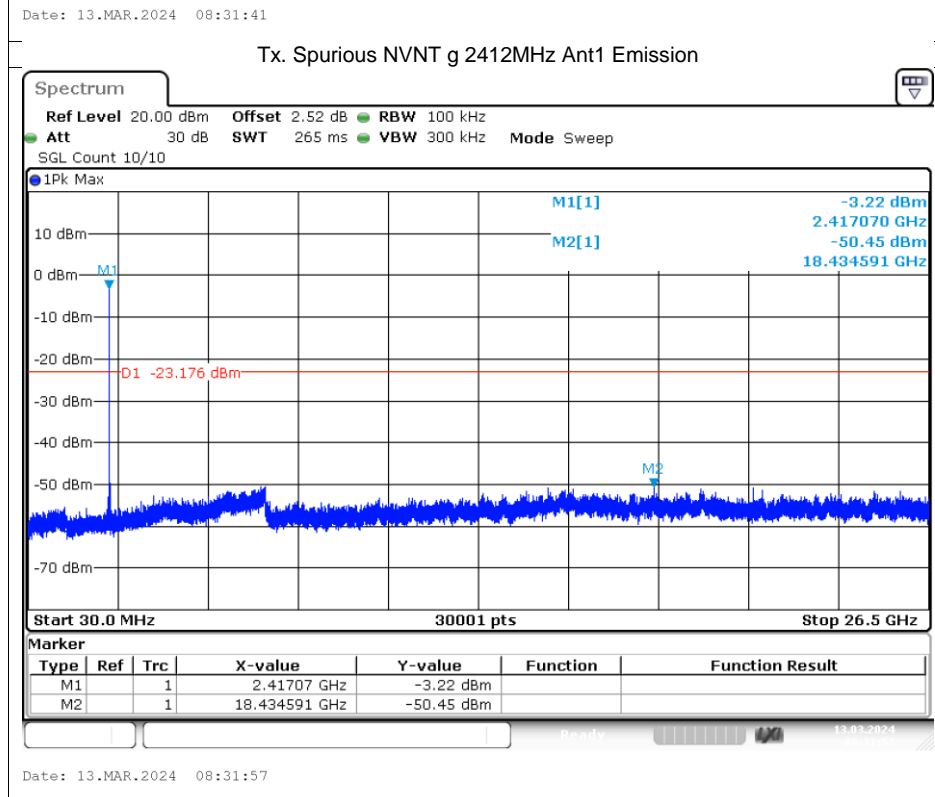
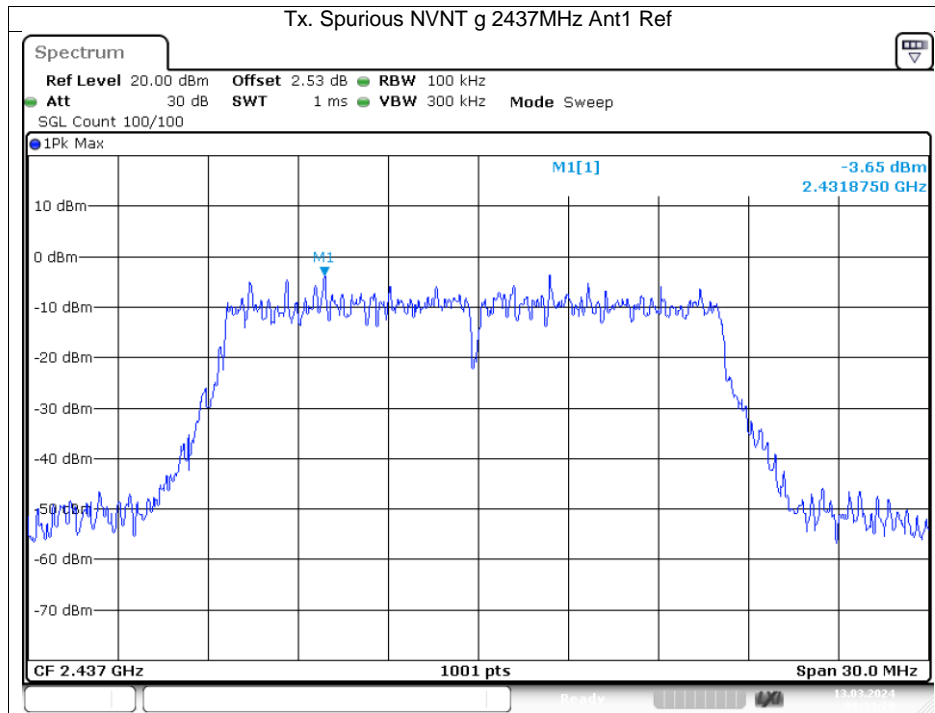
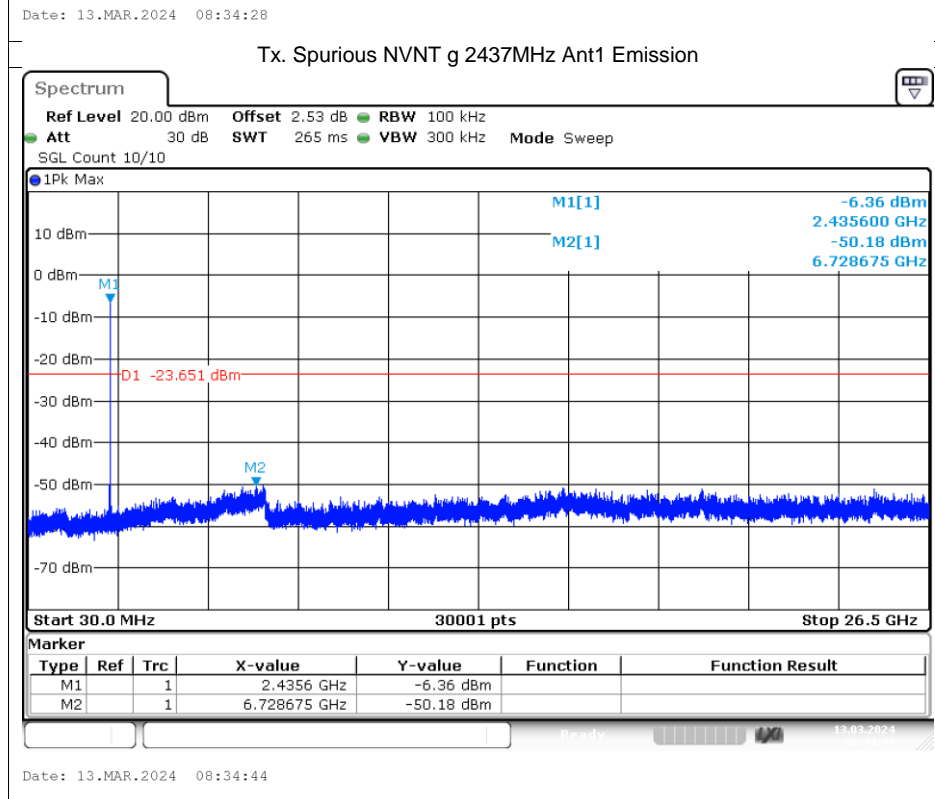
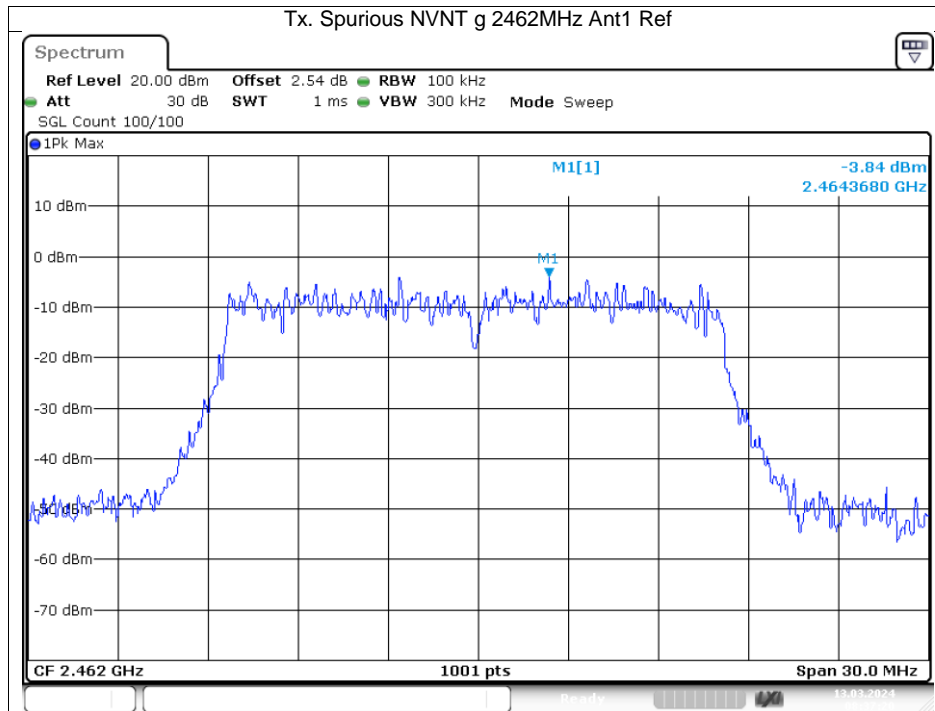
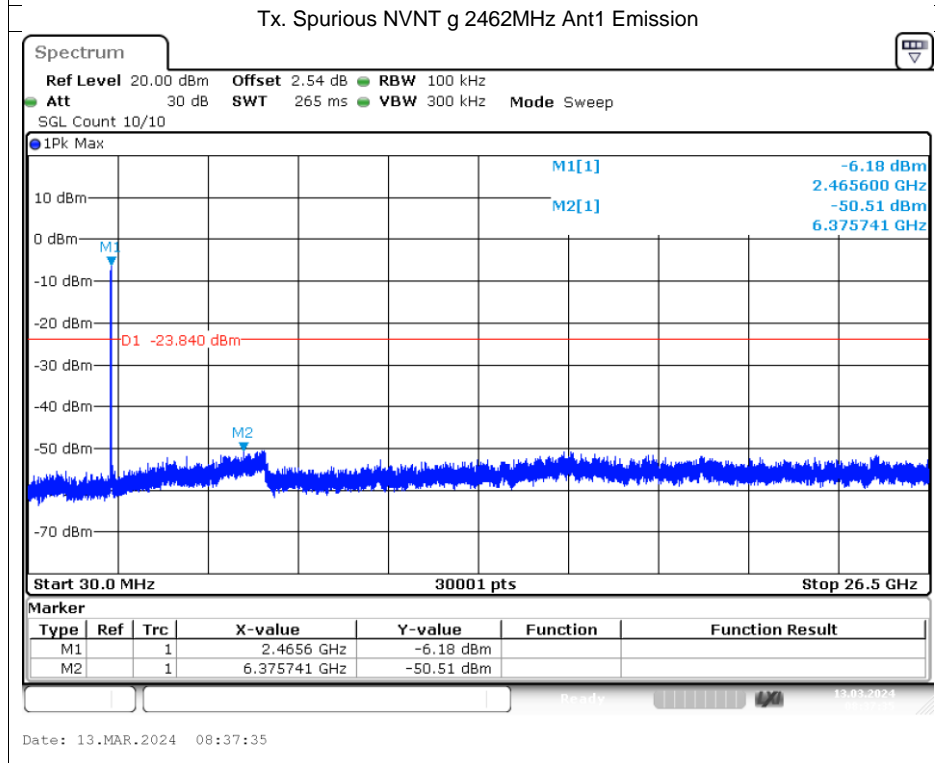
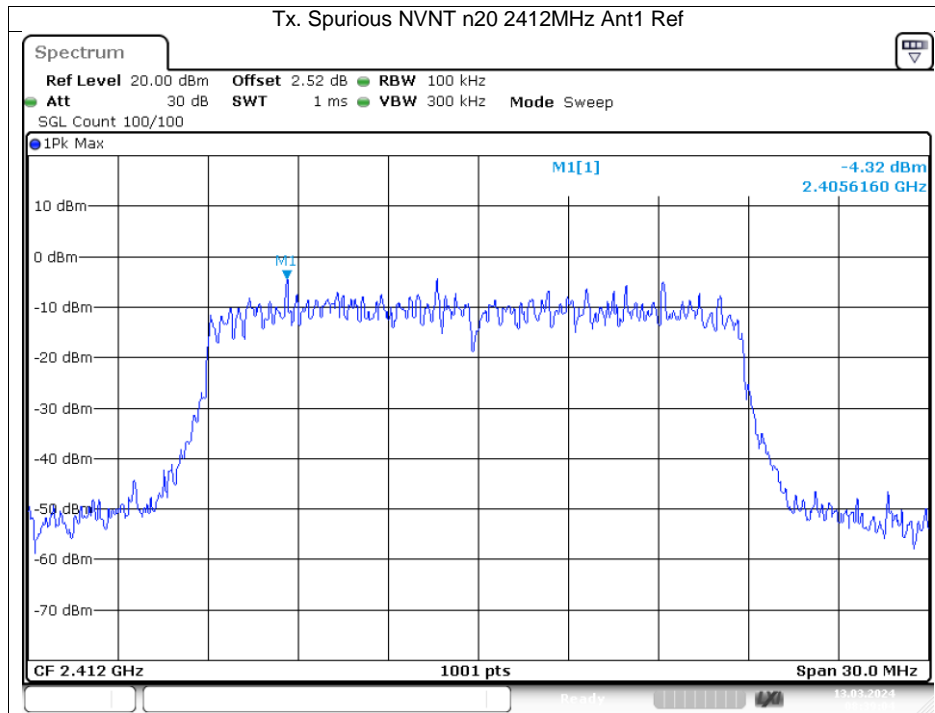
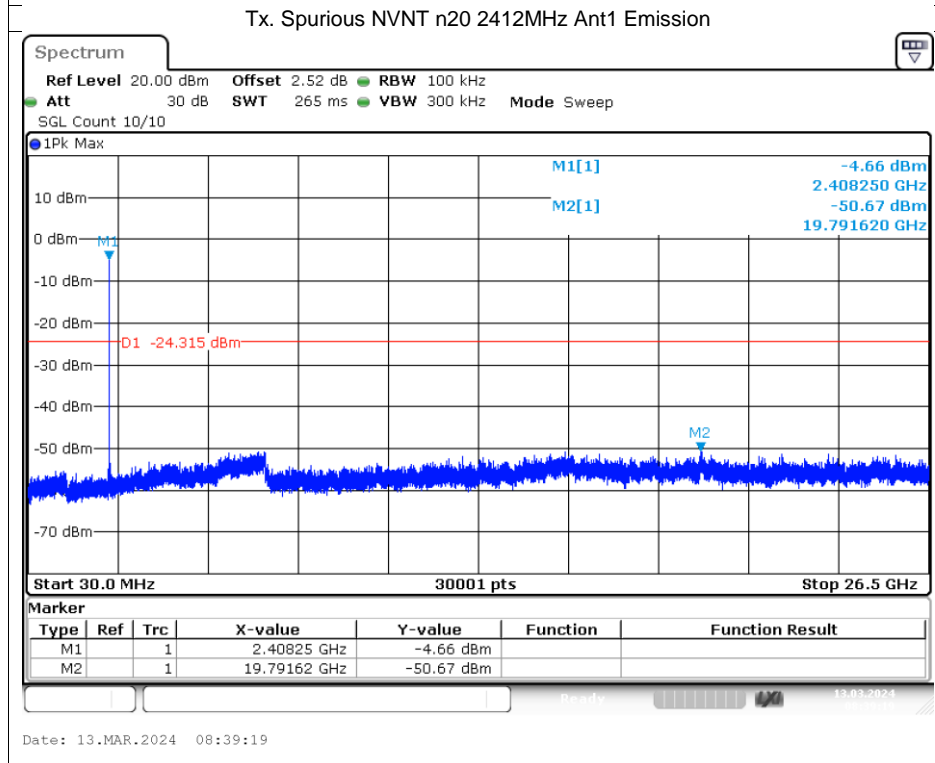
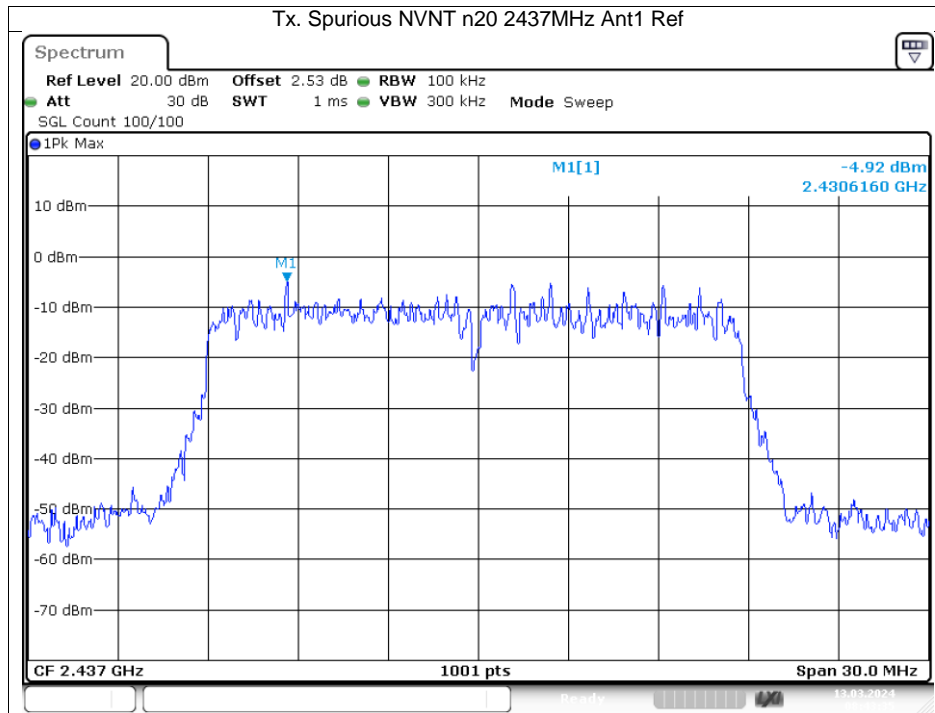
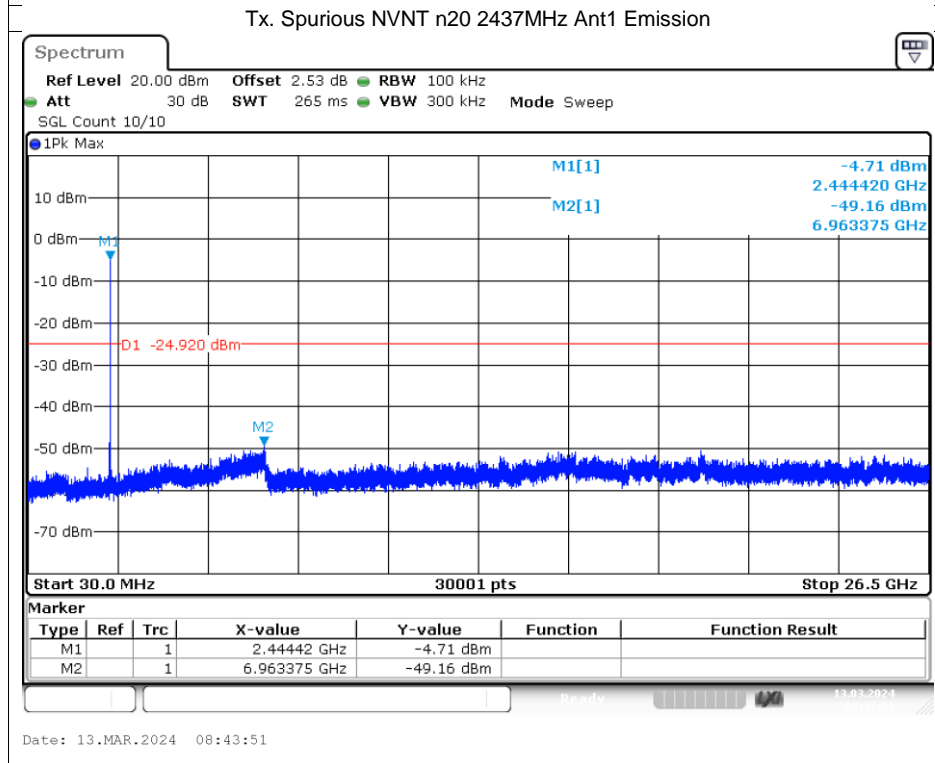
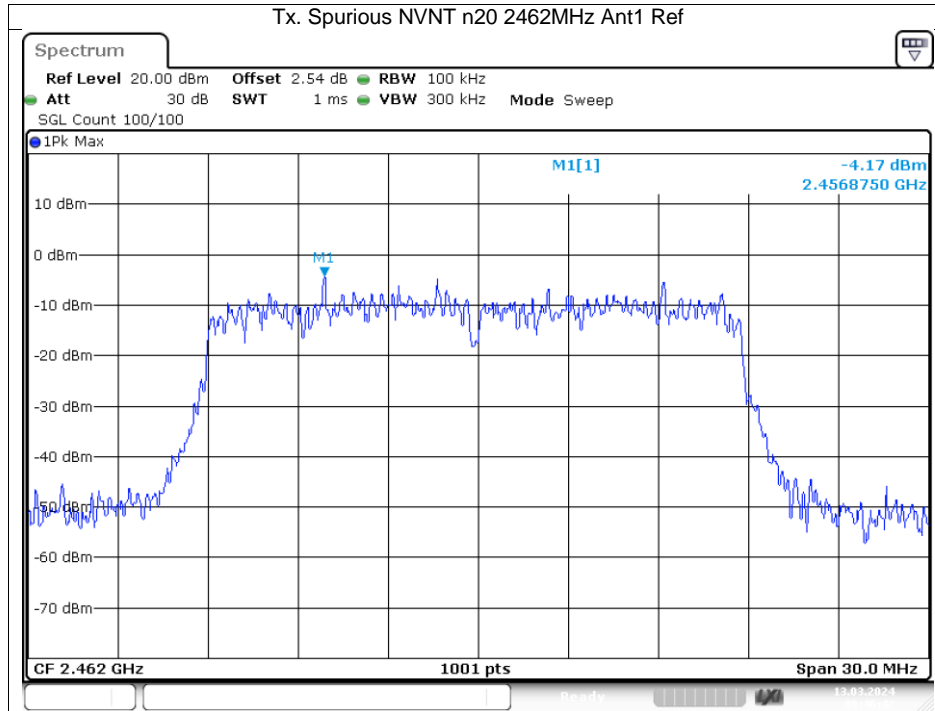
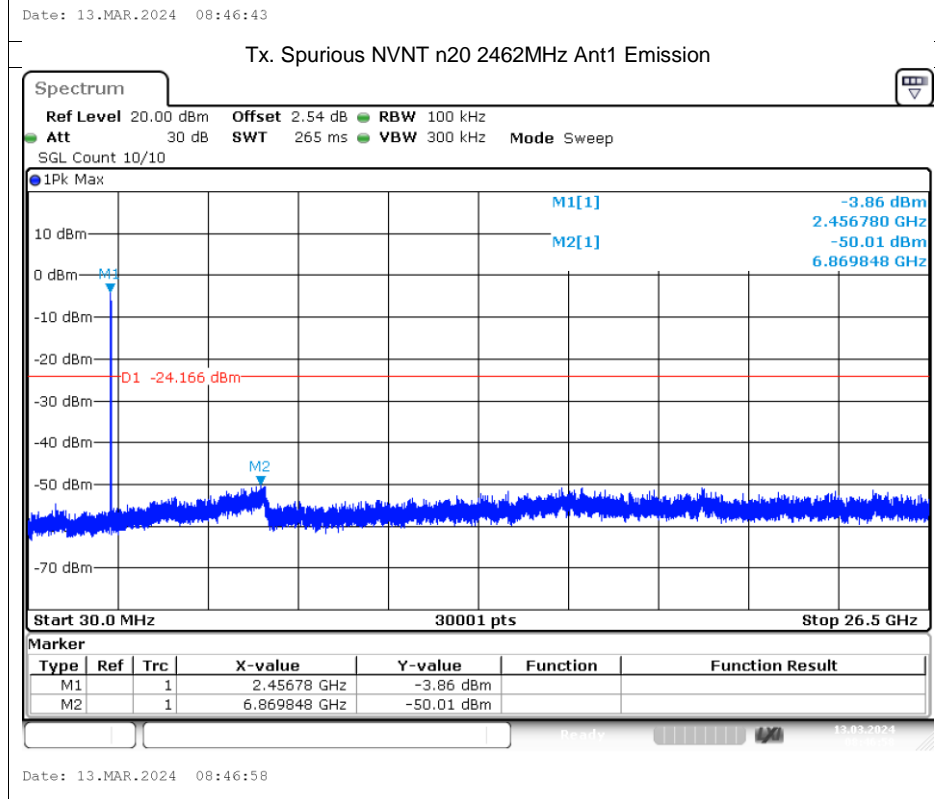
Conducted RF Spurious Emission

Condition	Mode	Frequency (MHz)	Antenna	Max Value (dBc)	Limit (dBc)	Verdict
NVNT	b	2412	Ant1	-49.94	-20	Pass
NVNT	b	2437	Ant1	-47.55	-20	Pass
NVNT	b	2462	Ant1	-48.93	-20	Pass
NVNT	g	2412	Ant1	-47.27	-20	Pass
NVNT	g	2437	Ant1	-46.53	-20	Pass
NVNT	g	2462	Ant1	-46.67	-20	Pass
NVNT	n20	2412	Ant1	-46.35	-20	Pass
NVNT	n20	2437	Ant1	-44.24	-20	Pass
NVNT	n20	2462	Ant1	-45.84	-20	Pass

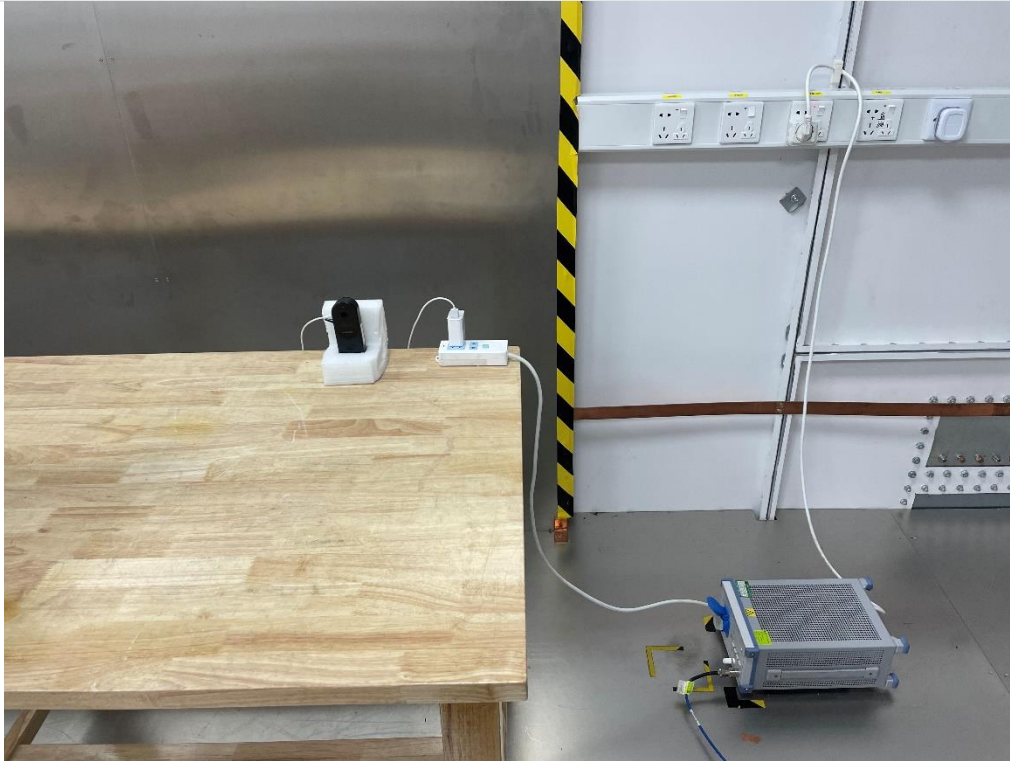
AC Power Line Conducted Emission

APPENDIX: PHOTOGRAPHS OF TEST CONFIGURATION
