Test report No.: KES-SR-22T0016 Page (1) of (8)

APPENDIX E: DUT ANTENNA DIAGRAM & SAR TEST SETUP PHOTOGRAPHS

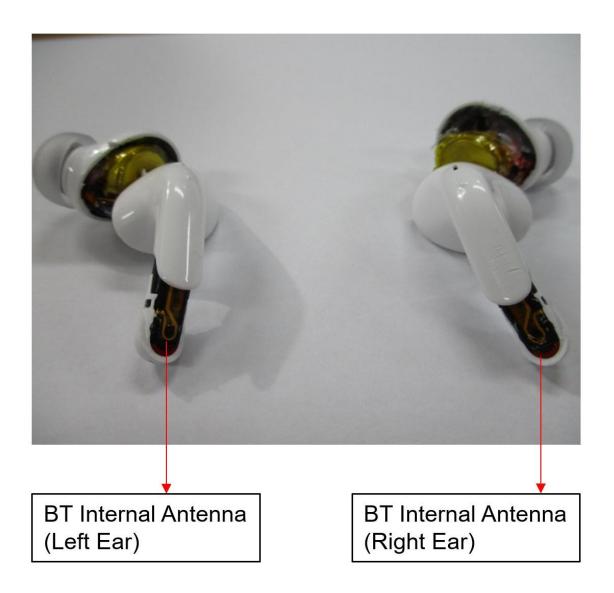
Figure E-1 Antenna Location (Rear Side View)

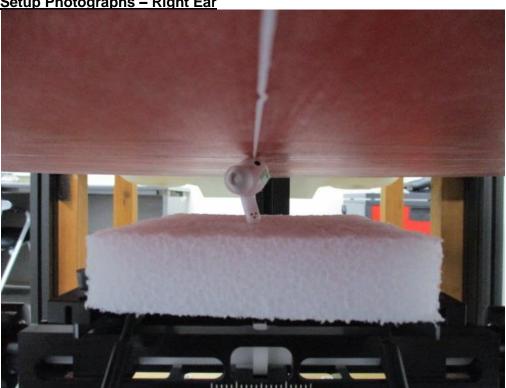
Top Side from Flat Phantom (Separation Distance: 0 cm) - Right Ear

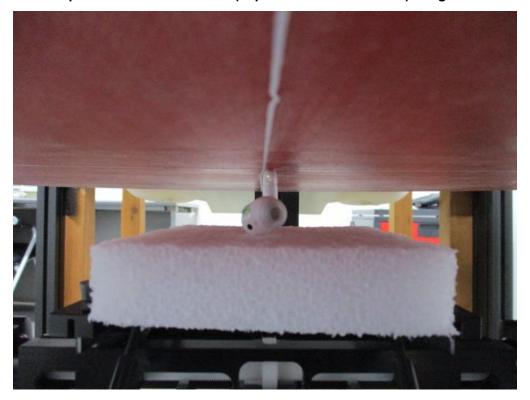
Bottom Side from Flat Phantom (Separation Distance: 0 cm) - Right Ear

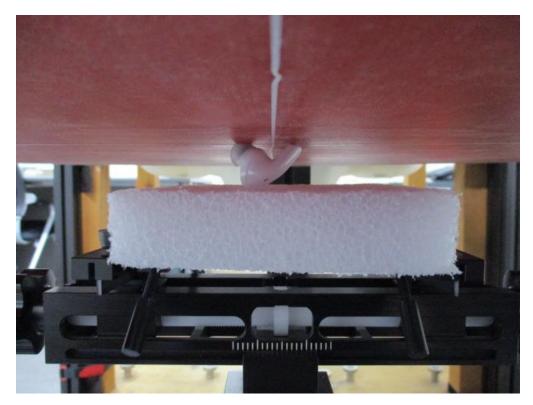
Right Ear & Front Side from Flat Phantom (Separation Distance: 0 cm) - Right Ear

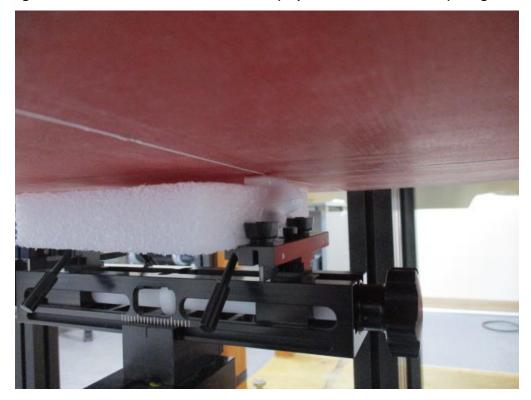
Rear from Flat Phantom (Separation Distance: 0 cm) - Right Ear

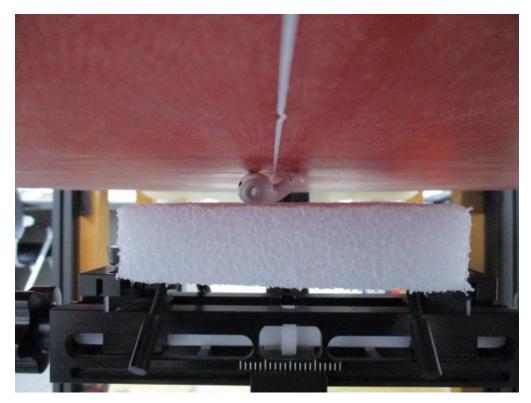
Right Side from Flat Phantom (Separation Distance: 0 cm) - Right Ear

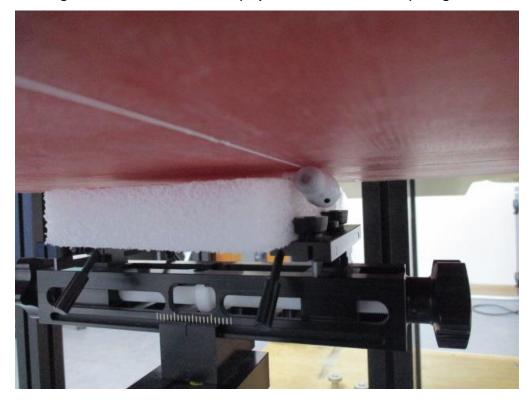
Left Side from Flat Phantom (Separation Distance: 0 cm) - Right Ear

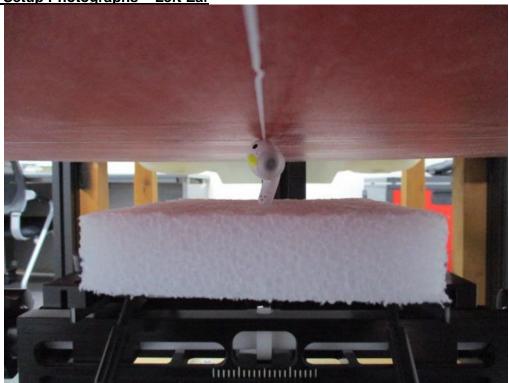
Top Side from Flat Phantom (Separation Distance: 0 cm) - Left Ear

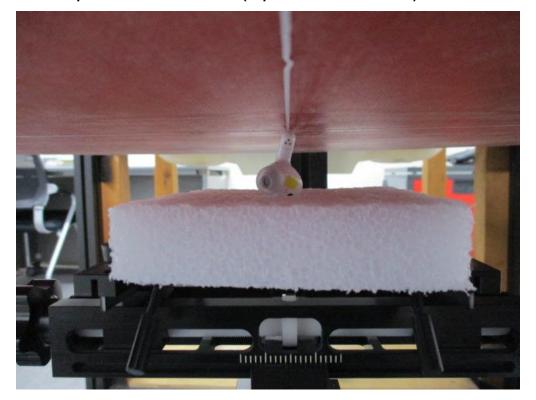
Bottom Side from Flat Phantom (Separation Distance: 0 cm) - Left Ear

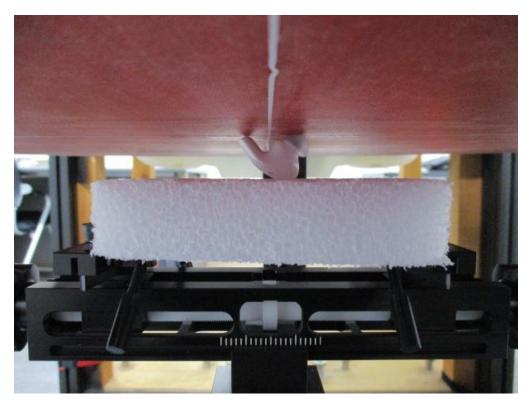
Left Ear & Front Side from Flat Phantom (Separation Distance: 0 cm) - Left Ear

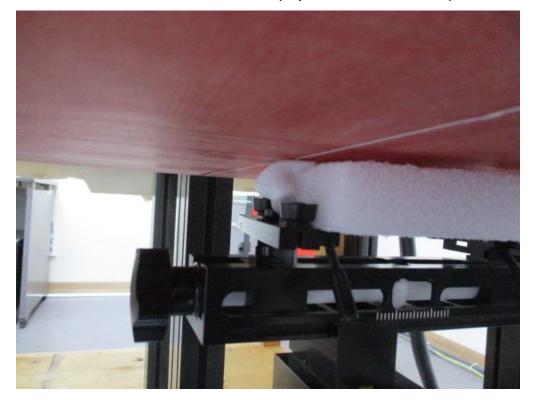
Rear from Flat Phantom (Separation Distance: 0 cm) - Left Ear

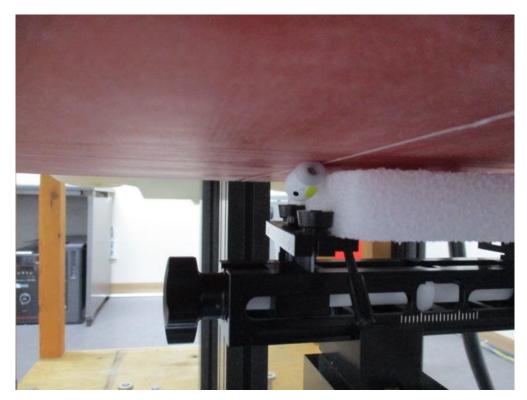
Right Side from Flat Phantom (Separation Distance: 0 cm) - Left Ear

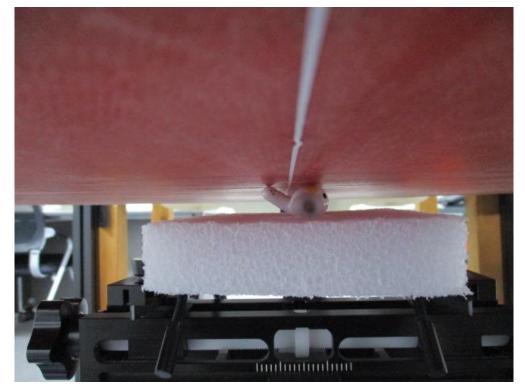
Left Side from Flat Phantom (Separation Distance: 0 cm) - Left Ear
