A TYPOGRAPHICAL ERROR WAS FOUND IN  
SHEET 18 OF EXHIBIT 06 – “TEST REPORT”

## EXHIBIT 6I – Transient Frequency Behavior (Note: Measurement made at 155.025 MHz)

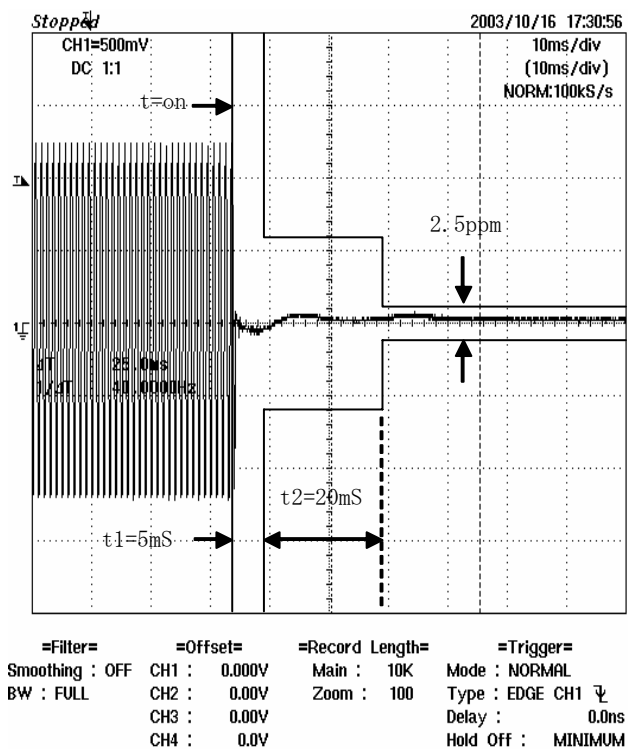
Figure 6I-1: 5 Watts, 12.5 KHz Key-Up Attack Time

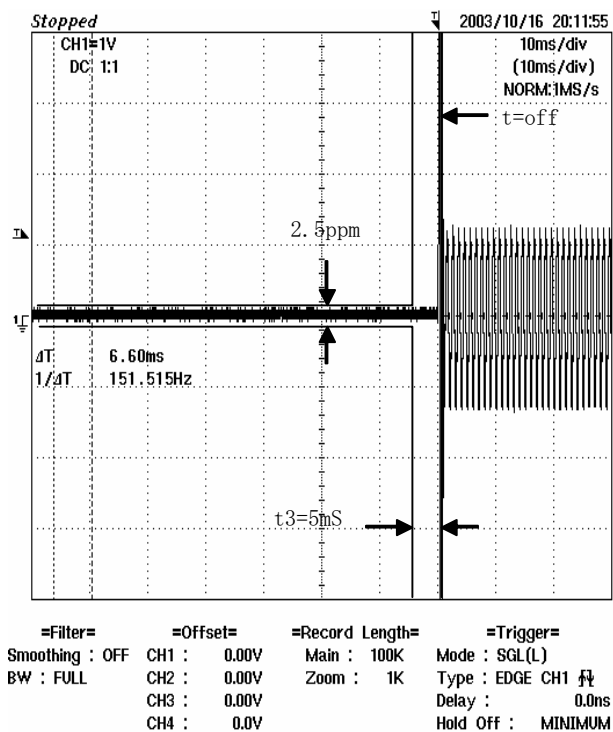
Figure 6I-2: 5 Watts, 12.5 KHz De-Key Decay Time
