Test Summary: Tensile Properties Test with Accelerated UV Aging
A Demonstration of NOAA DeOrbit Guideline Compliance in an 'Edge Case' Scenario

UV Weathering & Tensile Tests on Nanofil & Vantage Lines

Client: Mr. P. Platzer & G. Grantham Spire Global UK Ltd. Unit 5B, Sky Park 5 45 Finnieston Street Glasgow, G3 8JU	Date: 27 th July 2015	Mat Tech Job No: F5144
---	---	-------------------------------

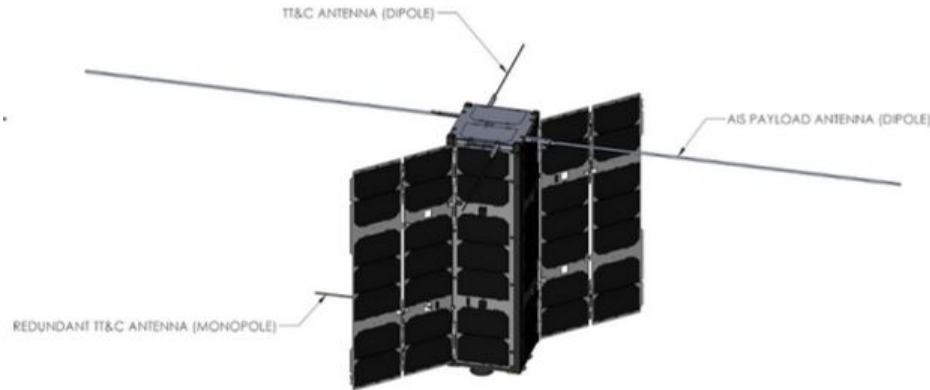
Figure 1. LEMUR-2 in Fully Deployed Configuration

Following its deployment from the launch vehicle, the satellite's orbit will naturally decay until it reenters the atmosphere. The time to reenter depends on the effective area exposed to drag. Nominally, the spacecraft deploys solar panels and antennae, and uses an on-board Attitude and Control Determination System (ADCS) to maintain the +Z direction pointing nadir. Figure 1 shows a nominal, fully deployed LEMUR-2 satellite.

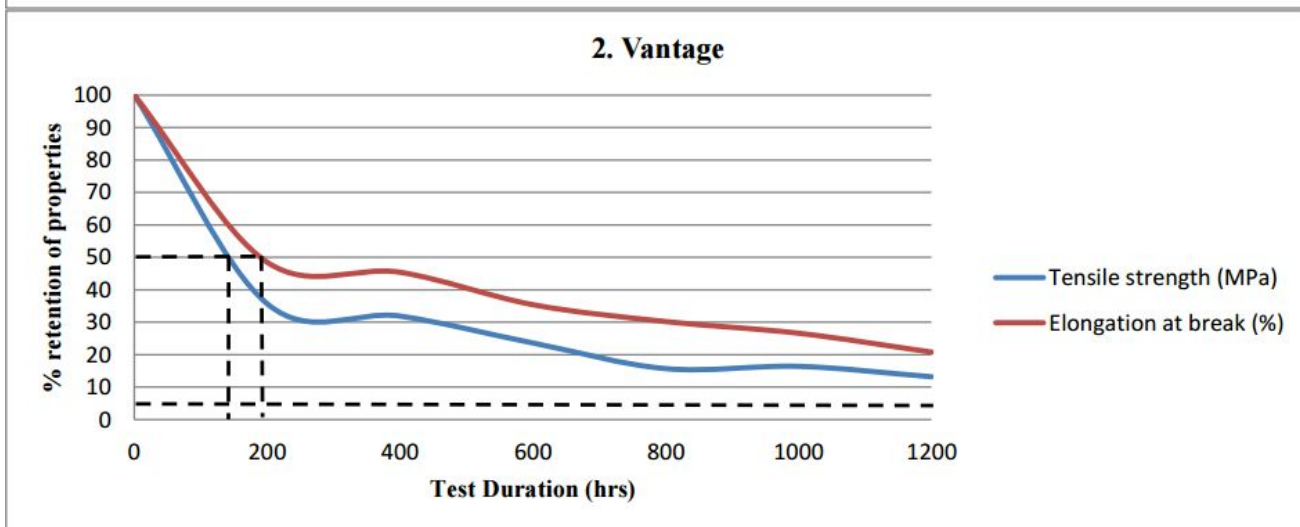
The testing showed a marked decrease in material properties after exposure to UV. The Nanofil sample degraded to less than 15% of original tensile strength at the 1200 hours of testing.

The tensile strength test clearly demonstrates the degradation of material strength of the burn wire over time.

Sample	Test Duration (hrs)						
		0	200	400	600	800	1000	1200
Tensile strength (MPa)	1. Nanofil	3320.8	1882.7	825	464.03	263.7	141.5	79.2
	% retention	100	56.7	24.8	14	7.9	4.3	2.4
	2. Vantage	784.6	280.4	250	185.36	123.57	128.77	103.4
	% retention	100	35.7	31.9	23.6	15.7	16.4	13.2
Elongation at break (%)	1. Nanofil	12.38	8.4	4.3	3.02	3.095	1.57	1.84
	% retention	100	67.9	34.7	24.4	25	12.7	14.9
	2. Vantage	69.64	33.79	31.64	24.62	21.05	18.55	14.46
	% retention	100	48.5	45.4	35.4	30.2	26.6	20.8

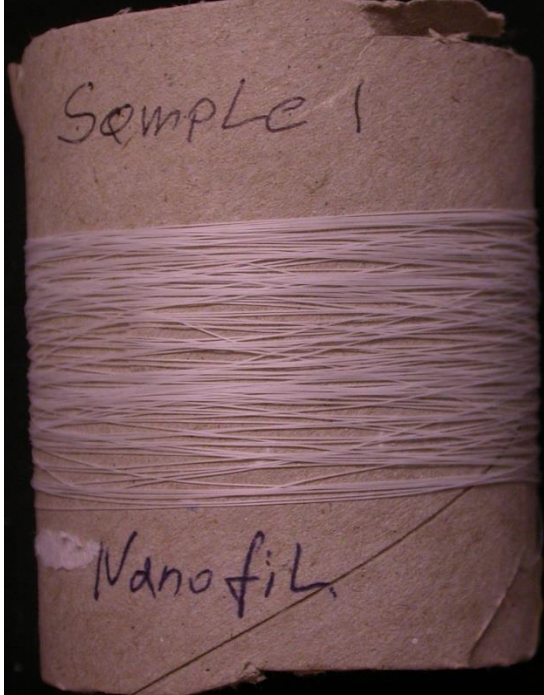
1. Nanofil	2. Vantage

The samples supplied are detailed in the table below:

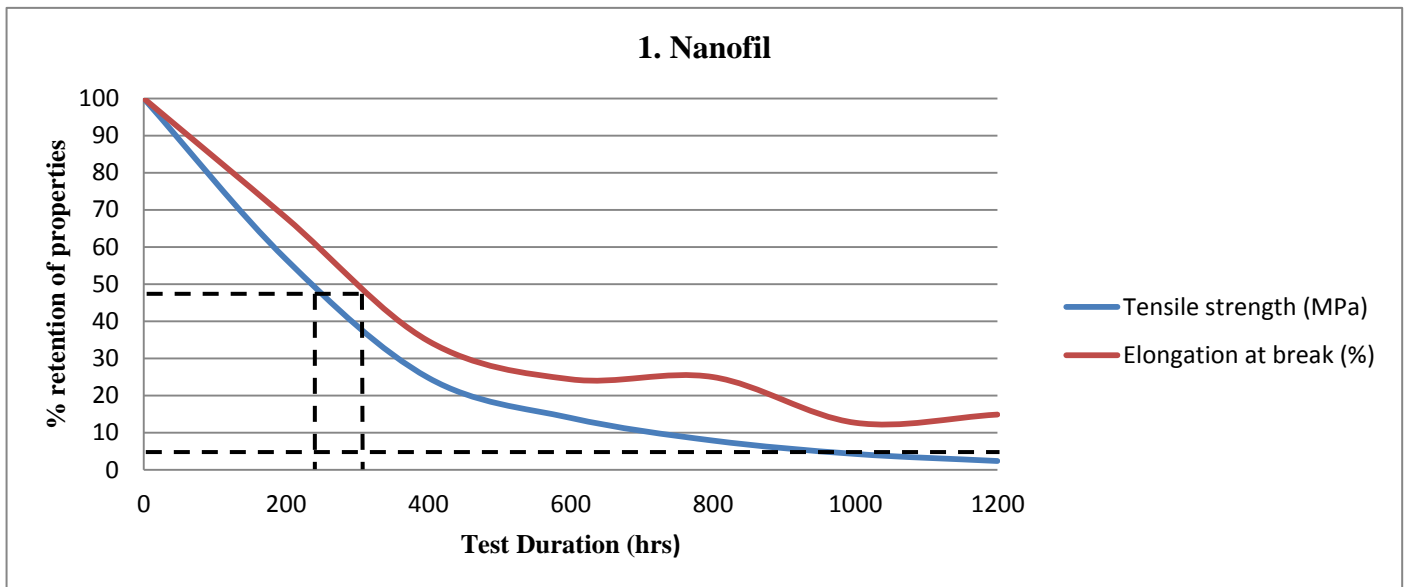
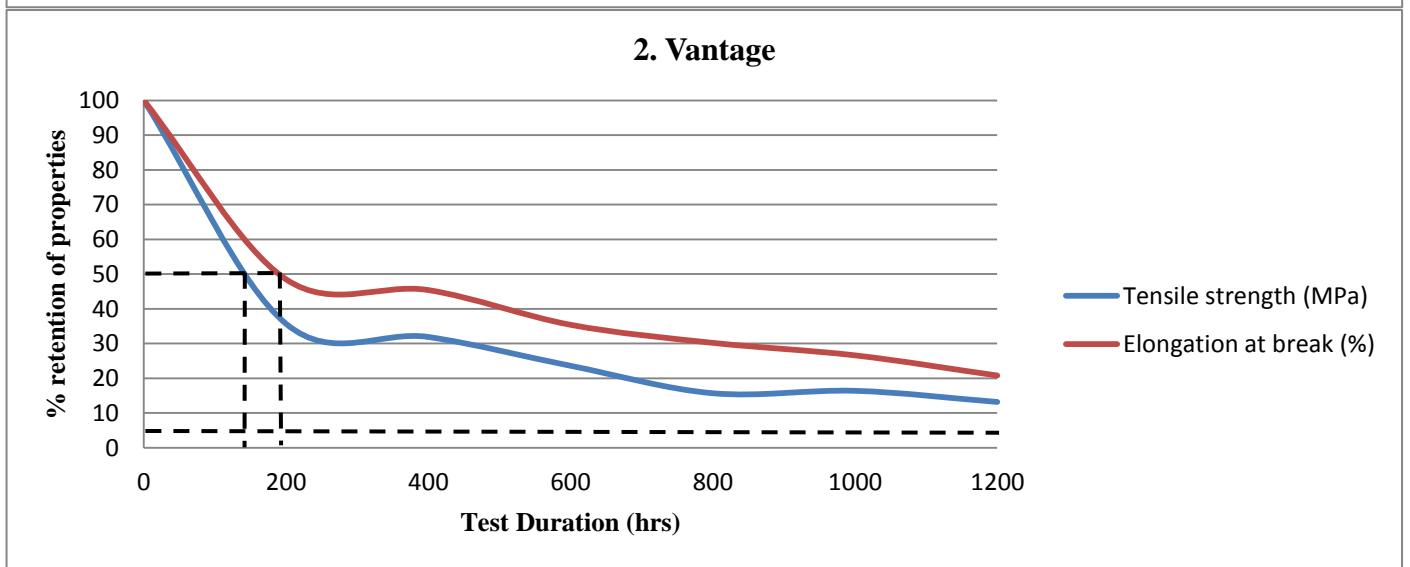
Results are shown in the table & graphically below:

It was requested that the test times at which the properties had dropped to 50% & 5% of original were highlighted. These are indicated by the dotted lines on the graphs and tabulated below:

Tensile strength (MPa)	Elongation at break (%)
1. Nanofil	50% retention	243hrs	320hrs
	5% retention	943hrs	-
2. Vantage	50% retention	146hrs	197hrs
	5% retention	-	-

The Nanofil had a significantly higher tensile strength than the Vantage at the test start (3320.8 & 784.6MPa respectively) however by the test completion it had retained only 2.4% of its tensile strength and had a lower tensile strength than the Vantage.

The Vantage had a higher elongation at break than the Nanofil (69.64% & 12.38% respectively). The Vantage retained a greater percentage of its elongation at break over the test duration than the Nanofil.

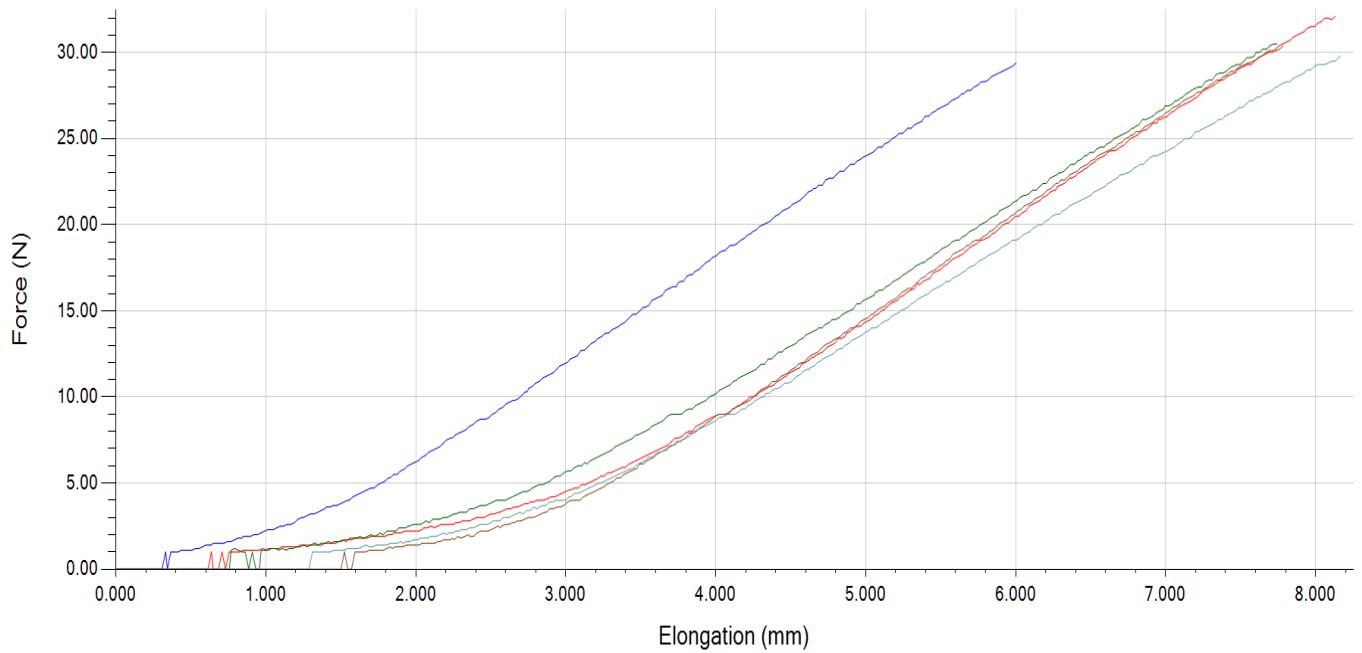
Client : Spire	Test Name : ISO 2062
Job Number : F5144-1	Test Type : Tensile
Material : 1	Test Date : 08/06/2015 08:56
Age : 200 hrs	Test Speed : 25.000 mm/min
	Pretension : Off
	Diameter : 0.150 mm
	Sample Length : 90.000 mm

Test No	Force @ Peak (N)	Elong. @ Peak (mm)	Strain @ Peak (%)	Diameter (mm)	Stress @ Peak (N/mm ²)
1	29.400	6.004	6.671	0.130	2214.985
2	32.100	8.131	9.034	0.150	1816.488
3	30.500	7.719	8.577	0.150	1725.947
4	30.400	7.784	8.649	0.150	1720.288
5	29.800	8.166	9.073	0.140	1935.844
Mean	30.440	7.561	8.401	0.144	1882.710
S.D.	1.031	0.893	0.992	0.009	205.287

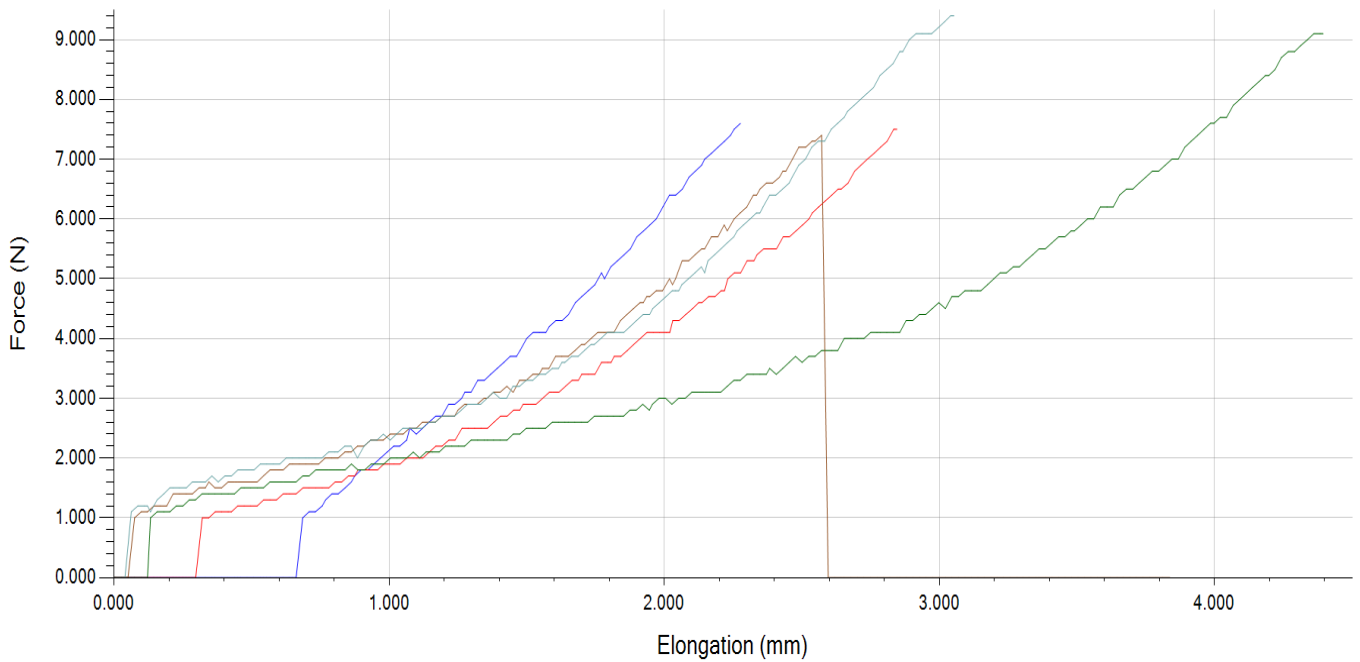
Client : Spire	Test Name : ISO 2062
Job Number : F5144-1	Test Type : Tensile
Material : 1	Test Date : 26/06/2015 09:16
Age : 600 Hours	Test Speed : 25.000 mm/min
	Pretension : Off
	Diameter : 0.150 mm
	Sample Length : 90.000 mm

Test No	Force @ Peak (N)	Elong. @ Peak (mm)	Strain @ Peak (%)	Diameter (mm)	Stress @ Peak (N/mm ²)
1	7.600	2.277	2.530	0.150	430.072
2	7.500	2.834	3.149	0.150	424.413
3	9.100	4.361	4.846	0.150	514.955
4	7.400	2.572	2.858	0.150	418.754
5	9.400	3.041	3.379	0.150	531.931
Mean	8.200	3.017	3.352	0.150	464.025
S.D.	0.967	0.804	0.893		54.718

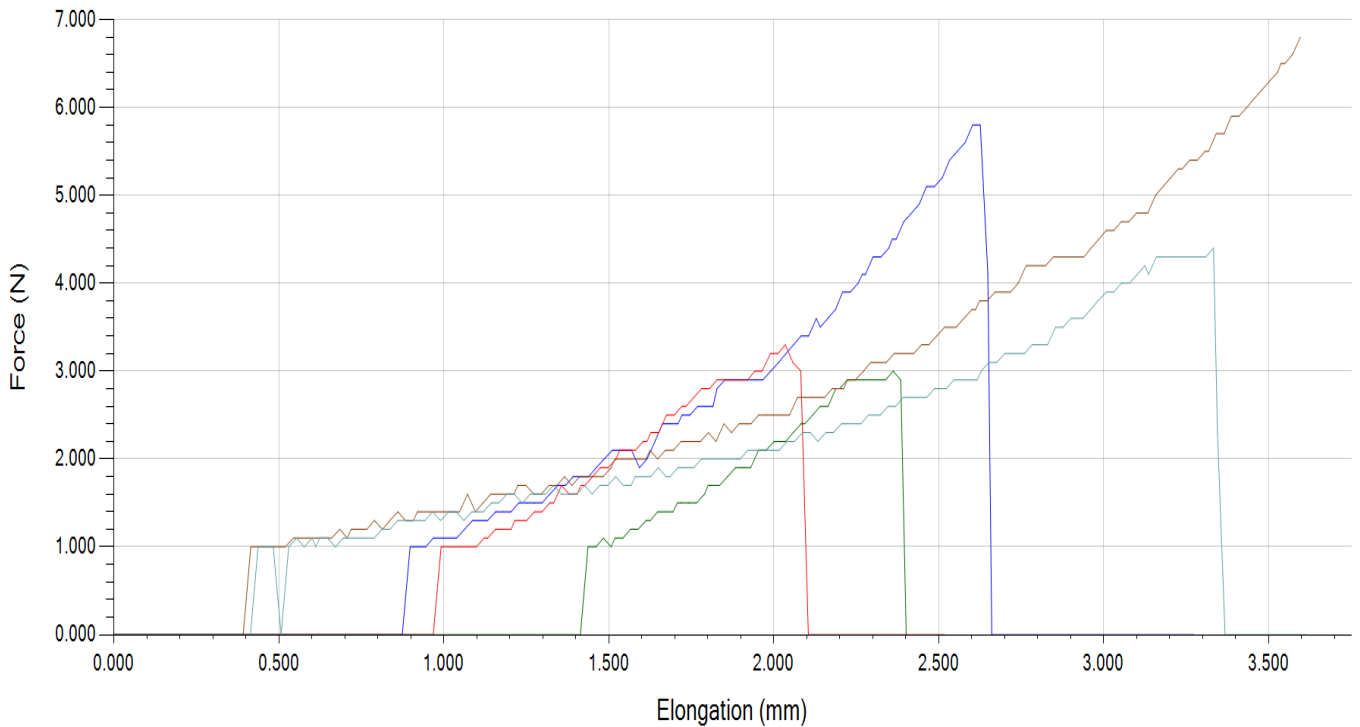
Client : Spire	Test Name : ISO 2062 Fibre
Job Number : F5144-1	Test Type : Tensile
Material : 1	Test Date : 06/07/2015 11:34
Age : 800 Hours	Test Speed : 25.000 mm/min
	Pretension : Off
	Diameter : 0.150 mm
	Sample Length : 90.000 mm

Test No	Force @ Peak (N)	Elong. @ Peak (mm)	Strain @ Peak (%)	Diameter (mm)	Stress @ Peak (N/mm ²)
1	5.800	2.603	2.892	0.150	328.213
2	3.300	2.035	2.261	0.150	186.742
3	3.000	2.362	2.624	0.150	169.765
4	6.800	3.596	3.996	0.150	384.801
5	4.400	3.333	3.703	0.150	248.989
Mean	4.660	2.786	3.095	0.150	263.702
S.D.	1.624	0.658	0.731		91.910

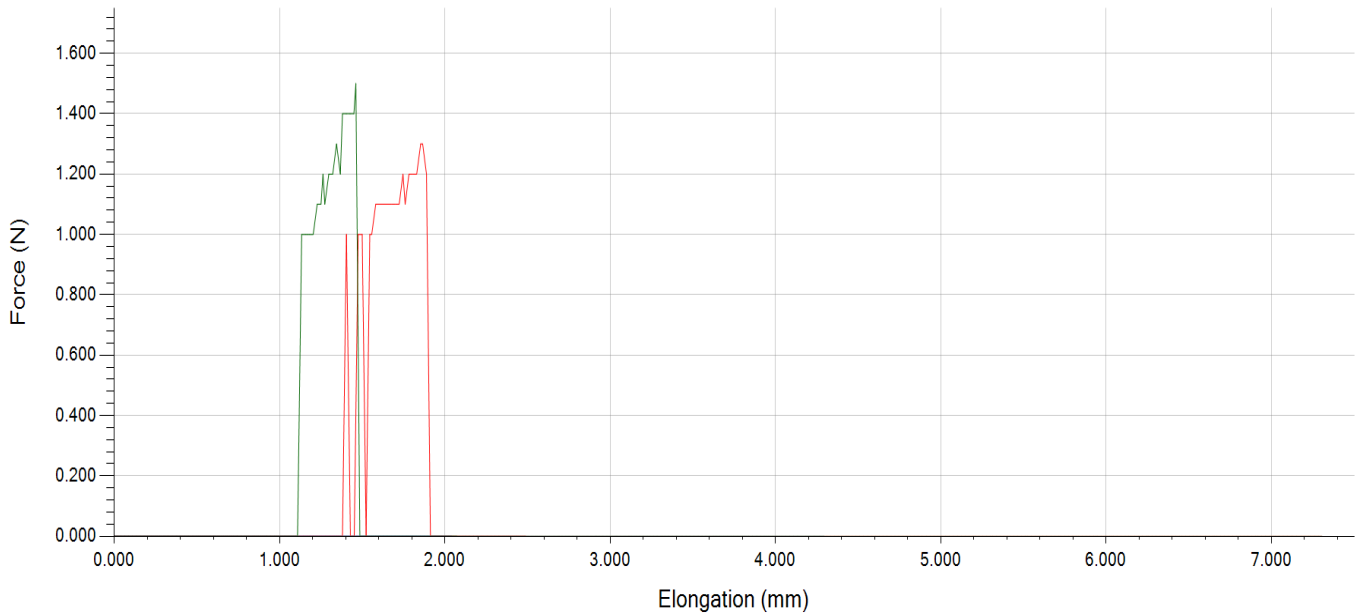
Client : Spire	Test Name : ISO 2062 Line
Job Number : F5144-1	Test Type : Tensile
Material : 1	Test Date : 27/07/2015 13:46
Age : 1200 Hours	Test Speed : 25.000 mm/min
	Pretension : Off
	Diameter : 0.150 mm
	Sample Length : 90.000 mm

Note tensile strength significantly reduced such that no braek was detected on samples 1, 4 & 5.

Test No	Force @ Peak (N)	Elong. @ Peak (mm)	Strain @ Peak (%)	Diameter (mm)	Stress @ Peak (N/mm ²)
1				0.150	
2	1.300	1.854	2.060	0.150	73.565
3	1.500	1.462	1.624	0.150	84.883
4				0.150	
5				0.150	
Mean	1.400	1.658	1.842	0.150	79.224

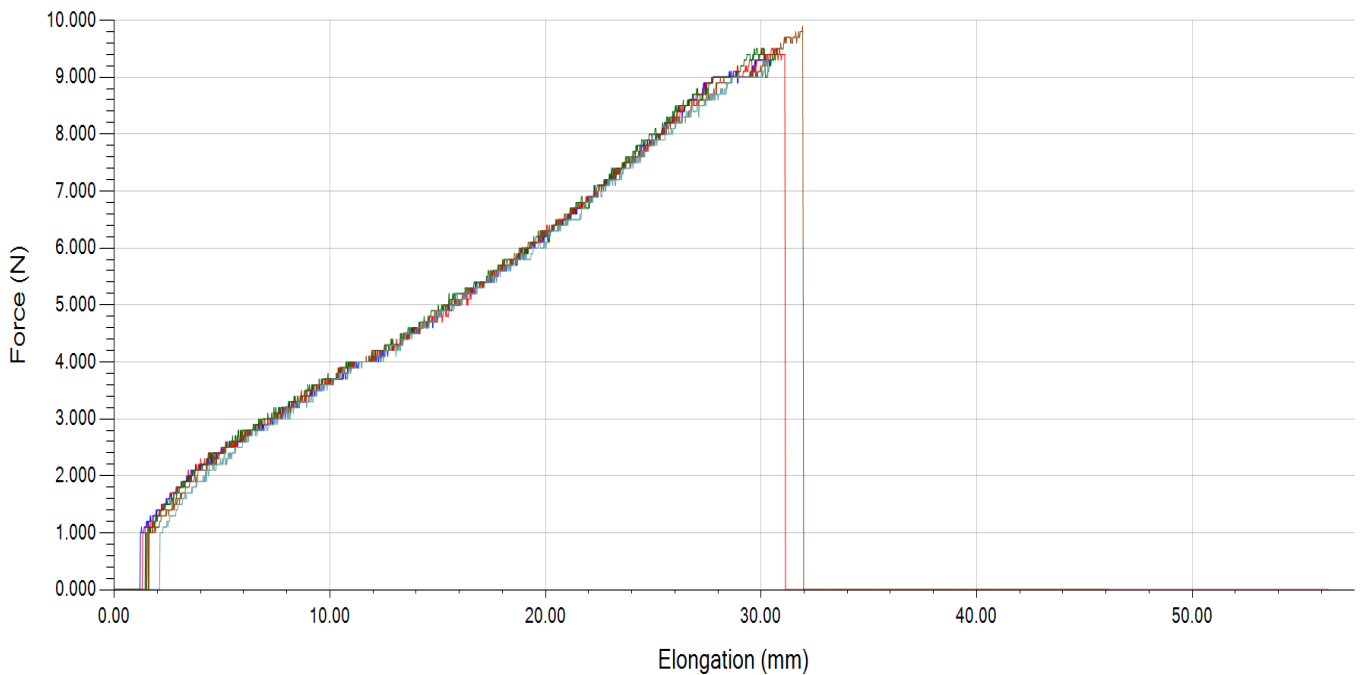
Client : Spire	Test Name : ISO 2062
Job Number : F5144-1	Test Type : Tensile
Material : 2	Test Date : 08/06/2015 09:34
Age : 200 hrs	Test Speed : 25.000 mm/min
	Pretension : Off
	Diameter : 0.150 mm
	Sample Length : 90.000 mm

Test No	Force @ Peak (N)	Elong. @ Peak (mm)	Strain @ Peak (%)	Diameter (mm)	Stress @ Peak (N/mm ²)
1	9.400	30.146	33.496	0.200	299.211
2	9.500	30.038	33.376	0.210	274.281
3	9.500	29.691	32.990	0.210	274.281
4	9.900	31.929	35.477	0.210	285.829
5	9.300	30.249	33.610	0.210	268.506
Mean	9.520	30.411	33.790	0.208	280.422
S.D.	0.228	0.874	0.972	0.004	12.244

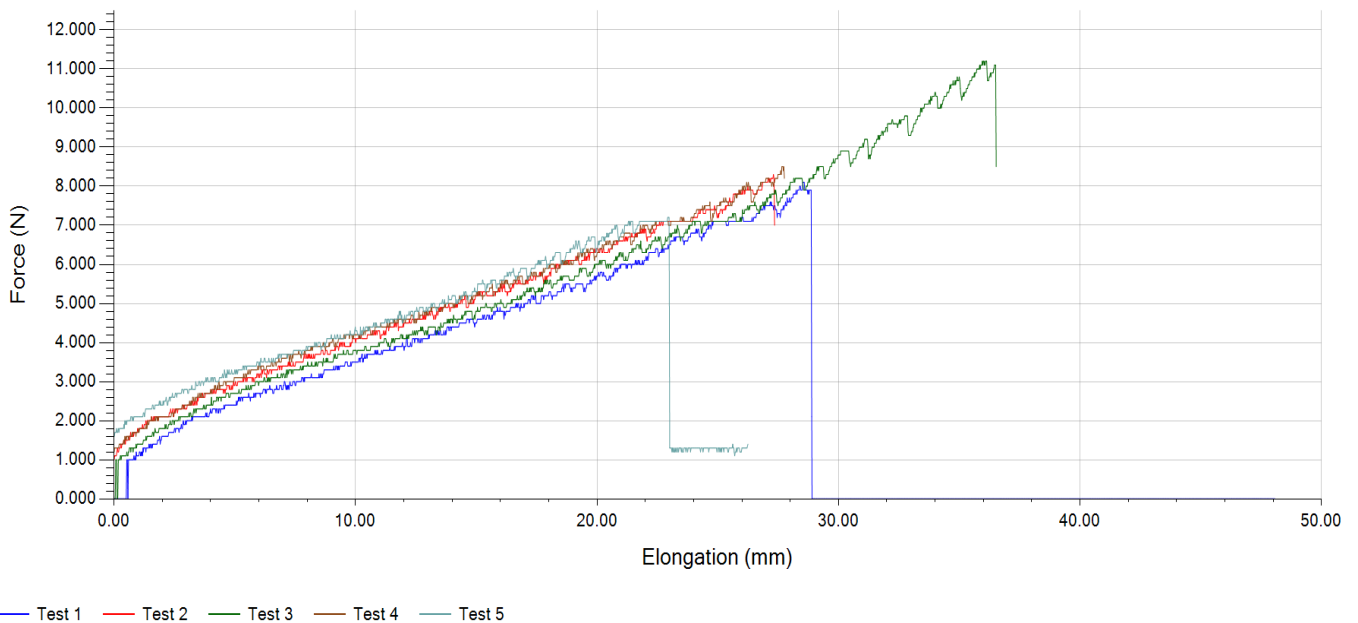
Client : Spire	Test Name : ISO 2062 Line
Job Number : F5144-1	Test Type : Tensile
Material : 2	Test Date : 17/06/2015 10:59
Age : 400 Hours	Test Speed : 25.000 mm/min
	Pretension : Off
	Diameter : 0.150 mm
	Sample Length : 90.000 mm

Test No	Force @ Peak (N)	Elong. @ Peak (mm)	Strain @ Peak (%)	Diameter (mm)	Stress @ Peak (N/mm ²)
1	8.100	28.523	31.692	0.210	233.860
2	8.300	27.305	30.339	0.210	239.635
3	11.200	35.949	39.943	0.210	323.362
4	8.500	27.653	30.726	0.210	245.409
5	7.200	22.928	25.476	0.210	207.876
Mean	8.660	28.472	31.635	0.210	250.028
S.D.	1.504	4.708	5.232	0.000	43.432

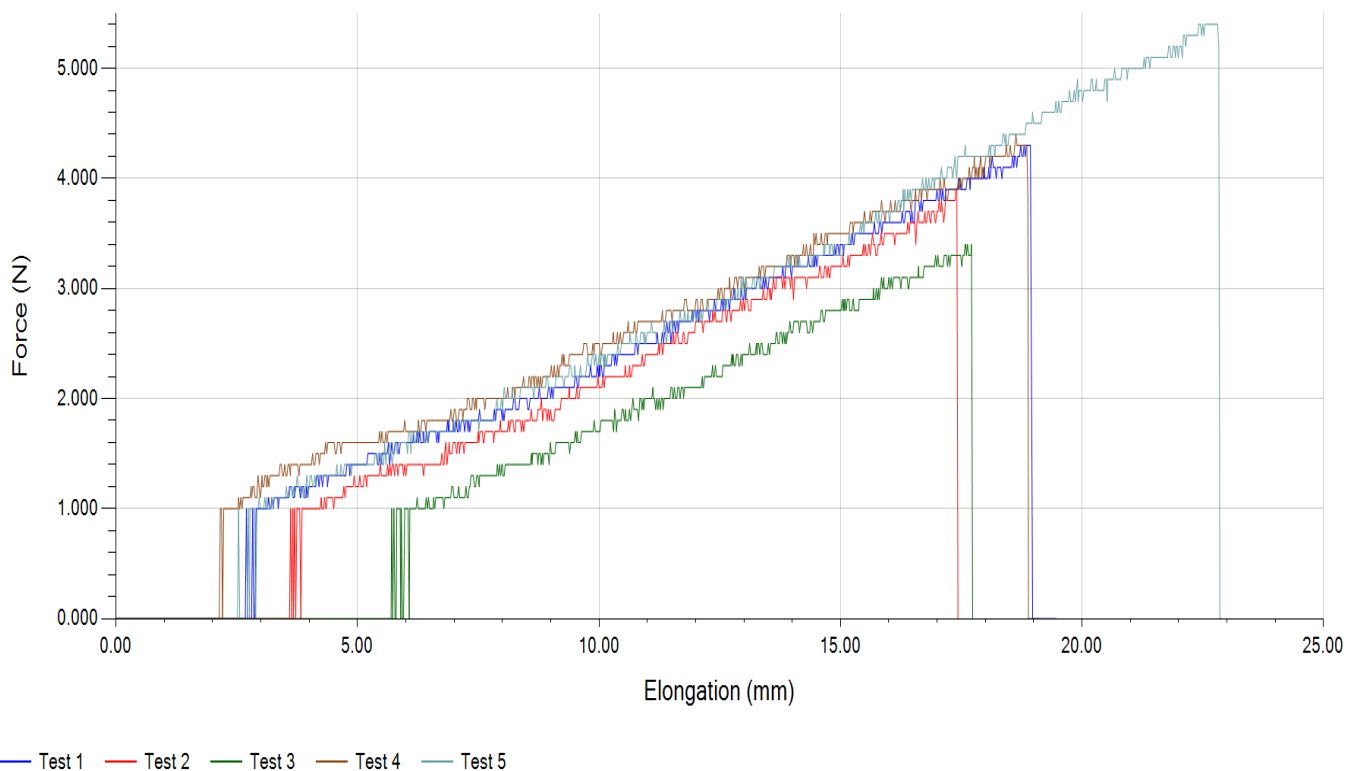
Client : Spire	Test Name : ISO 2062 Fibre
Job Number : F5144-1	Test Type : Tensile
Material : 2	Test Date : 06/07/2015 11:40
Age : 800 Hours	Test Speed : 25.000 mm/min
	Pretension : Off
	Diameter : 0.150 mm
	Sample Length : 90.000 mm

Test No	Force @ Peak (N)	Elong. @ Peak (mm)	Strain @ Peak (%)	Diameter (mm)	Stress @ Peak (N/mm ²)
1	4.300	18.730	20.811	0.210	124.148
2	3.900	17.384	19.316	0.210	112.599
3	3.400	17.582	19.536	0.210	98.164
4	4.400	18.631	20.701	0.210	127.035
5	5.400	22.417	24.908	0.210	155.907
Mean	4.280	18.949	21.054	0.210	123.571
S.D.	0.740	2.031	2.256	0.000	21.353

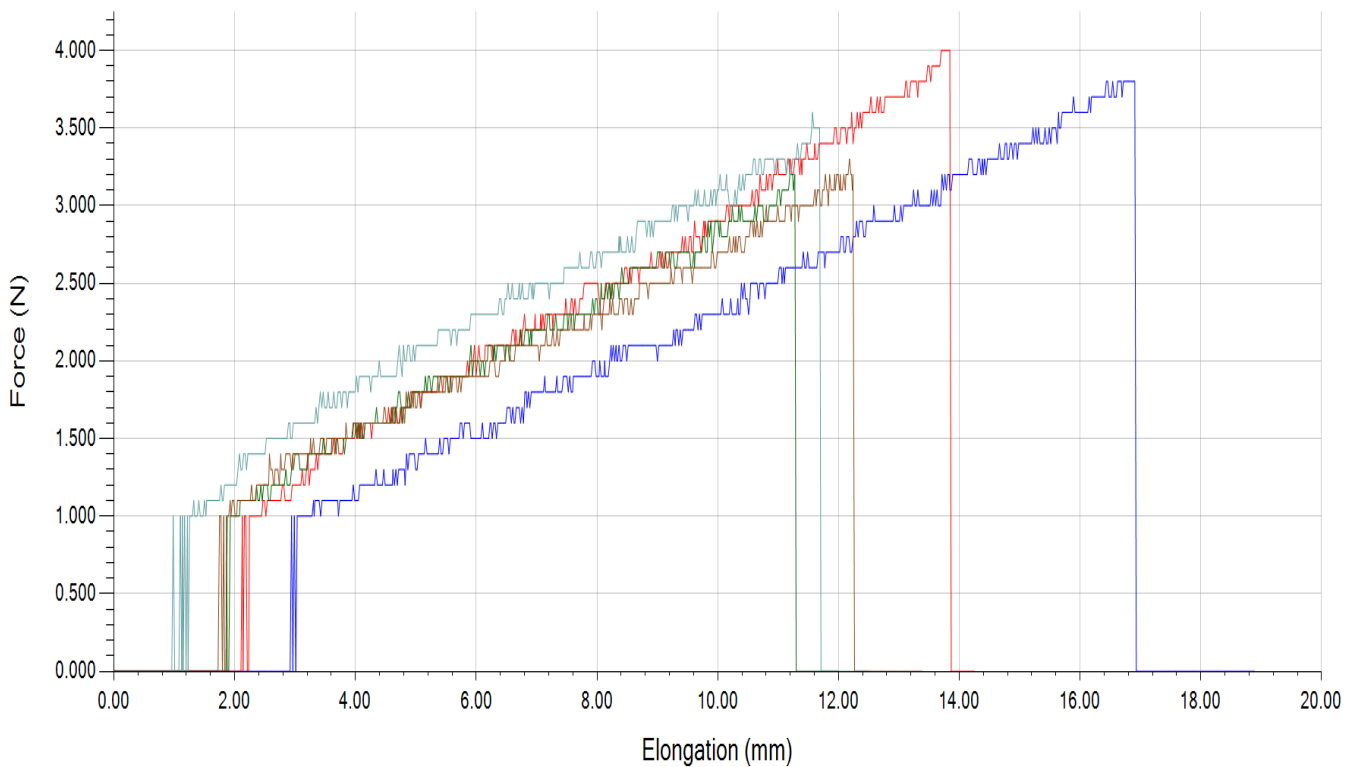
Client : Spire	Test Name : ISO 2062 Line
Job Number : F5144-1	Test Type : Tensile
Material : 2	Test Date : 27/07/2015 13:55
Age : 1200 Hours	Test Speed : 25.000 mm/min
	Pretension : Off
	Diameter : 0.150 mm
	Sample Length : 90.000 mm

Test No	Force @ Peak (N)	Elong. @ Peak (mm)	Strain @ Peak (%)	Diameter (mm)	Stress @ Peak (N/mm ²)
1	3.800	16.435	18.261	0.210	109.712
2	4.000	13.701	15.223	0.210	115.487
3	3.200	11.195	12.439	0.210	92.389
4	3.300	12.182	13.536	0.210	95.276
5	3.600	11.568	12.853	0.210	103.938
Mean	3.580	13.016	14.462	0.210	103.360
