# **MICROWAVE PATH SURVEY REPORT**

## **RADIO FREQUENCY INTERFERENCE (RFI) MEASUREMENT REPORT**

ViaSat

**November 17, 2014**

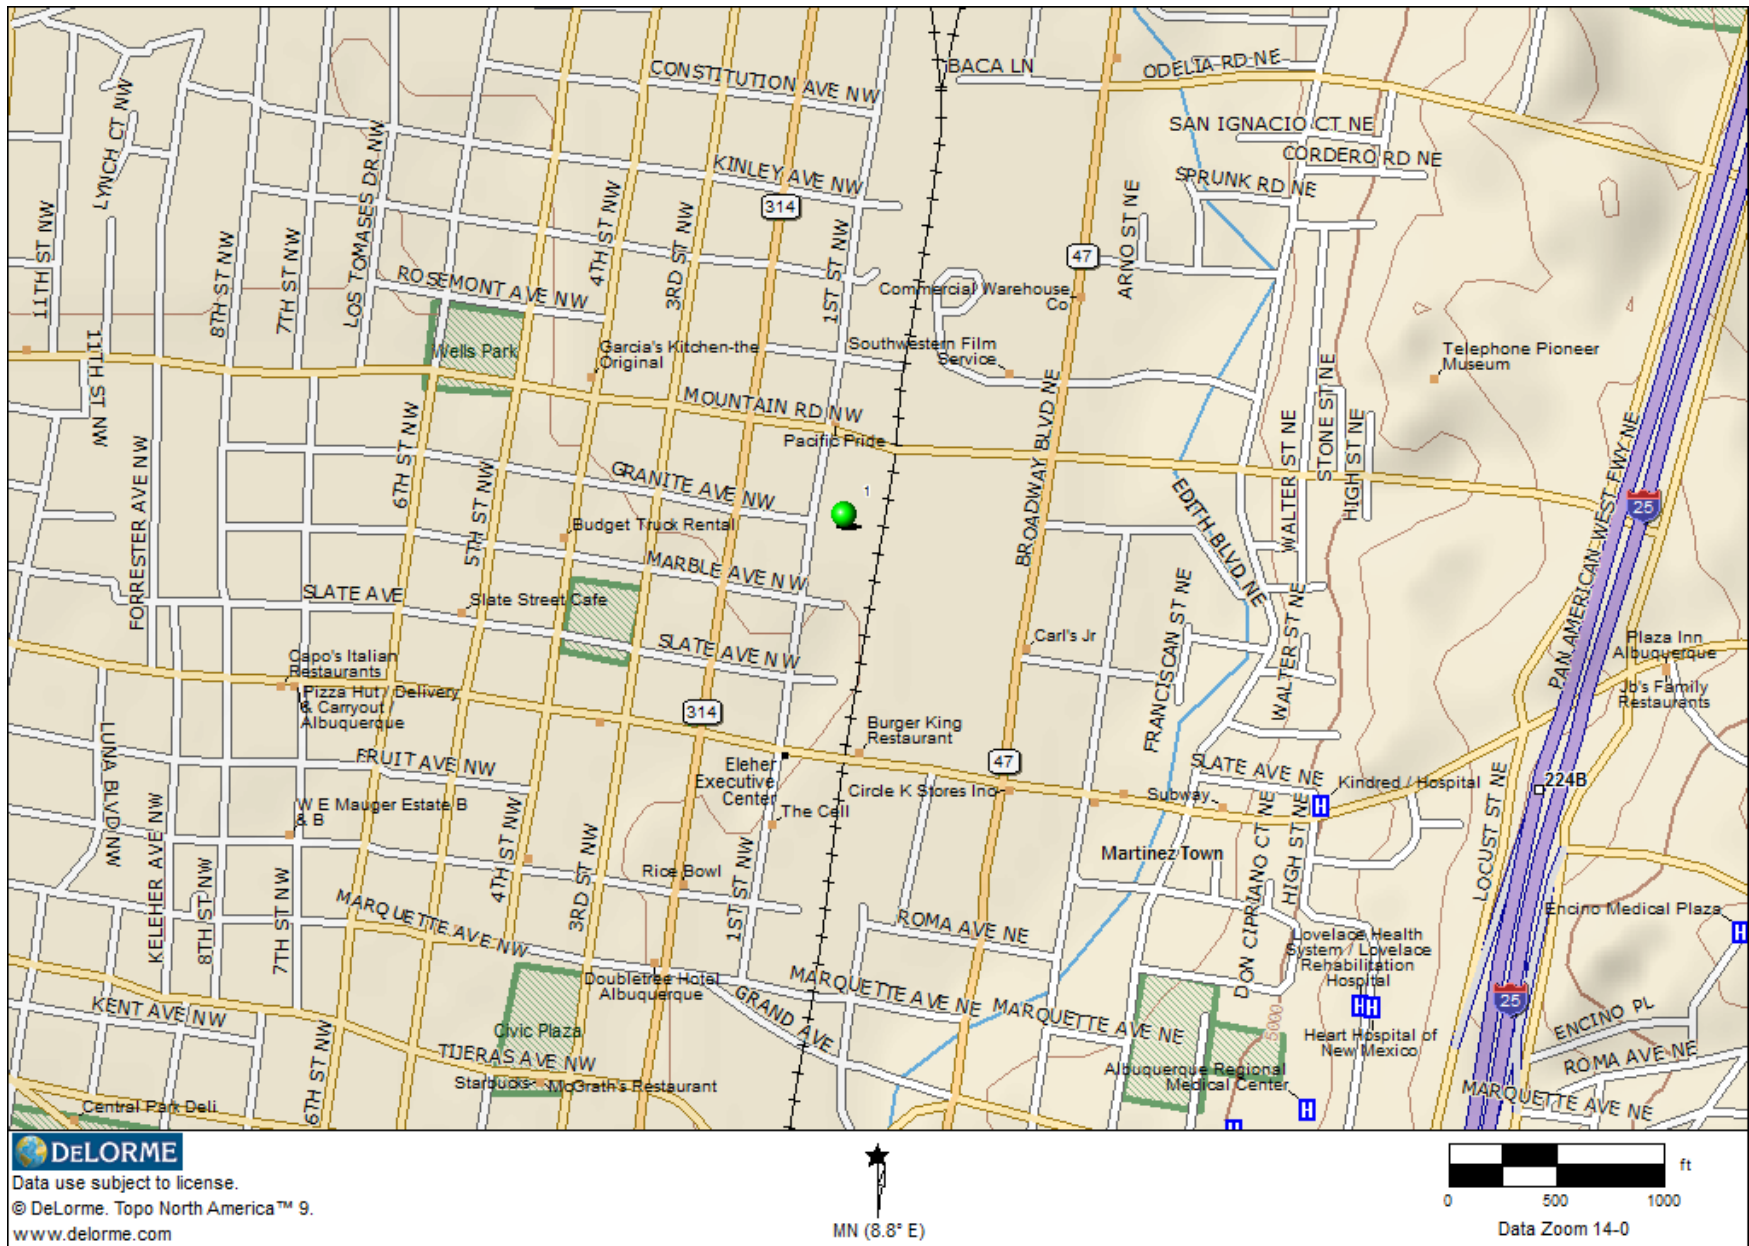
Figure 1.2-1 – Topographic Map

The measured site is identified on a portion of a topographic map shown in Figure 1.2-1. An aerial photo of the site location is shown in Figure 1.2-2. A photo of the measurement using a GPS is shown in Figure 1.2-3.

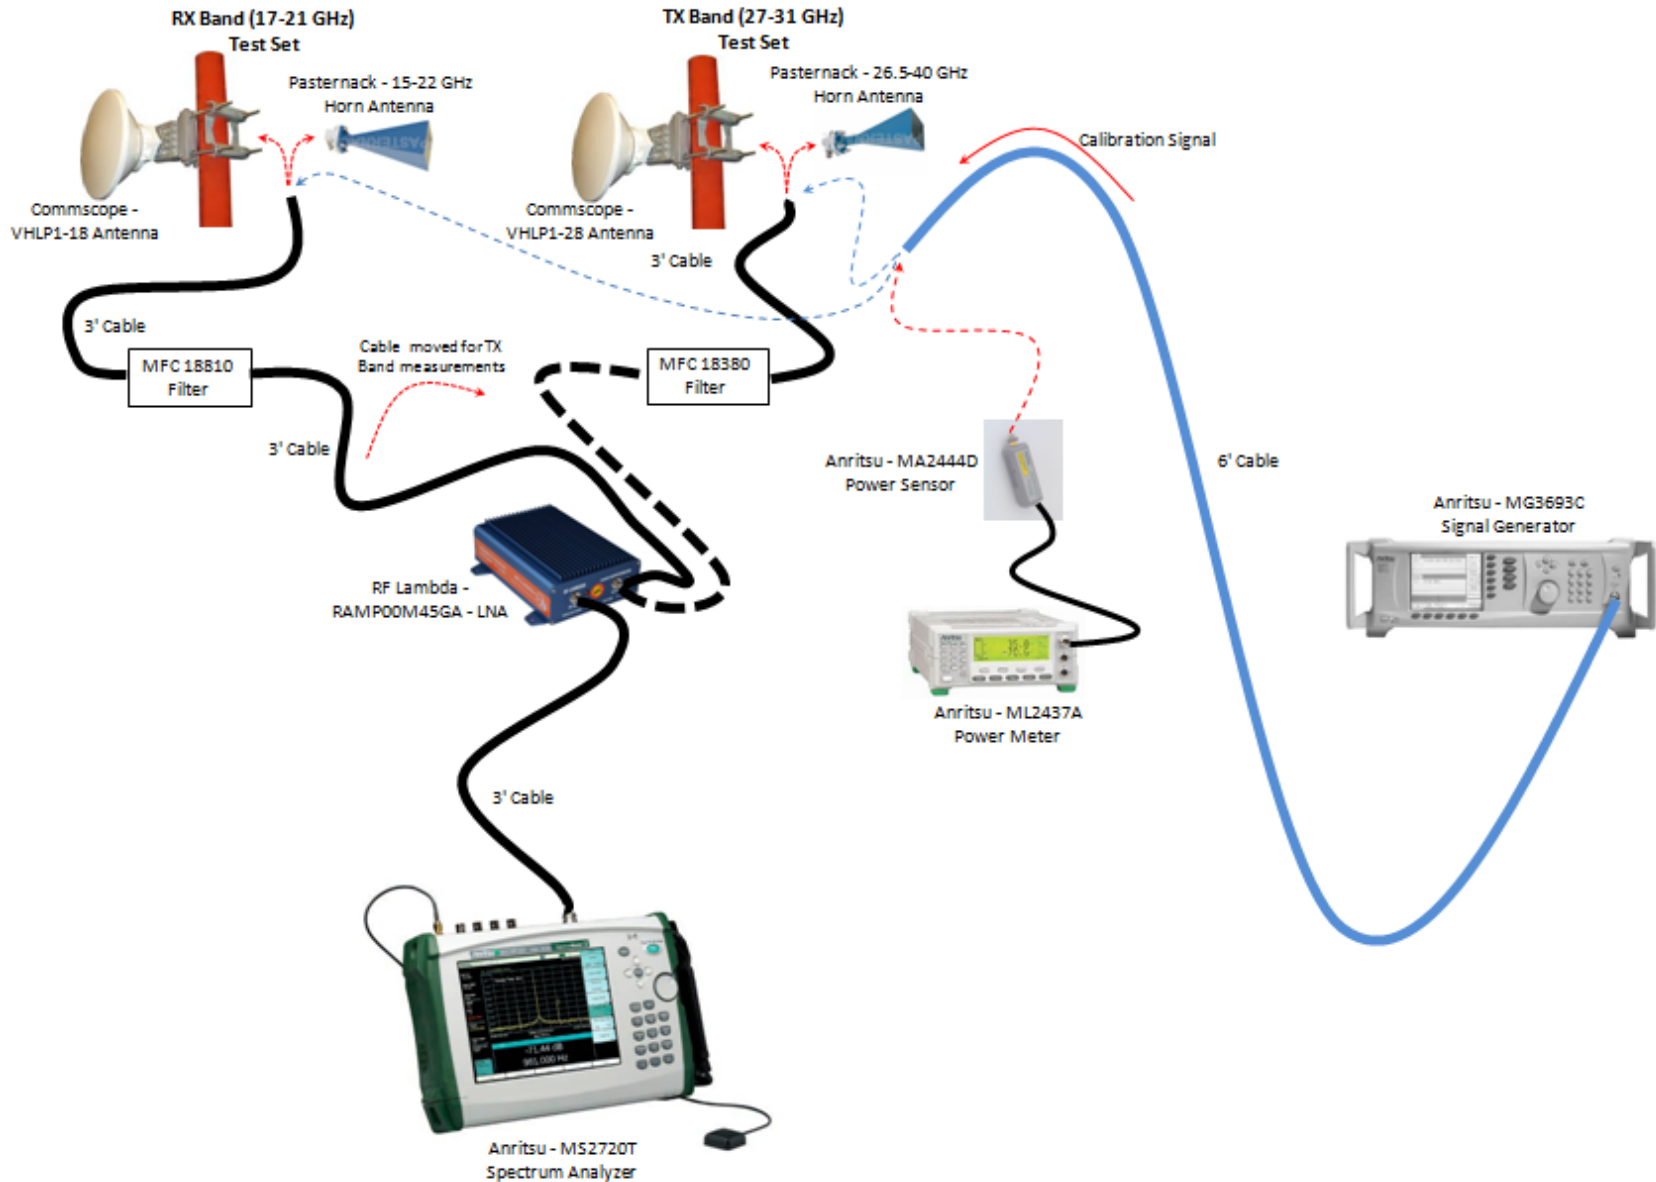
Figure 2.1-1 Receive Test Equipment Block

Figure 2.1-1 is the block diagram of the test set for all bands to be tested. All test equipment used was allowed a proper warm-up period prior to calibration. The test set was calibrated by the signal substitution method, as recommended by NSMA, utilizing a synthesized signal generator. The reference signal from the signal generator was adjusted for the center frequency of each band to be tested and measured with a thermal power meter for calibrated reference test level (-60 dBm). This calibrated reference signal from the signal generator was then injected into the end of the coaxial cable of the test set at the point, which normally connects to the test antenna. A spectrum analyzer then measured the reference test signal level after passing through the test set. At this point, the spectrum analyzer was calibrated such that the top graticule of the spectrum analyzer display (-60 dBm) corresponded to the injected reference signal (-60 dBm) by utilizing the reference level offset function of the Anritsu – MS2720T spectrum analyzer. Upon completion of the calibration process, a known reference level was obtained for the measurements that correspond to a given set of spectrum analyzer display readings.

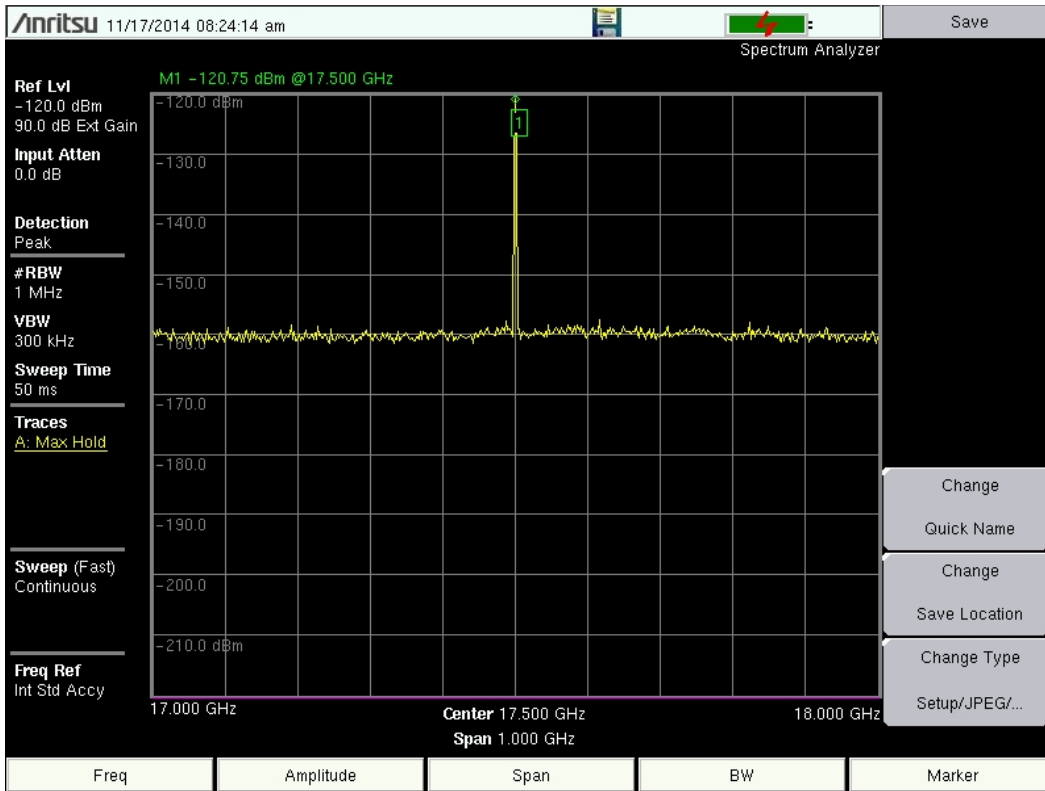
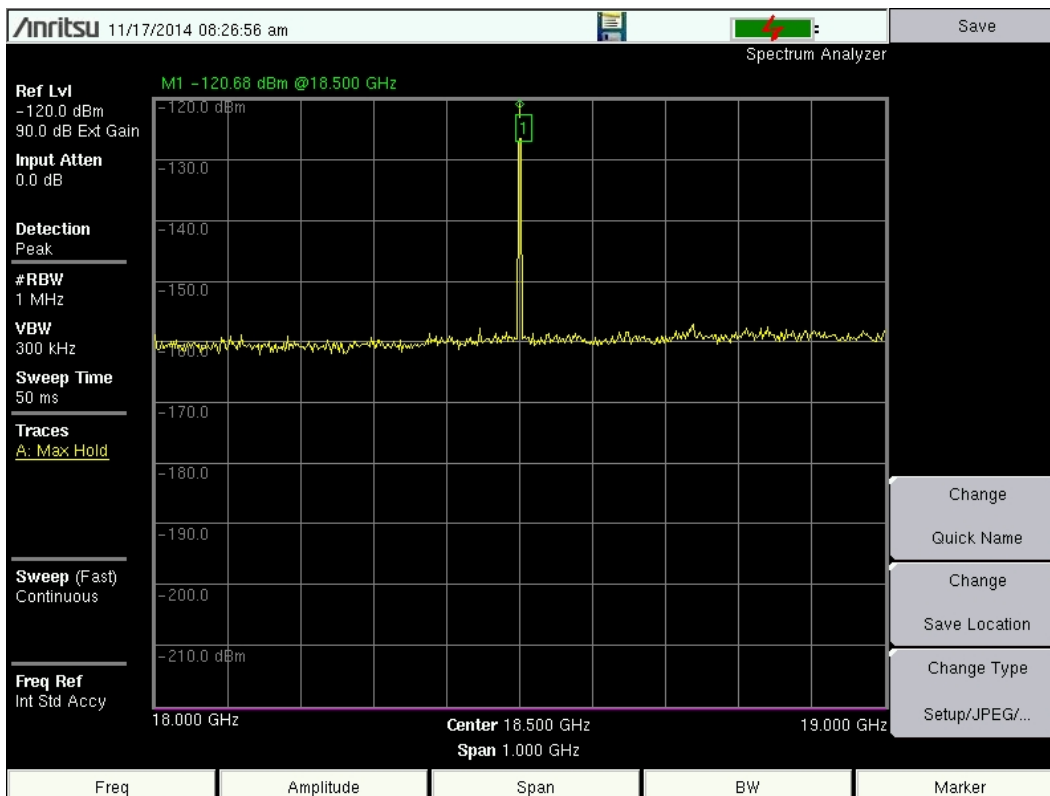
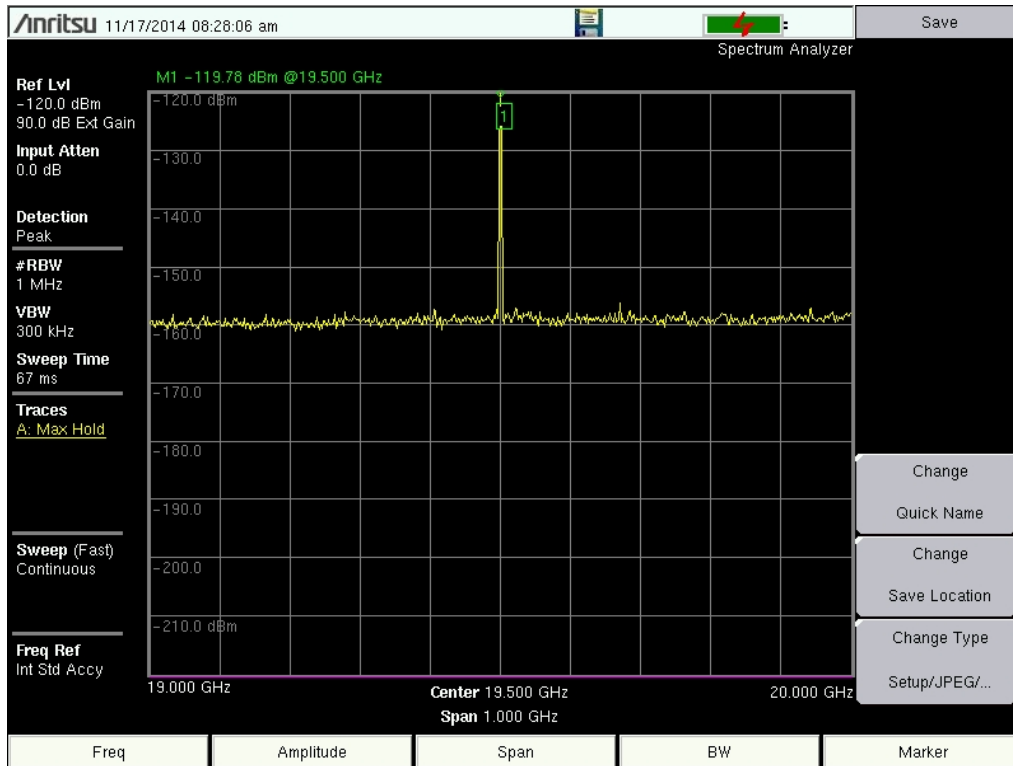
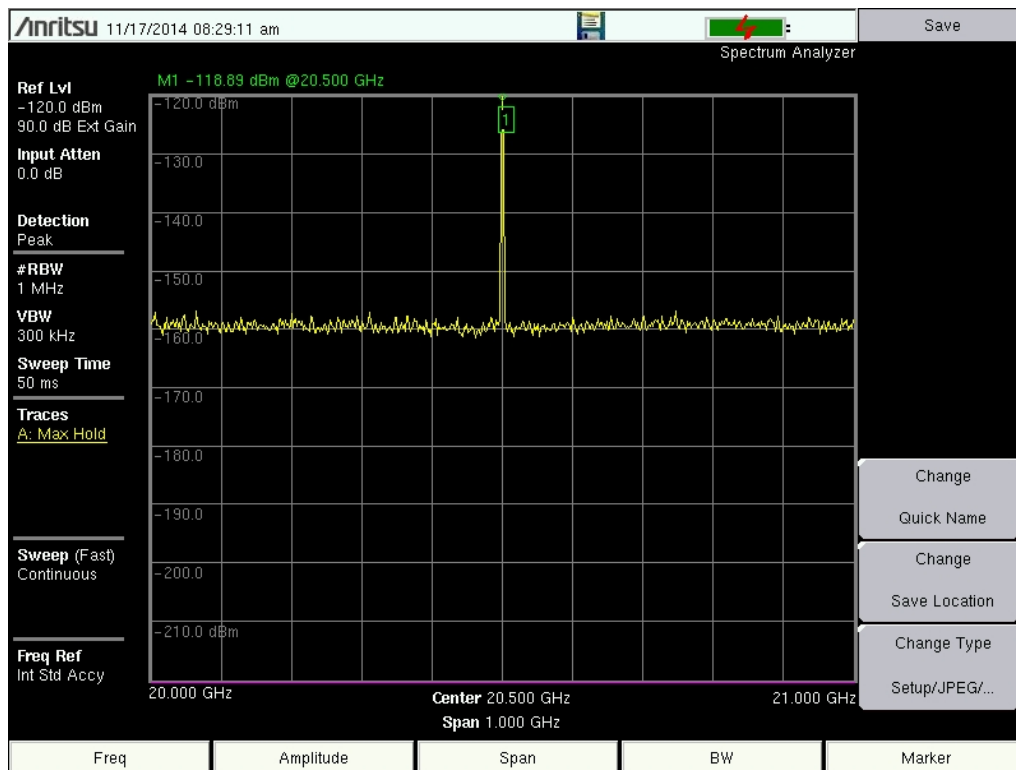
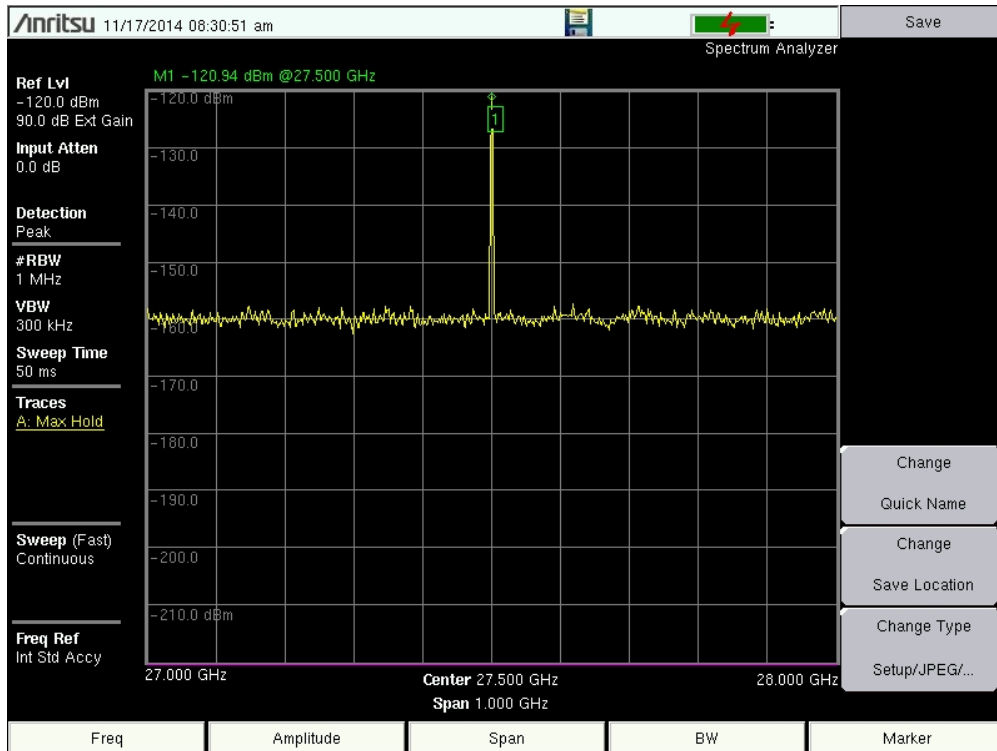
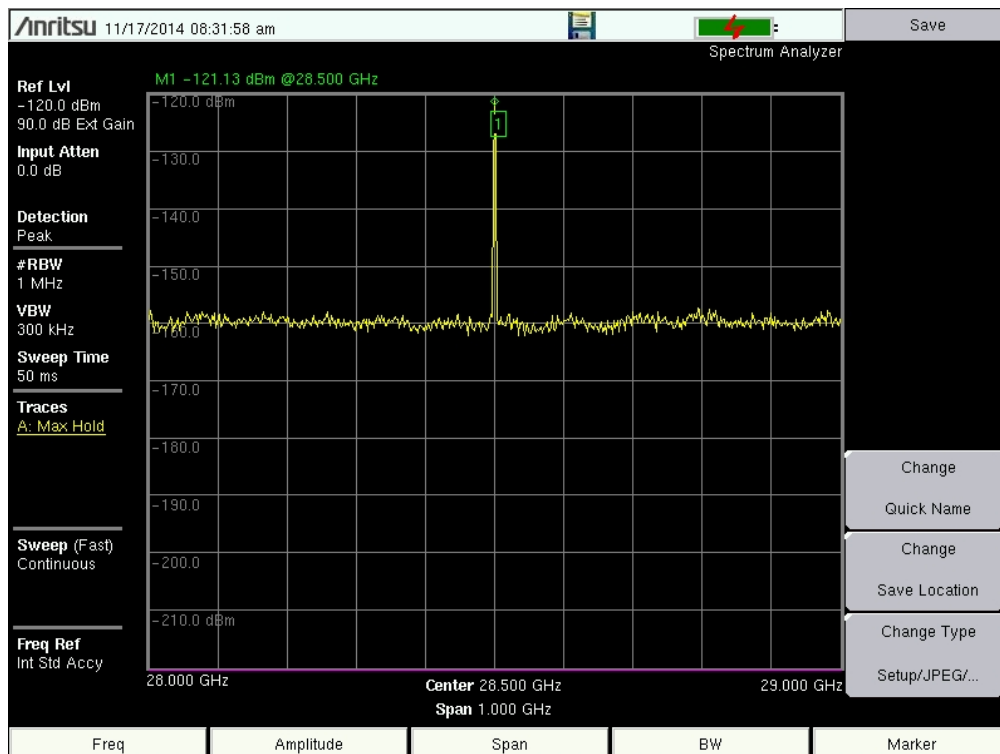
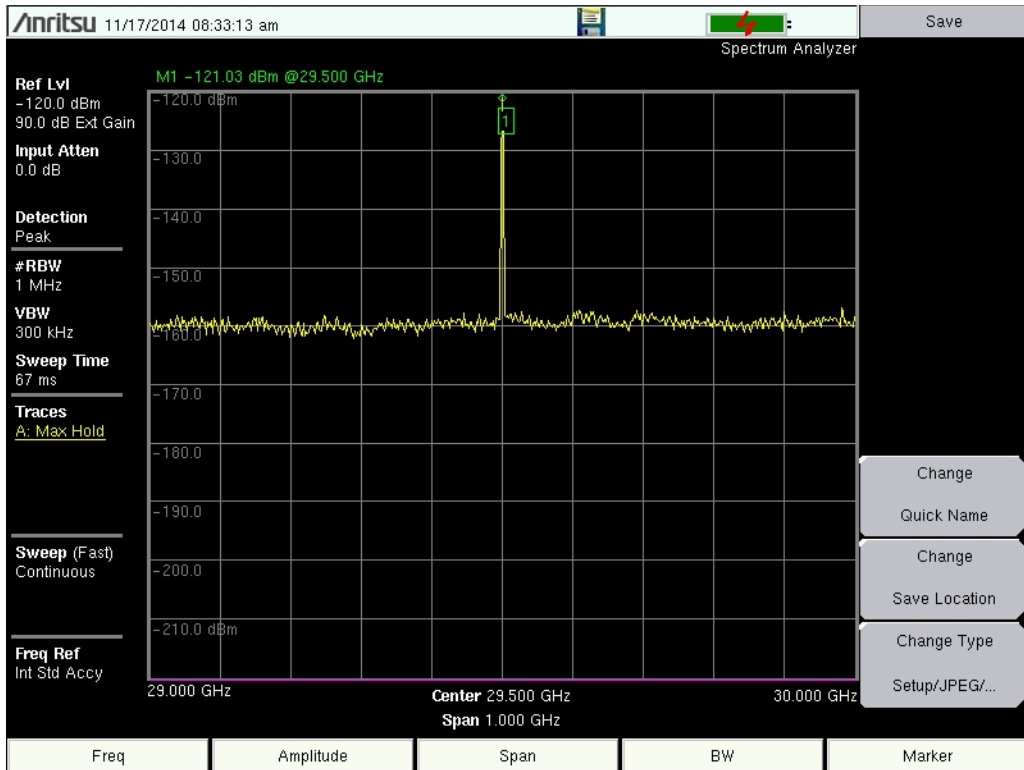
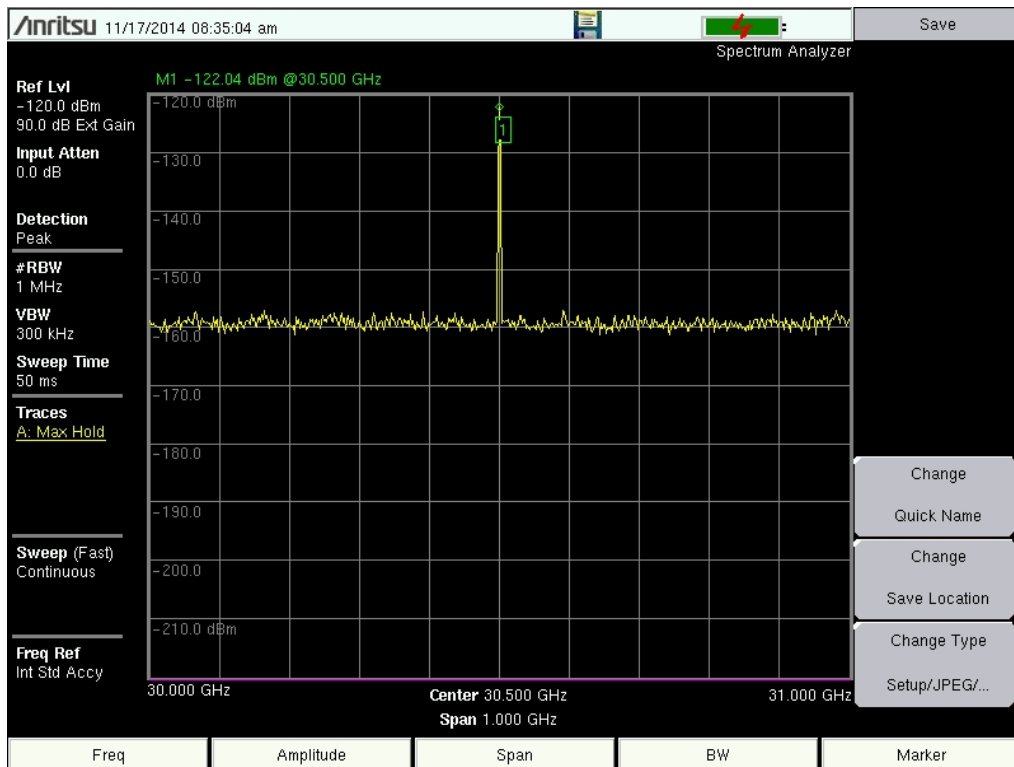
$$\begin{aligned} \text{at 19.5 GHz: } \quad \text{dBW}_I &= -60 \text{ dBm} - 30 \text{ dB} - 30 \text{ dB} \\ &= -120 \text{ dBW}_I \end{aligned}$$

In this instance, the spectrum analyzer displayed measured signal level of -60 dBm equates to an isotropic signal level of -120 dBW<sub>I</sub>.

Figures 2.1-2(A-H) displays the spectrum photographs of the described calibration procedure employed during these measurements.

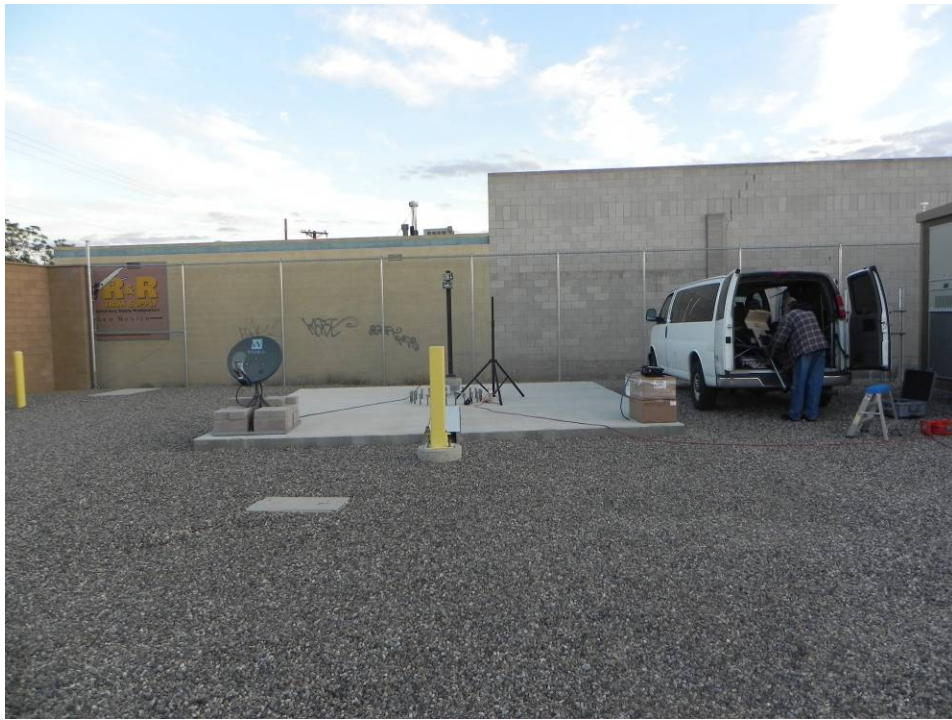
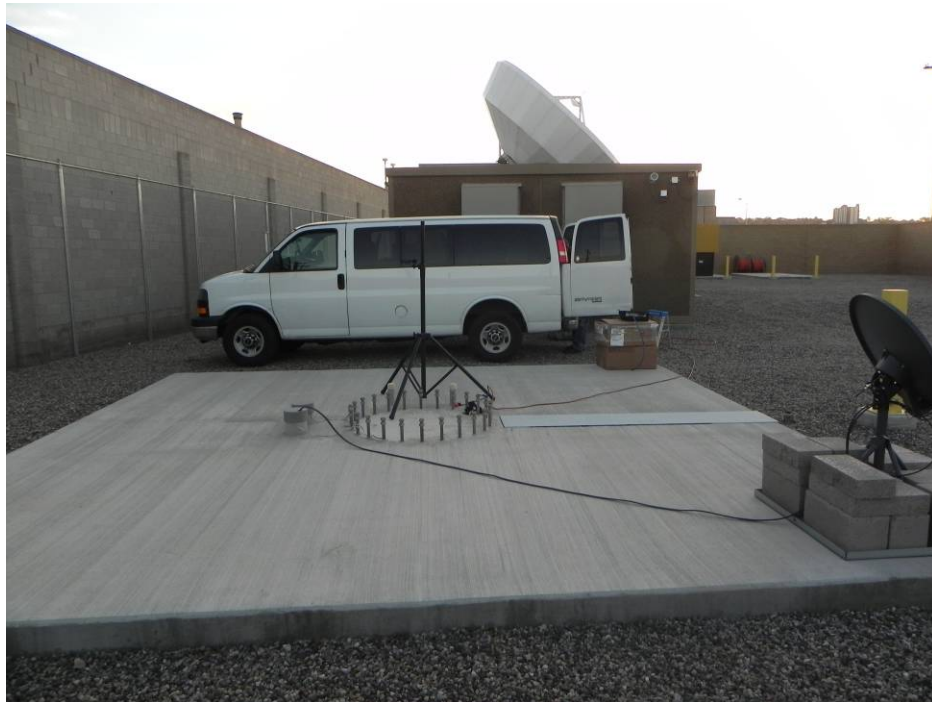
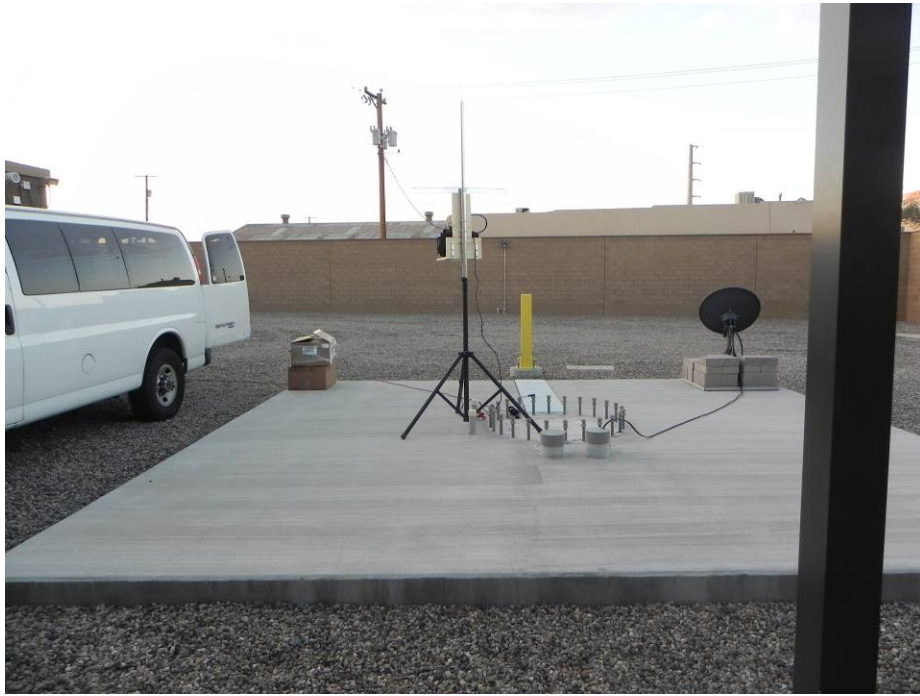
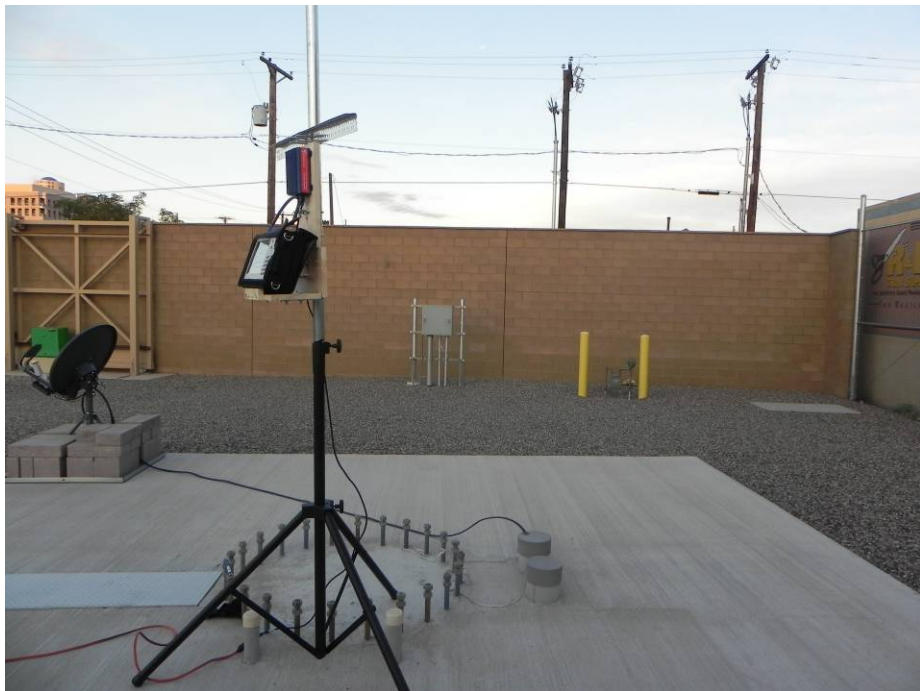
Figure 3.1-1 Earth Station Site Photographs

| 8. GEOSTATIONARY ARC VISIBILITY: | Satellite arc has no blockage at this time |

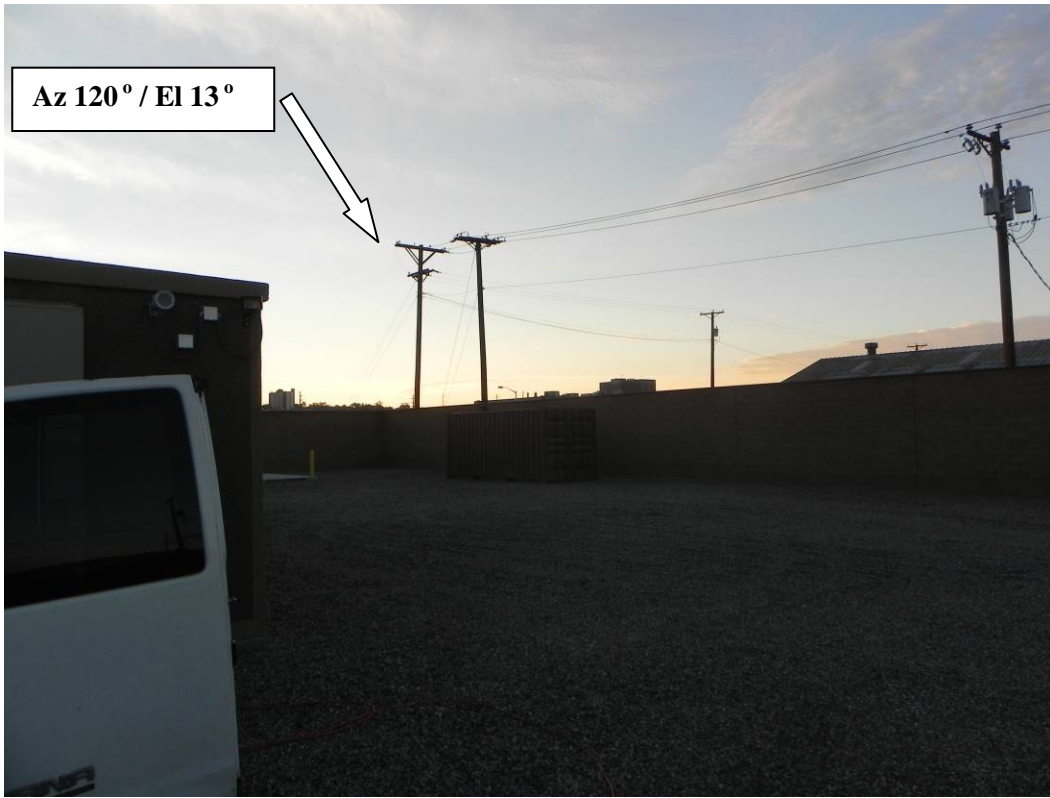
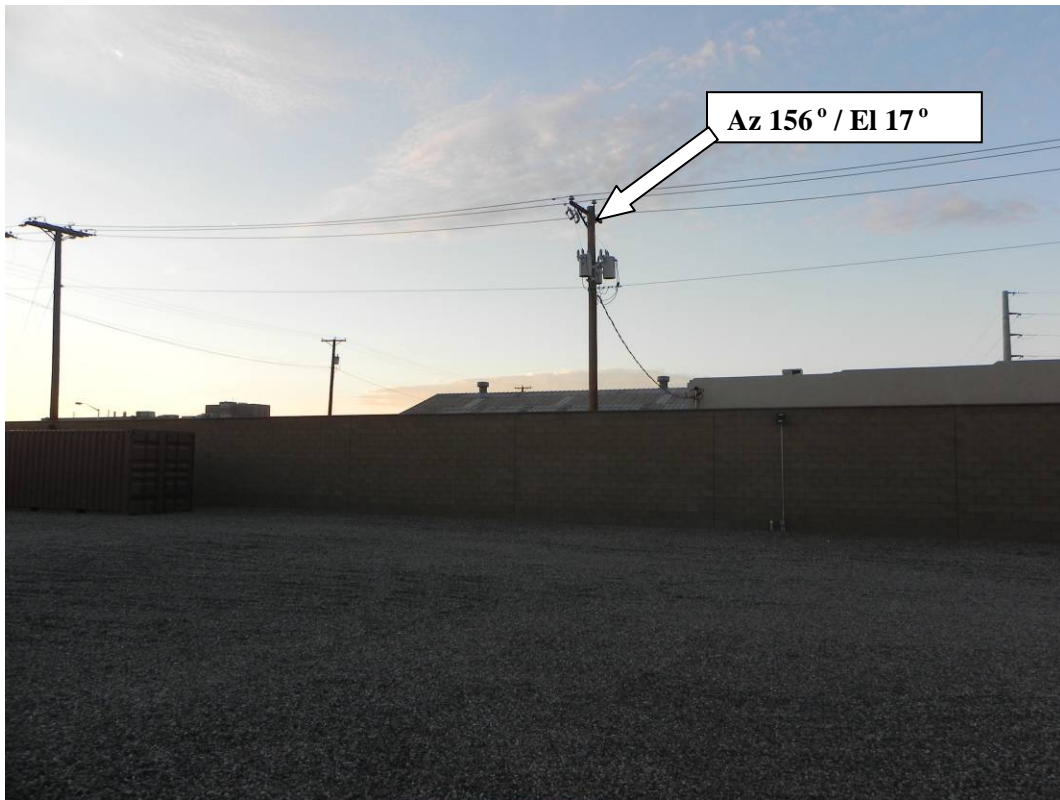
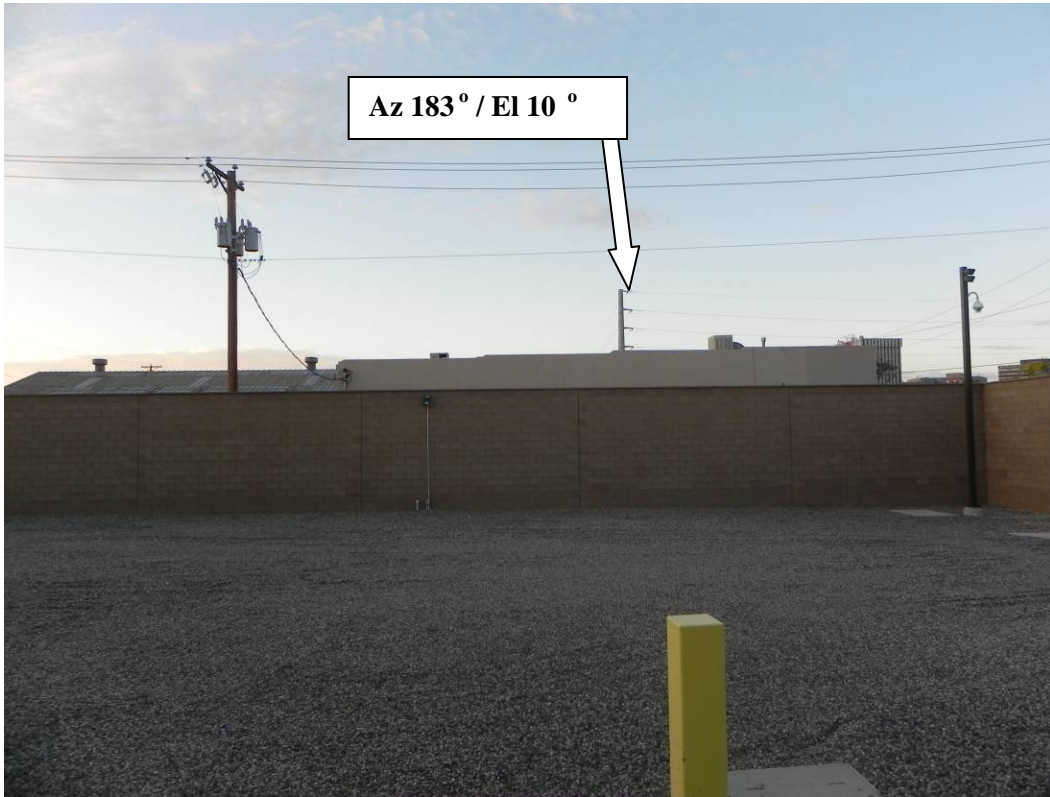
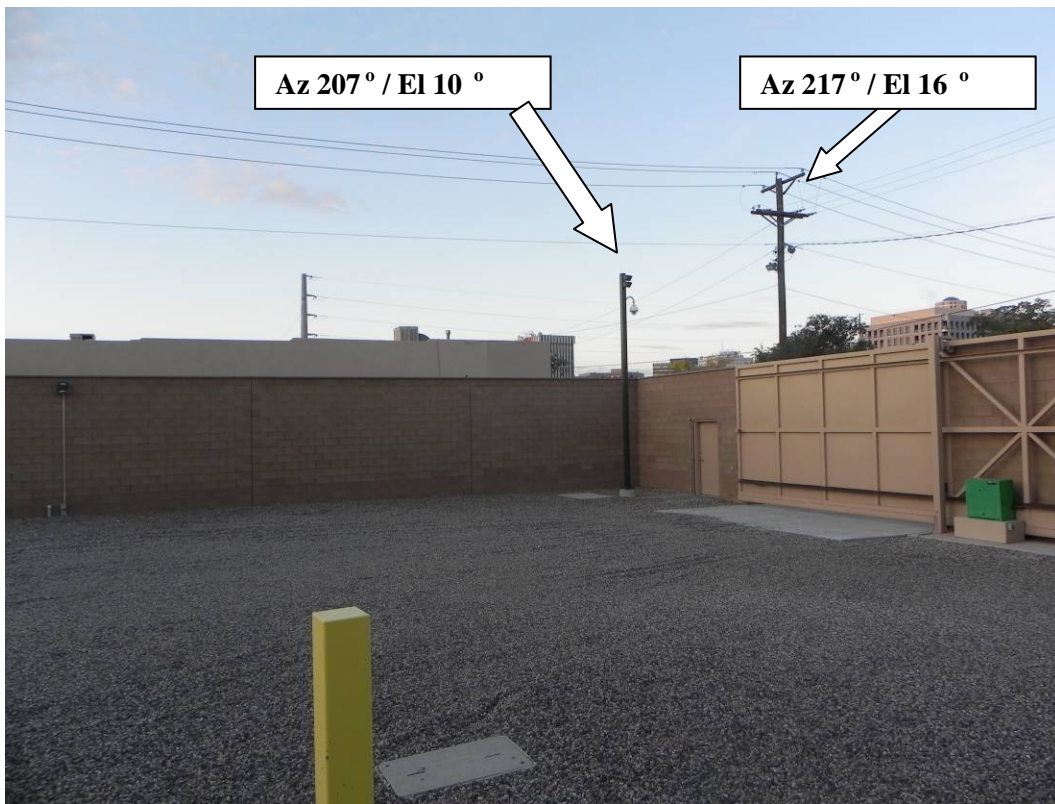
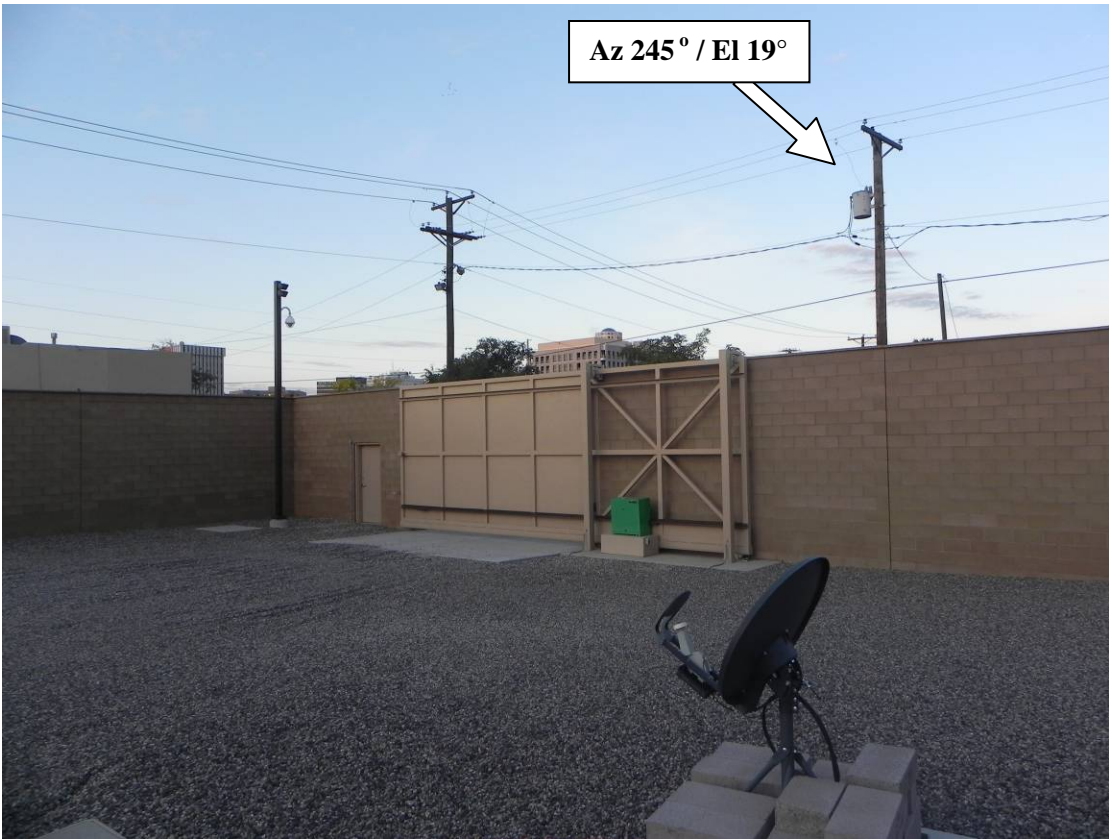
Figure 3.1-2 Horizon Photographs of Earth Station Site

- Table 3.1-1 presents a site data sheet including all pertinent site information.
- Figures 3.1-1 and 3.1-2 are the photographs depicting the existing earth station site and satellite arc.
- Figures 3.1-3 through 3.1-10 are the RF spectrum photographs depicting the interference environment at the test site.

There is no potential satellite arc blockage at this site. Final arc clearance will depend on antenna placement.

The satellite arc has no potential blockage from 55W through 115W.

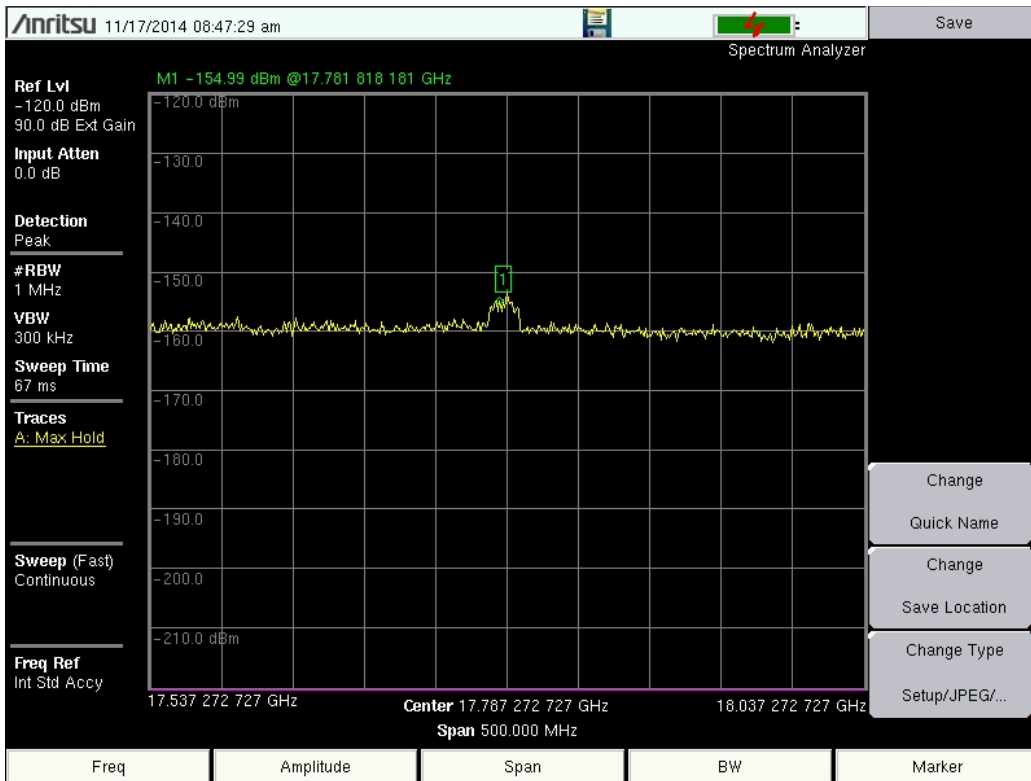
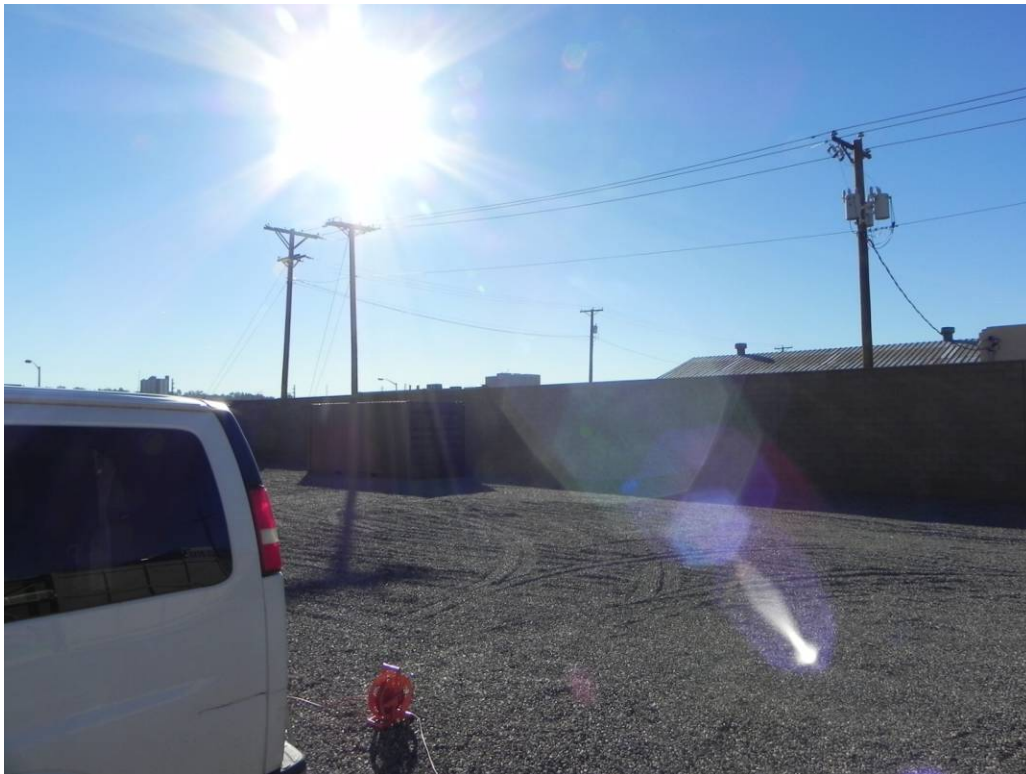
**FIGURE A1.2.1-A (4 – Crest Site)**

Based on actual On-Site measurements at the Albuquerque ViaSat location of the 15 possible interference cases there were five (5) signals detected of known licensed broadcasts in the Receive bands. This Addendum contains the spectral photo of the received carrier as well as the direction and possible transmit site for each.

ViaSat, Inc should review the system parameters for this down-link in order to verify the viability of this objective. It is recommended that frequency coordination of this site be initiated to protect this location at the more stringent digital receive interference objective.

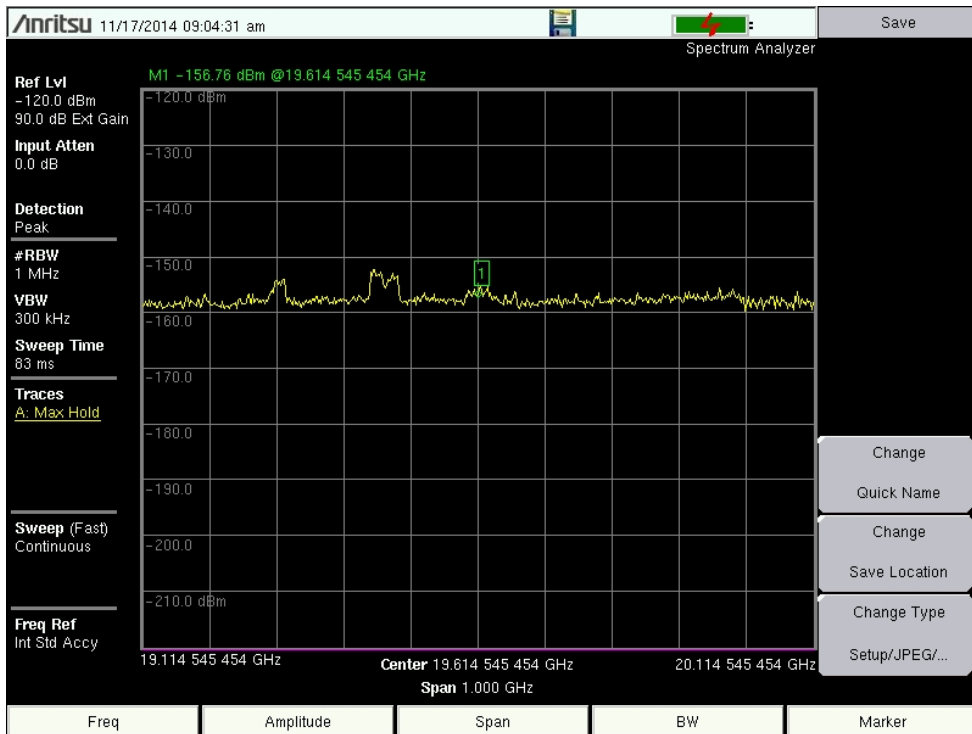
**FIGURE A1.2.4-A (Unknown)**

There was also one signal detected from an unknown source apparently transmitting from an adjacent building just outside the proposed arc, at approximately  $222^{\circ}$ . Photos are shown below in Figures A1.2.1- A1.2.6. The licensed site name is in parenthesis after the figure number.

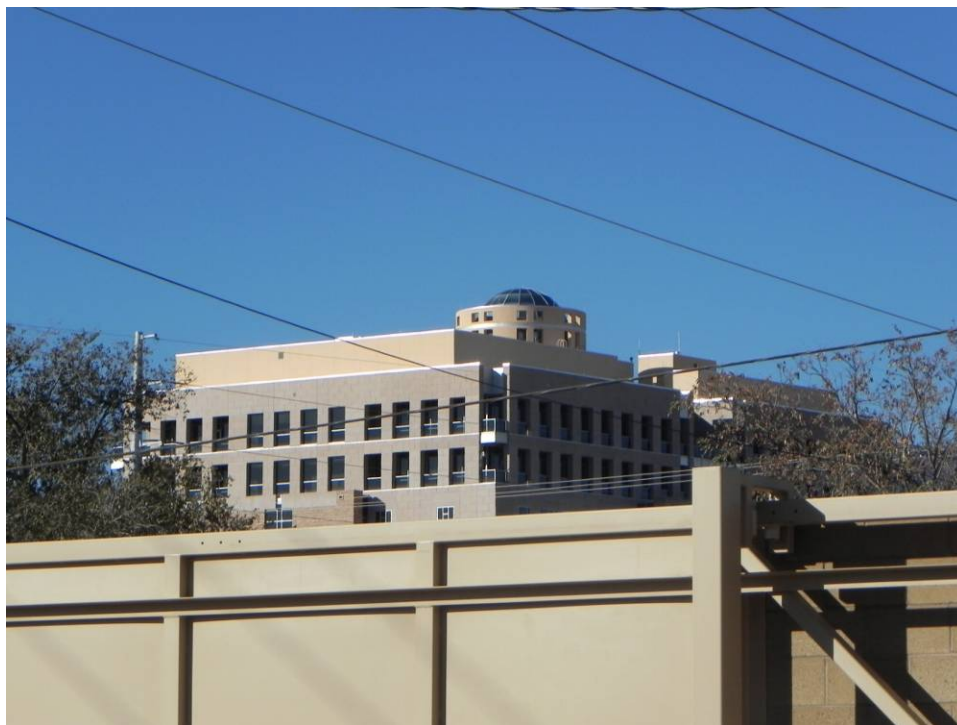
**FIGURE A1.2.4-B (Unknown)**

There was six (6) radio frequency interference cases measured at this site above the noise floor of the test equipment. Fifteen (15) cases were predicted but only six (6) were observed during the measurement period (See Addendum 1).
