MICROWAVE PATH SURVEY REPORT

RADIO FREQUENCY INTERFERENCE (RFI) MEASUREMENT REPORT

ViaSat

Transmit and Receive Earth Station
17-21 GHz and 27-31 GHz

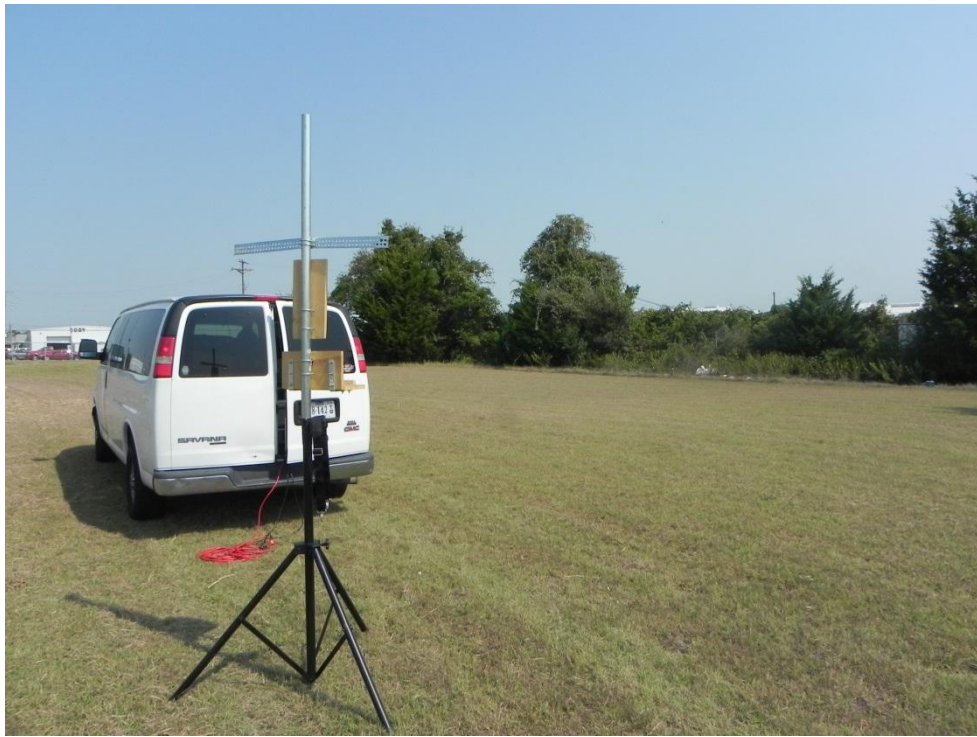
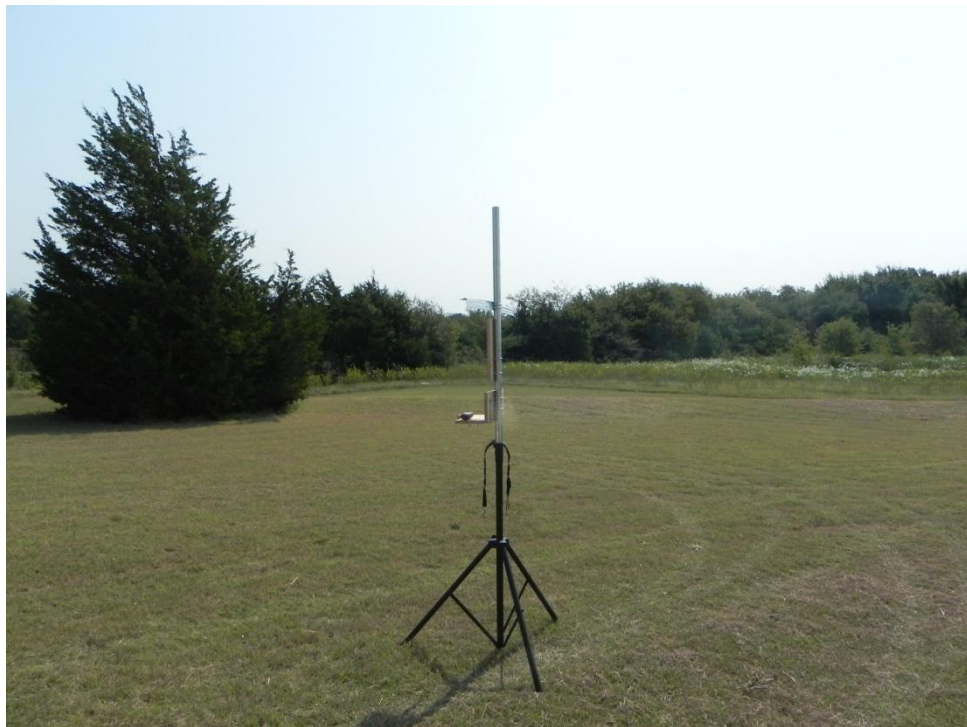
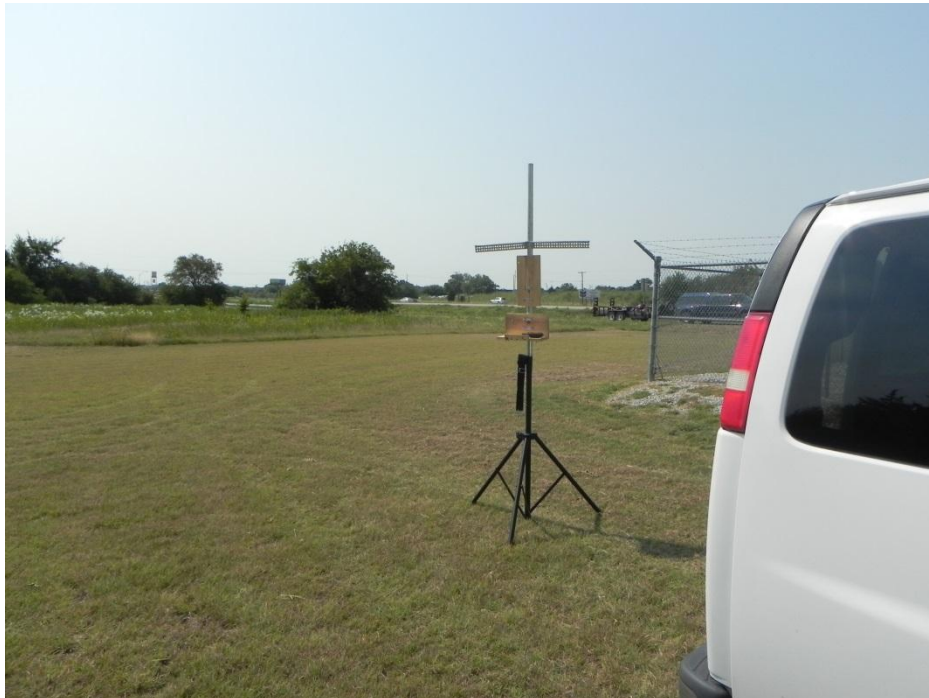
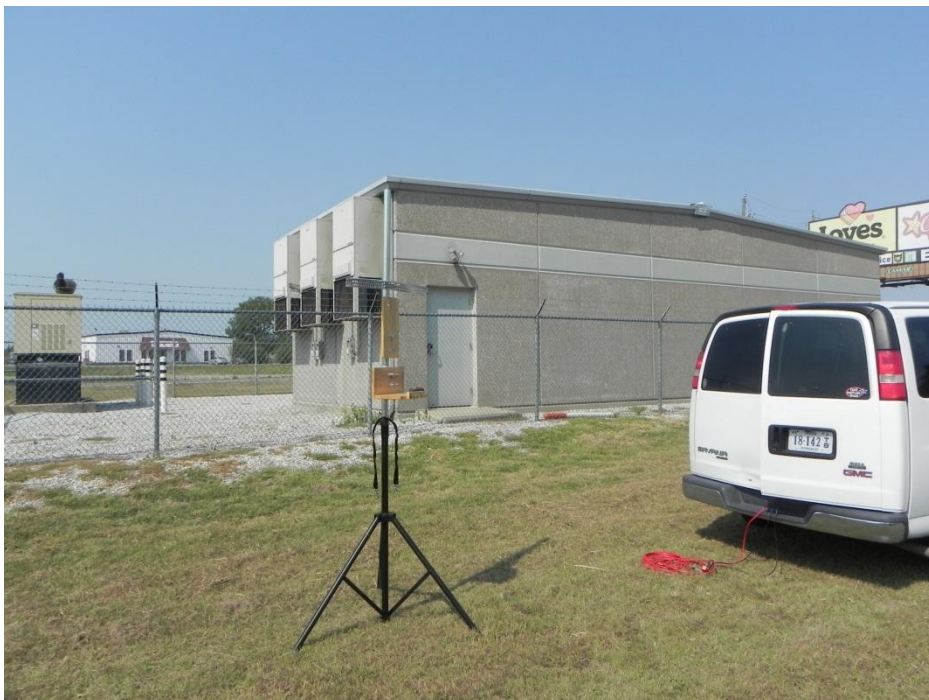
Figure 3.1-1 Earth Station Site Photographs

- Table 3.1-1 presents a site data sheet including all pertinent site information.
- Figures 3.1-1 and 3.1-2 are the photographs depicting the existing earth station site and satellite arc.
- Figures 3.1-3 through 3.1-10 are the RF spectrum photographs depicting the interference environment at the test site.

| 8. GEOSTATIONARY ARC VISIBILITY: | Satellite arc has no blockage at this time |

There is no potential satellite arc blockage at this site. Final arc clearance will depend on antenna placement.
